**RAILROAD SPECIAL INVESTIGATION
REPORT**

**DERAILMENT OF AMTRAK TRAIN NO. 12 AND
SIDESWIPE OF AMTRAK TRAIN NO. 79 ON PORTAL
BRIDGE NEAR SECAUCUS, NEW JERSEY,
NOVEMBER 23, 1996**

**Adopted: December 18, 1997
Notation 6813B**

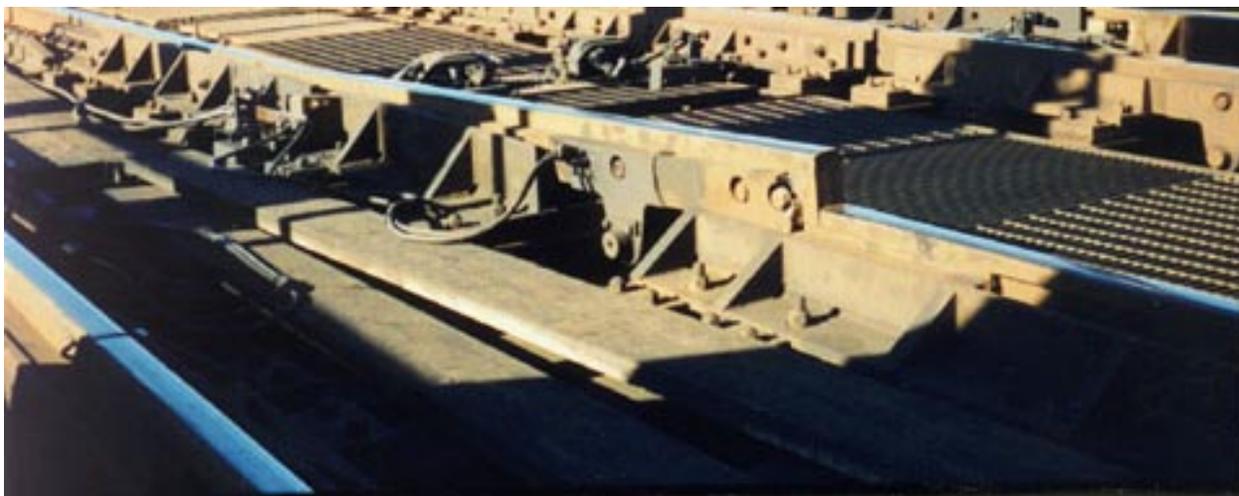
Neither the bridge operator nor the B&B technician was aware that, during the aborted bridge opening, a 10-foot 6-inch movable section of the north rail of track 1 became improperly aligned. While the west-facing portion of the rail section mated properly with the rail on the approach to the bridge, the trailing end was elevated 5 inches above the track with which it was supposed to align. (See figure 2.) As a result, the right lead truck of any *westbound* train crossing Portal Bridge on track 1 would have struck the elevated butt end of the misaligned rail, and the left lead truck of any *eastbound* train would ride up the "ramp" created by the rail and then drop off the elevated end. Because the mitered end of the rail was positioned properly and electrical continuity was maintained throughout the misaligned rail, the signals governing train movements along track 1 over the bridge continued to display a clear aspect.

Figure 2 — Looking west at the west end of track 1. The heel of the miter rail is elevated about 5 inches above the running rail, creating a ramp for the left side trucks of any eastbound train. (Photograph taken on the day of the accident after removal of the derailed equipment.)

When the bridge operator lowered the miter rails, the broken side bars on the heel of the track 1 north rail miter bar came to rest on top of the broken side bars of the running rail, leaving the miter rail surface about 5 inches higher than the running rail. This position corresponded to the position in which the miter rail was found after the derailment.

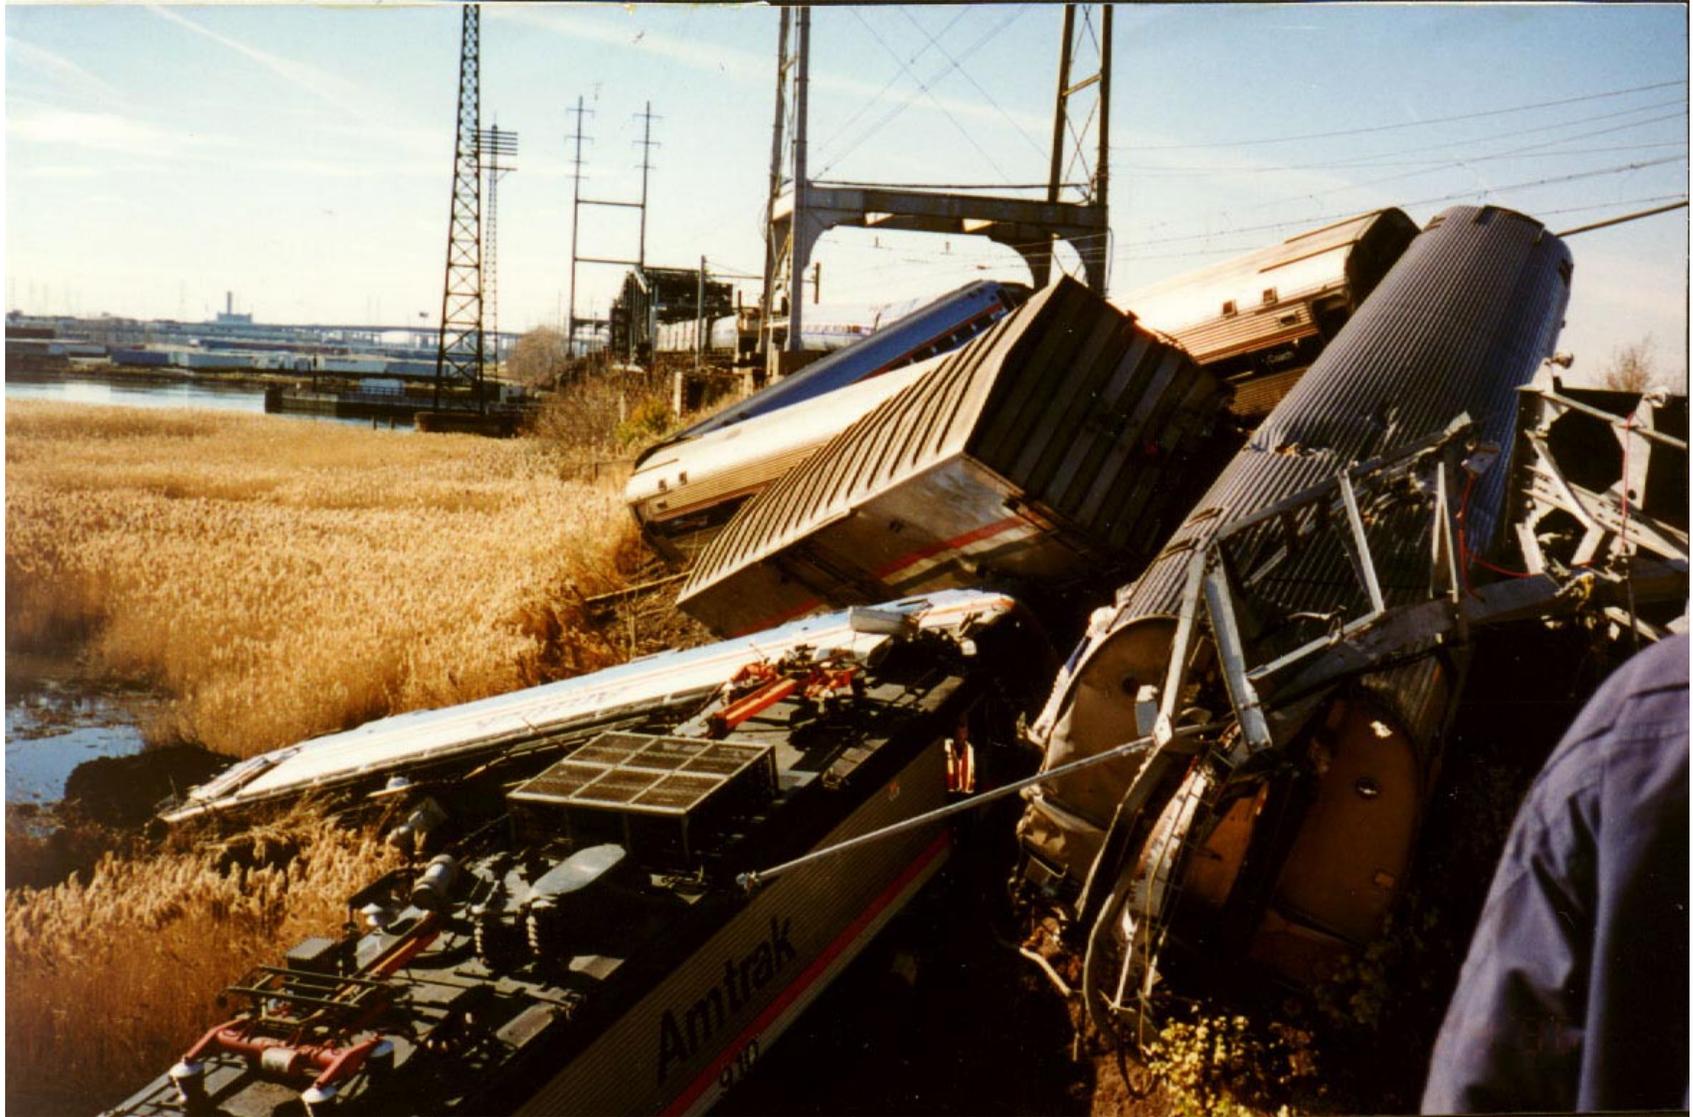
Train No. 79 sustained sideswipe damage but stopped with the entire train intact and on the rails west of Portal Bridge. Train No. 12 came to rest with both locomotives, one material handling car, and the three head passenger coaches entirely derailed and located in various positions to the south of track 1 and down the embankment at the east end of the bridge. (See figure 3.) The remaining eight cars of train No. 12 remained upright and in line, but they were all or partially derailed.

Figure 3 – Wreckage of train No. 12 at the east end of Portal Bridge

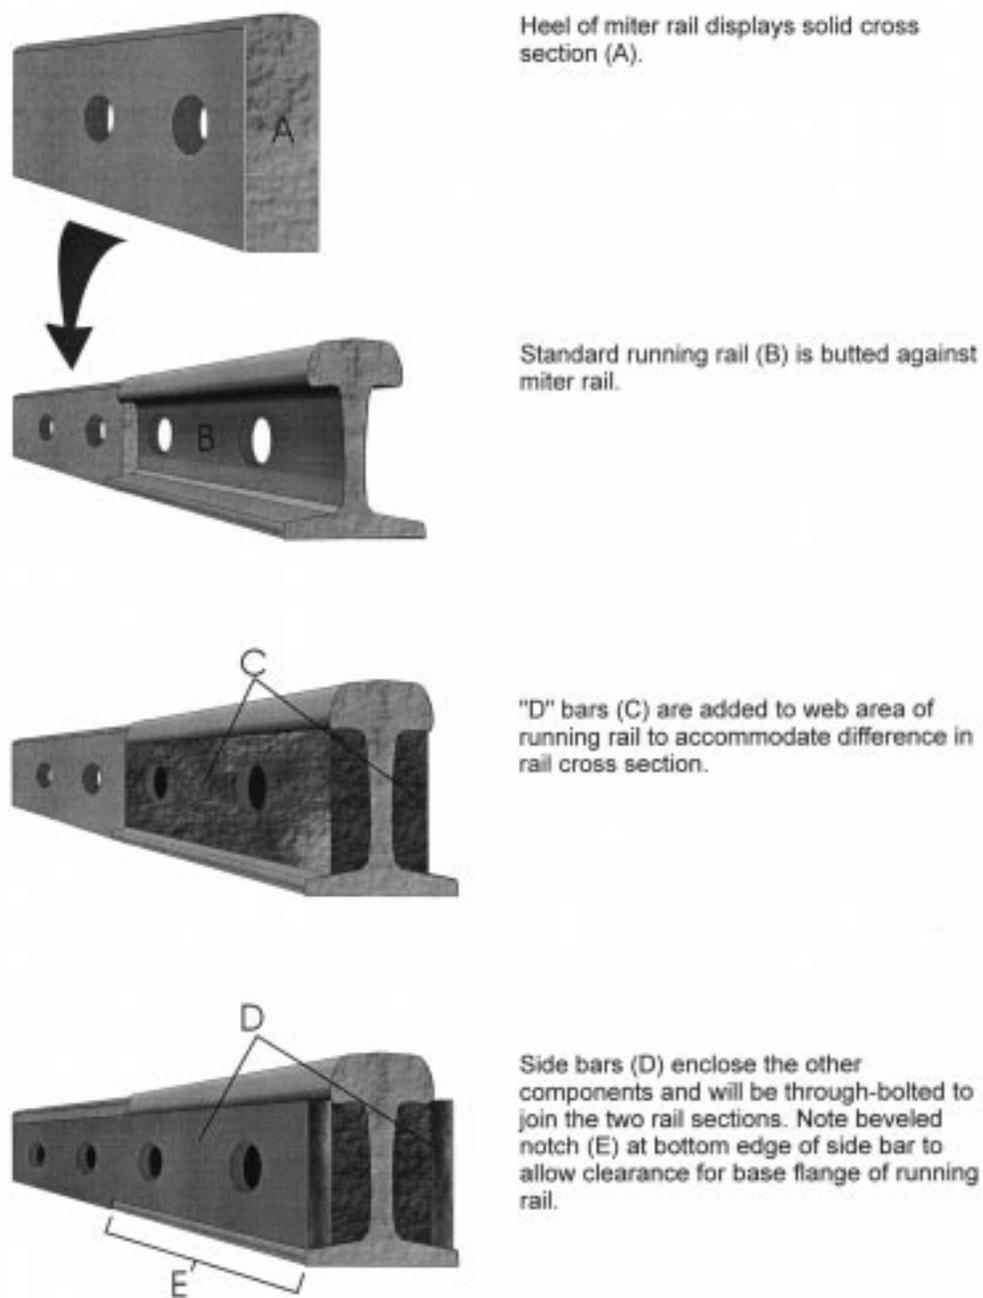
Heel of miter rail displays solid cross section (A).

Standard running rail (B) is butted against miter rail.

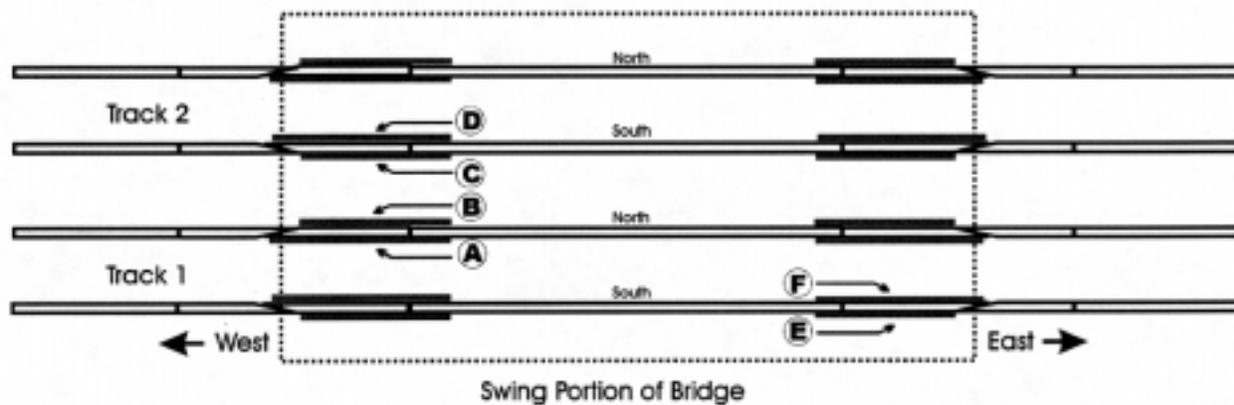
Metallurgical Information -- Six cracked or broken side bars were removed from Portal Bridge and examined in the Safety Board Materials Laboratory. For reference, the side bars were labeled “A” through “F.” (As indicated on figure 7 – opposite.) Side bars A, B, C, and D were broken into two pieces. Bars A and B had been broken through at the time of the postaccident inspection; bars C and D were cracked when inspected after the derailment and broke as they were being removed from the assembly. Bars E and F were cracked but not broken through.

All the fractures and cracks were located near the beginning point of the notch where the width of the side bar changed from the full width along the miter rail to the reduced width (to accommodate the base flange) along the running rail. This was also the area where the bottom edge of the side bar transitioned from straight (along the miter rail) to beveled (along the running rail, to clear the base flange). The engineering drawings for the side bars showed the beginning of the notch as a straight cut resulting in a 90° transition. Side bars E and F displayed such a straight, right-angle cut, but the beginning point of the notches on bars A, B, C, and D had the appearance of a curved chamfer. Because of cracking and fracturing, investigators could not obtain an exact measurement of the radii of any of the notch transitions.

Figure 7 — Location and identification of the six side bars removed from Portal Bridge and examined in Safety Board laboratories

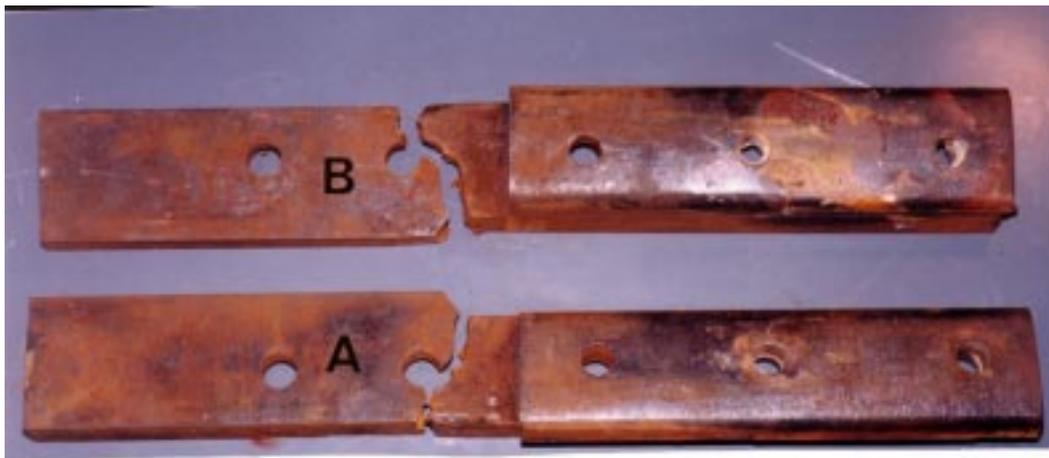
The fractured areas of side bars A and B (taken from the location of the misaligned miter rail) were cut from the side bars and are shown in figure 8 (opposite). Amtrak told the Safety Board that cracks in both these side bars had been welded during trackwork performed during April and August 1996. Remnants of the repair welds were visible on the lower bar surfaces and in the countersunk portion of the bolt holes. Weld beads on the exposed faces of both bars appeared to have been smoothed with a grinder, slightly reducing the thickness of bar A at the fracture location.

Examination of the cross section of the fracture area revealed that the weld repair beads had fractured generally in the same plane as the previously existing cracks. The welds only penetrated 1/4 to 1/2 of the thickness of the bars and did not completely consume the existing cracks in the lower fracture segments. The fractured welds and surrounding surfaces displayed areas of porosity, slag inclusions, and lack of fusion in the weld fusion zone. In some areas on both bars, molten weld metal and slag had flowed onto the crack surfaces and solidified without fusing to the crack surfaces.

Figure 8 — Inner surfaces (with D bars attached) of the broken side bars removed from the accident location

On both bars, the fatigue propagated upward completely across the lower fracture segments, intersecting with the bolt holes. Fatigue zones were also apparent on the upper fracture segments of both bars. The upper segments of both bars showed evidence of weld repairs that partially consumed the preexisting fatigue zones.

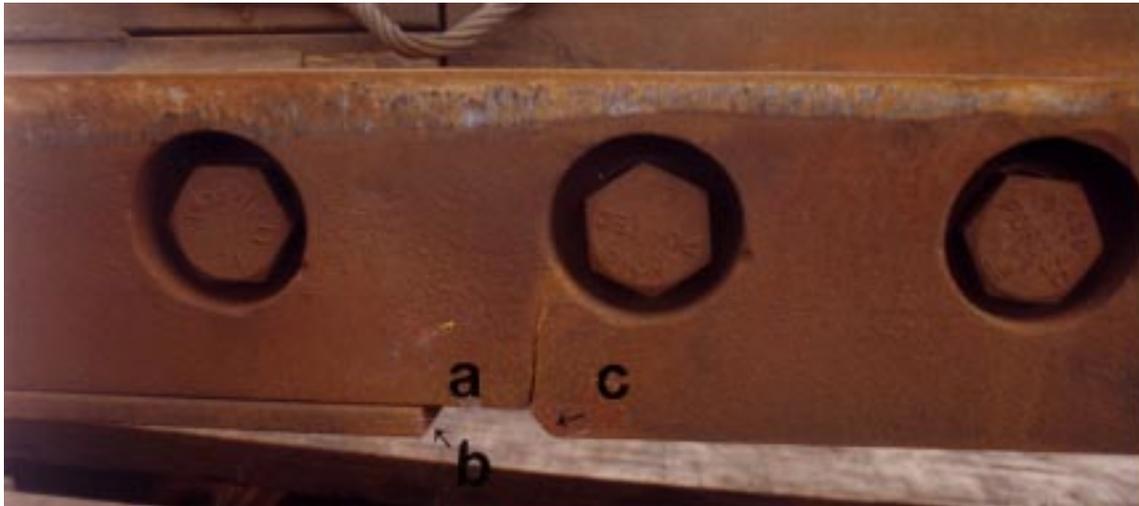
On February 15, 1996, the Amtrak supervisor of structures sent a memorandum regarding the cracked side bars to the director of structures maintenance and the assistant division engineer for structures. The memorandum advised that three of the eight miter rail side bars on the west end of Portal Bridge were cracked at the bolt holes near the joint with the running rail. Photographs were enclosed with the memorandum. (See figure 9 – next page.)

Figure 9 — One of the photographs of cracked Portal Bridge side bars sent in February 1996 by the Amtrak supervisor of structures to the director of structures maintenance and the assistant division engineer for structures. Note that the notch along the bottom edge of the side bar (a) extends beyond the end of the running flange (b), placing the transition to the notch (c) in proximity to a bolt hole.
