Railroad Accident Investigation Report

Report No. 79-10

**MISSOURI PACIFIC RAILROAD COMPANY
ST. LOUIS SOUTHWESTERN RAILWAY COMPANY
GORHAM, ILLINOIS
MAY 17, 1978**

RAILROAD ACCIDENT INVESTIGATION
ACCIDENT REPORT NO. 79-10

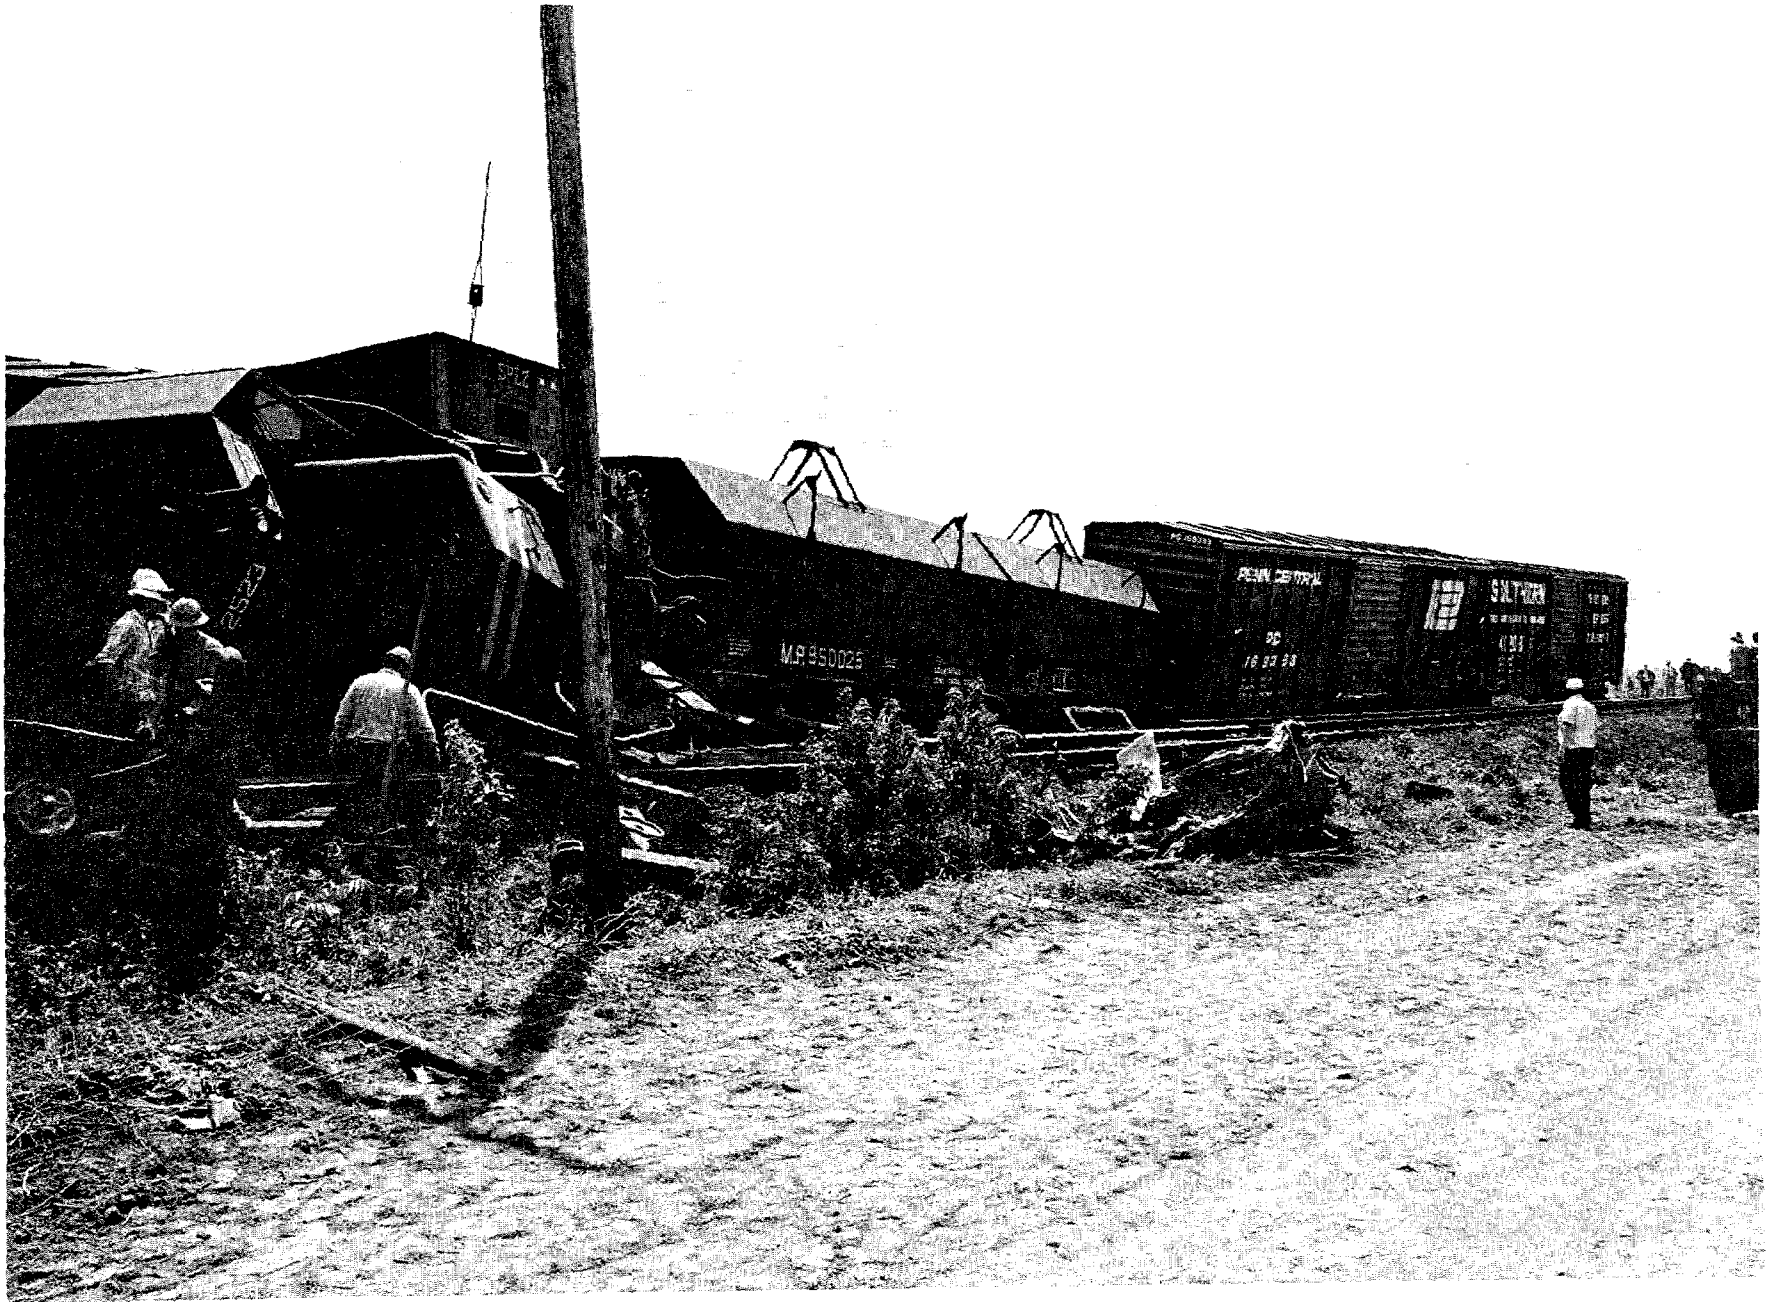
As the lead locomotive unit of Extra 2296 struck the rear end of Extra 9610, the caboose was propelled upward and crushed between the locomotive unit and the car preceding it in the train. The rear portion of the caboose overrode the locomotive unit, destroying the control compartment, and coming to rest on the engine compartment. The front portion of the caboose was propelled upward into and onto the rear end of the 108th car, a tri-level automobile carrier. The tri-level carrier was shoved forward, coming to rest on its right side parallel with and 15 feet east of the east track structure. The rest of the train was shoved forward about 100 feet by the force of the impact. Only the last six cars derailed. The conductor's body was later found in the wreckage of the locomotive unit MP 2296 and the caboose of Extra 9610 North.

From the point of impact with the rear end caboose of Extra 9610, the lead locomotive unit moved northward 325 feet and jackknifed to the west blocking both main tracks. The second locomotive unit MP 2523 jackknifed to the east coming to rest on its right side also blocking both tracks. The first five cars behind the locomotive unit derailed and stopped at various angles to the track structure, although all cars remained upright.

VIEW OF ACCIDENT SITE
