RAILROAD ACCIDENT REPORT

**COLLISION OF MISSOURI-KANSAS-TEXAS
RAILROAD COMPANY TRAIN NO. 103
WITH STANDING FREIGHT CARS
NEAR TEMPLE, TEXAS
MARCH 17, 1983**

NTSB/RAR-83/08

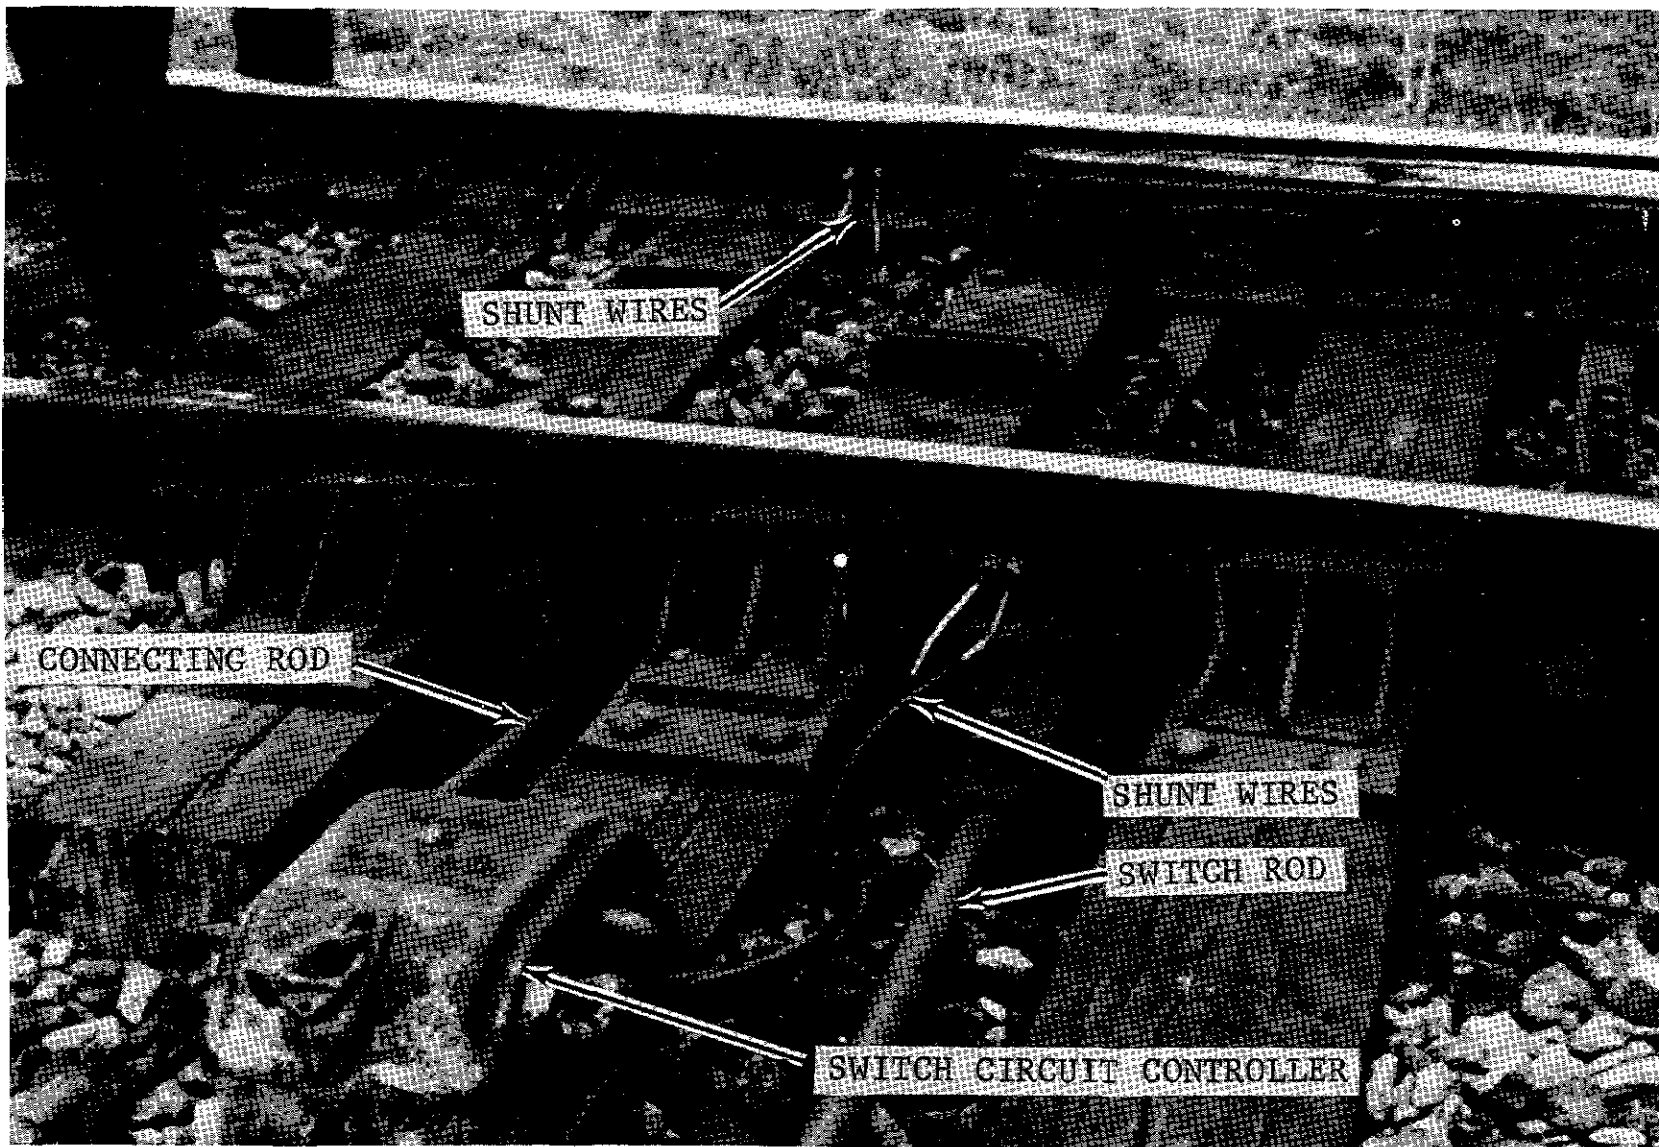
Shortly after beginning the work, the signal maintainer stopped working and departed the job site to buy a file to sharpen a chain saw that he would be using later at the job site. About 11:30 a.m., after taking a short lunch break, the signal maintainer returned to the job site. At the time, a local service freight train was proceeding southwardly through the location. After the freight train passed, the signal maintainer removed the switch circuit controller housing from the 11-foot long crosstie ahead of the headblock tie. He then cut off the end of the tie (to which the housing had been secured) evenly with the ends of the crossties to facilitate access to the underside of the adjacent headblock tie and to insert the housing retaining bolts from the underside of the headblock tie. After relocating the housing to the headblock tie, he reconnected the connecting rod from the switch point to the opposite side of the switch circuit controller. The noninsulated shunt wires were then replaced with new insulated shunt wires but were not connected to the rails. (See figure 2.)

Figure 2.--Switch circuit controller after relocation.

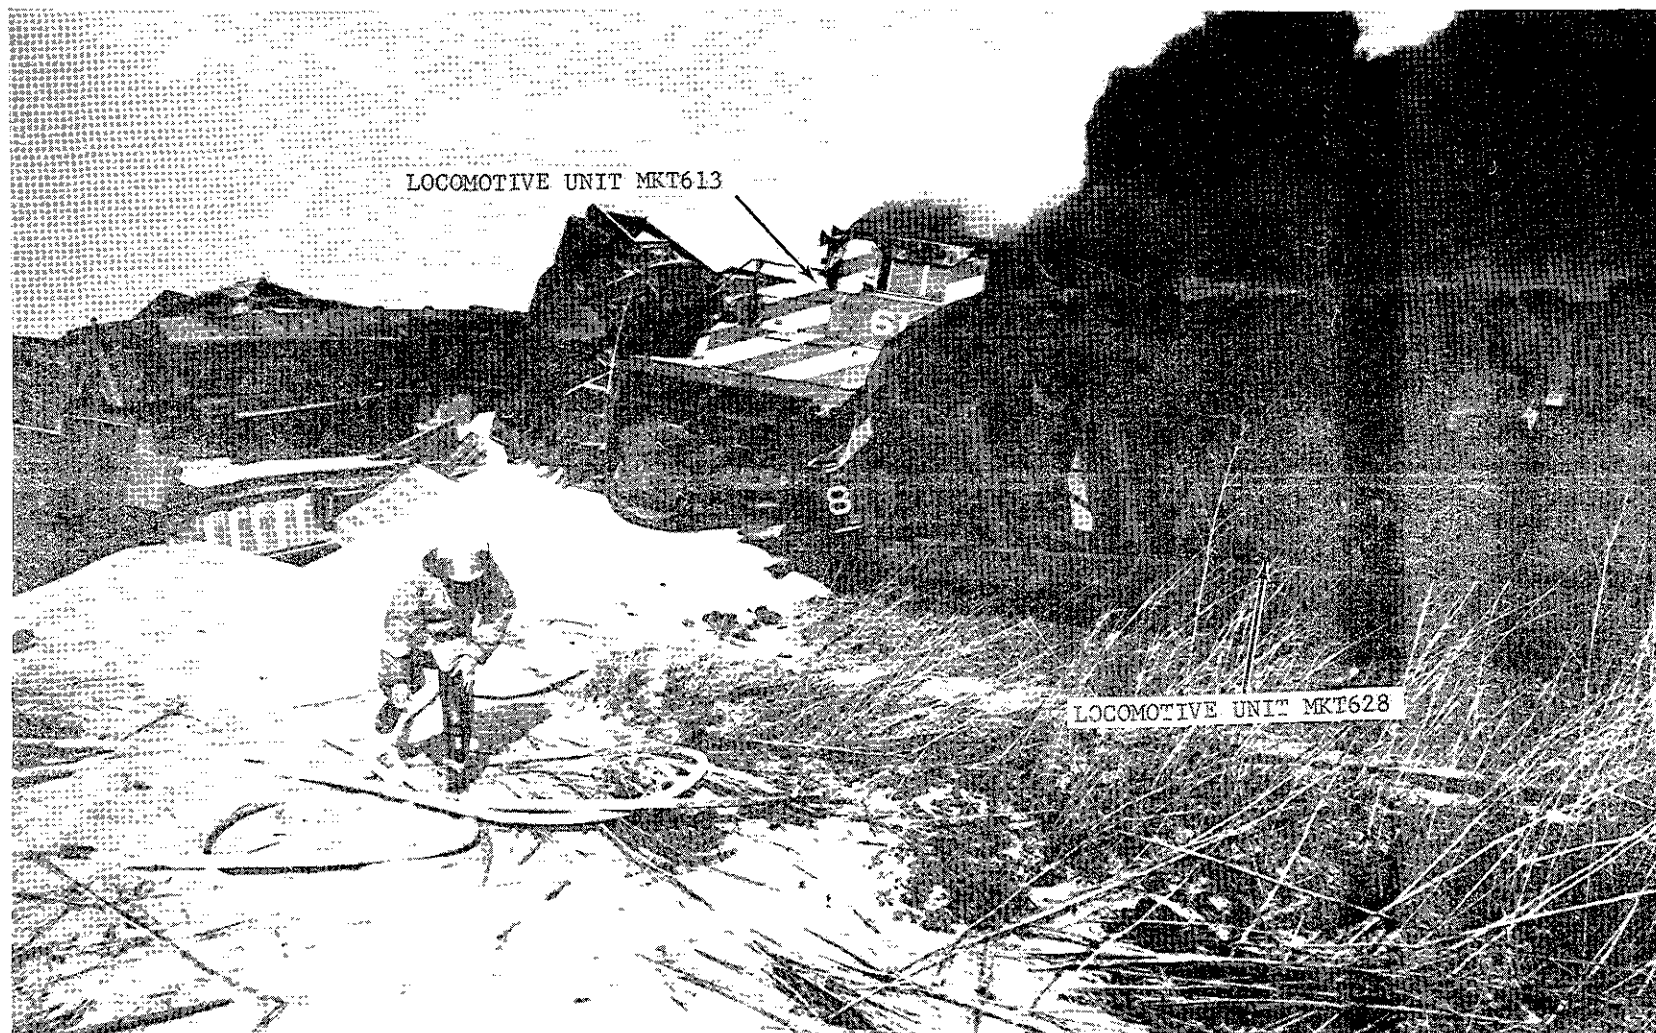
The last two units of the four-unit locomotive sustained extensive damage in the collision and ensuing fire, and were considered destroyed. (See figure 4.) The operating compartment of the third unit was crushed, and the fuel tank on the fourth unit was torn open about one-half of the circumference of the tank. The pilot and front platform of the leading unit were damaged and the underframe, electrical, and air brake equipment of the first two units were damaged. (See figure 5.)

Figure 4.—Last two locomotive units of train No. 103.

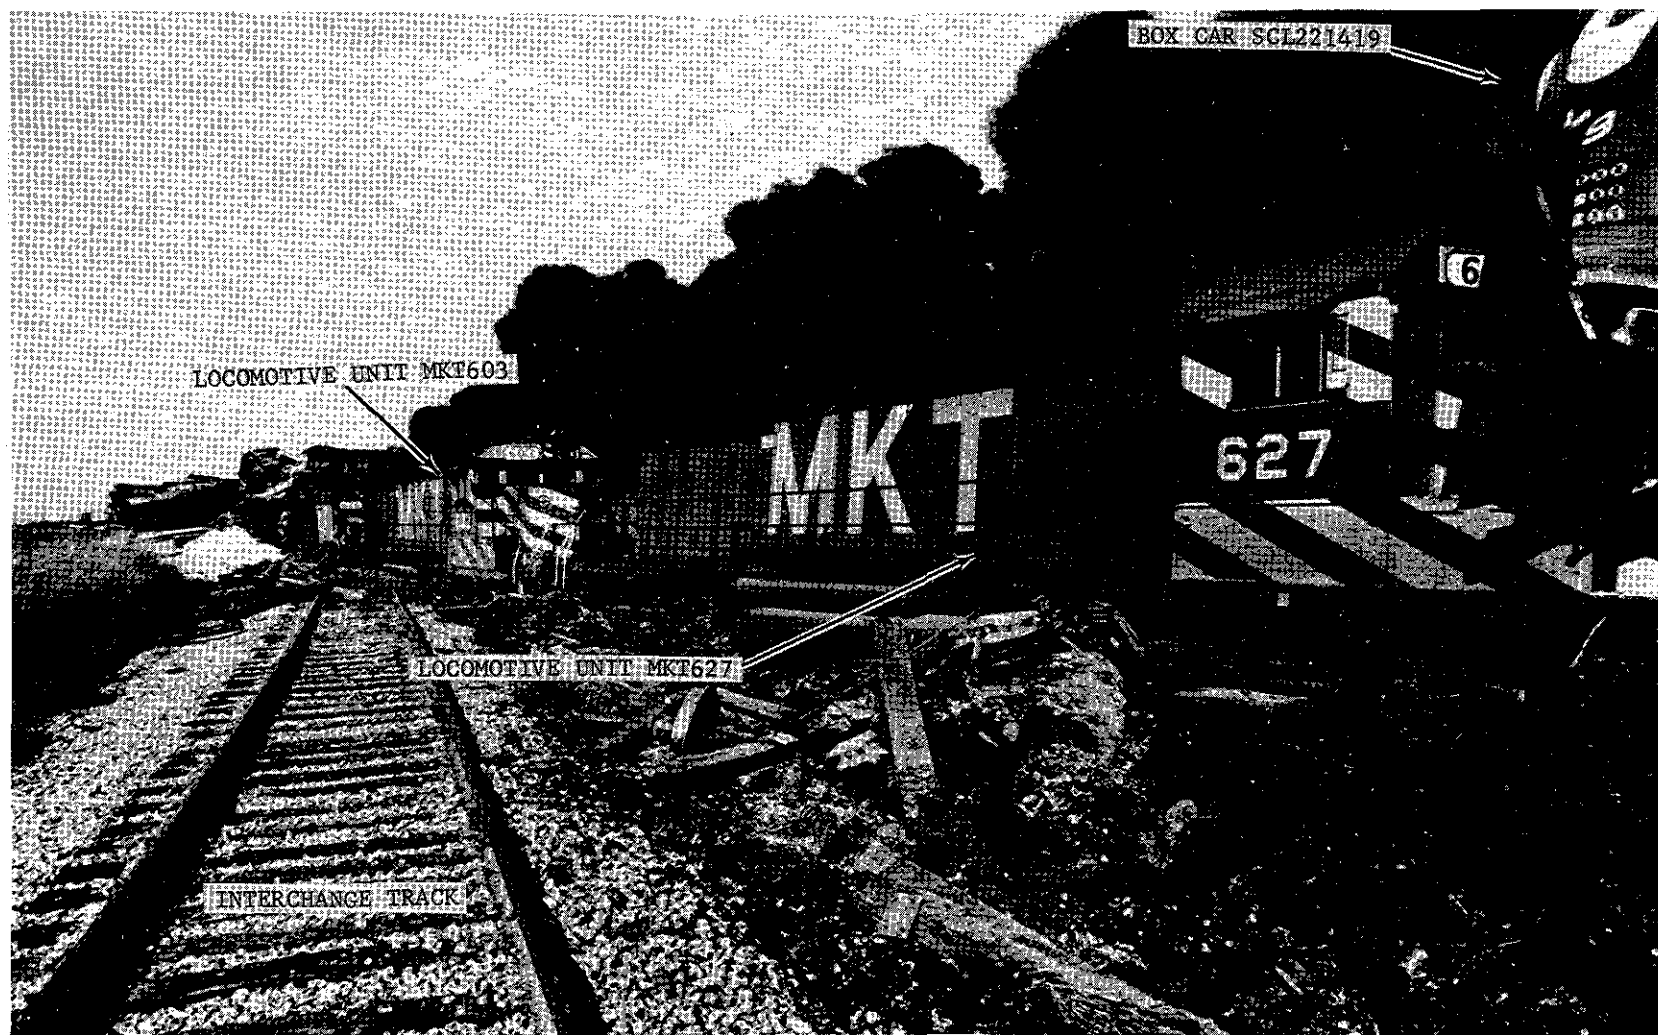
Figure 5.--First two locomotive units of train No. 103.

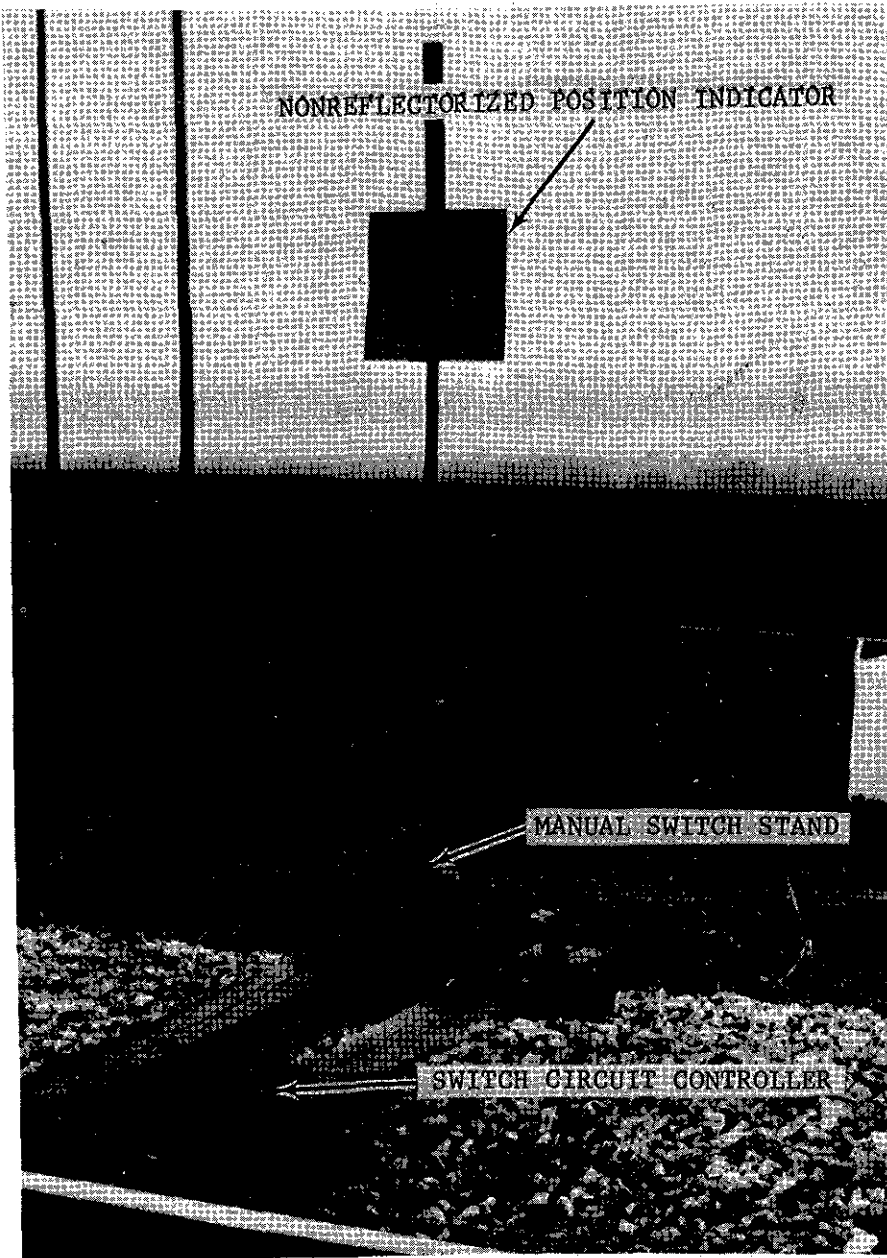
Figure 6.--Switch position indicator at switch to interchange track, with switch set in normal position.

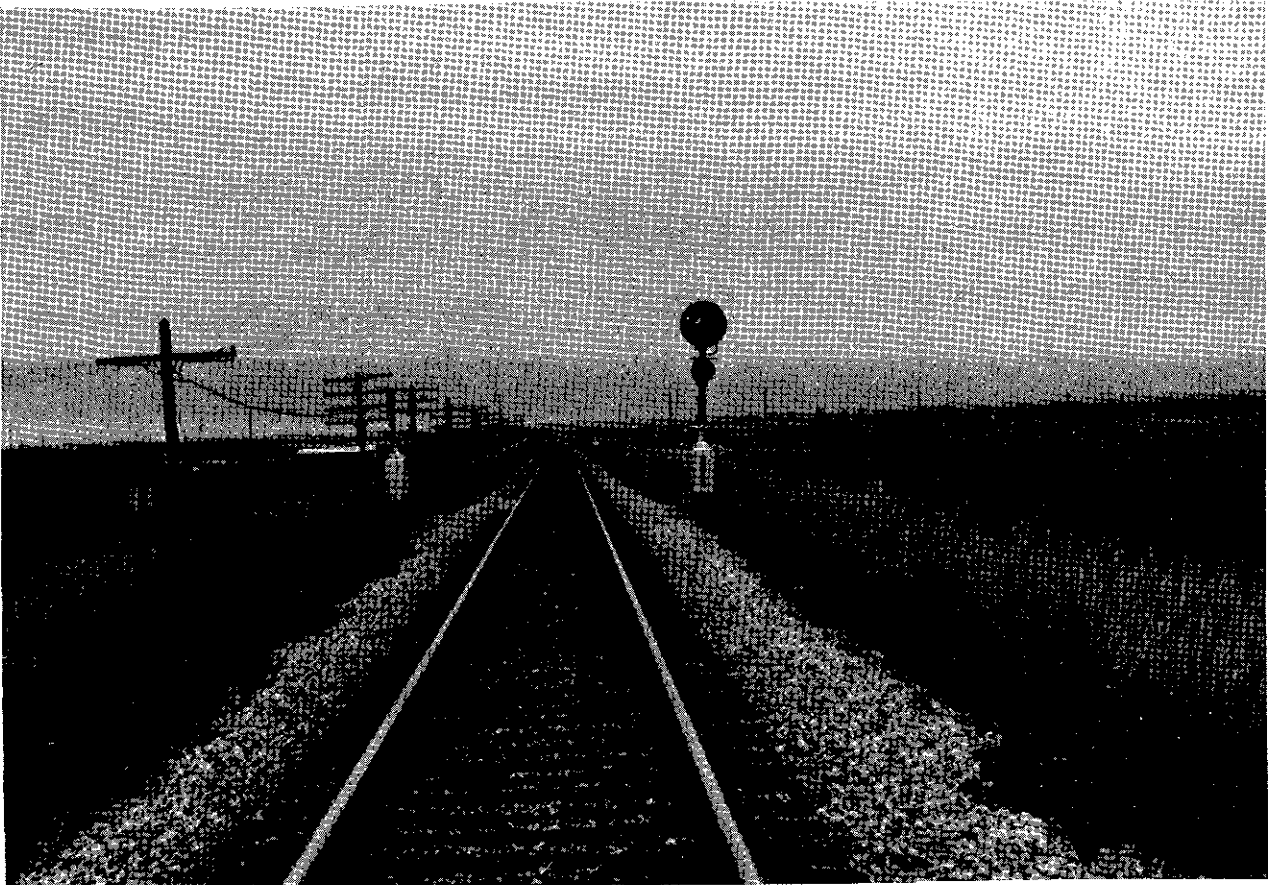
Automatic signal No. 8829, a color light signal, governs southbound movements on the MKT main track through the signal block in which the interchange track is located. (See figure 7.) Signal No. 8817 is located in approach to signal No. 8829, and signal No. 8809 is located in approach to signal No. 8817. According to the MKT's senior signal supervisor, if the signal block governed by signal No. 8829 is occupied, or if the main track switch is not fully closed in its normal position for a main track movement, signal Nos. 8829 and 8817 should display red (stop and proceed) aspects, and signal No. 8809 should display a yellow (approach) aspect, which requires the engineer to reduce train speed and be prepared to stop for the next signal.

Figure 7.--Signal No. 8829 displaying a green (clear) aspect.

The fireman and engineer were operating train No. 103 in accordance with applicable rules and regulations. Although the fireman and engineer saw the misaligned switch when the lead locomotive unit was at or near the at-grade county road crossing and the fireman immediately initiated an emergency brake application, there was insufficient distance to stop or slow the train sufficiently to lessen the effect of the accident. Automatic signal No. 8829 was displaying a green (clear) aspect despite the misaligned main track switch since the shunt wires, which would have caused the signal to display a red (stop and proceed) aspect, had not been connected to the rails. Therefore the Safety Board concludes that the signal was displaying a false proceed 12/ aspect.
