RAILWAY ACCIDENT REPORT

HEAD-ON COLLISION OF SOUTHERN PACIFIC
TRANSPORTATION COMPANY FREIGHT TRAINS
YUMA, ARIZONA

JUNE 15, 1987

NTSB/RAR-88/02

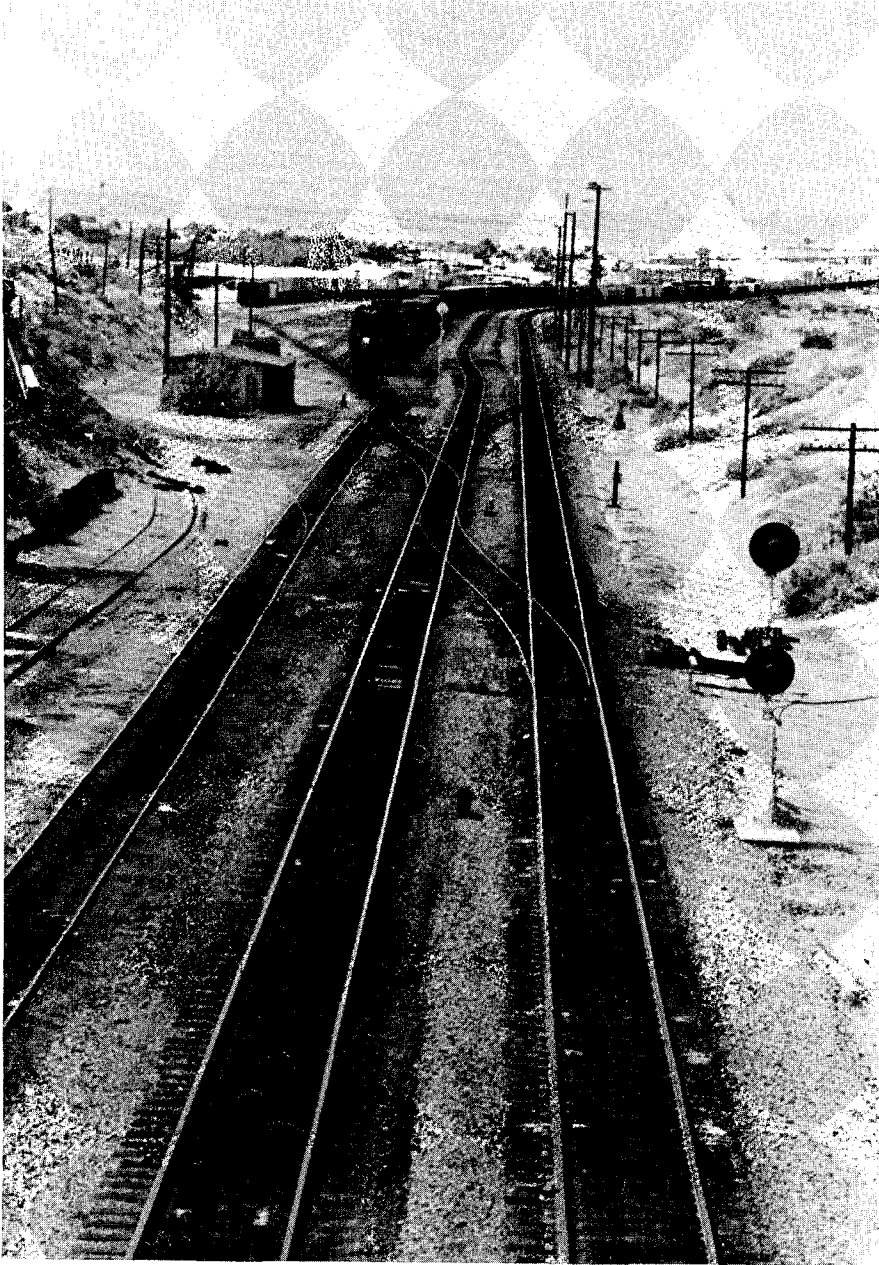
Figure 2.--Westward view of the subway crossovers.

While trying to resolve the problem with signal 7340, the signal supervisor discovered the switch point gapped in excess of 1/4 inch on the east end of the crossover between No. 2 track (eastbound main) and the yard lead track. This resulted in signal 7342 displaying a red aspect. The signal supervisor removed the switch from service for reverse movement and spiked it in normal position. This was the crossover switch that the ACC had reported "Point open 1/4 inch" in the inspection made after the accident on June 15, 1987. With the switch spiked in the normal position,

The Safety Board believes that the switch point at the subway, reported by the ACC to SP as violating both State and Federal regulation, should have been repaired or removed from service immediately.

The Yuma road-foreman-of-engines arrived and arranged through the SP train dispatcher for track repair forces to repair the crossover switch. After adjustments were made to the switch hardware, the signal still would not clear. The track repair forces determined that metal flow from the stock rail was forcing the switch point open. The track forces ground the stock rail to allow the switch points to close. Then the signal supervisor adjusted the switch signal circuitry and signal 7342 cleared.

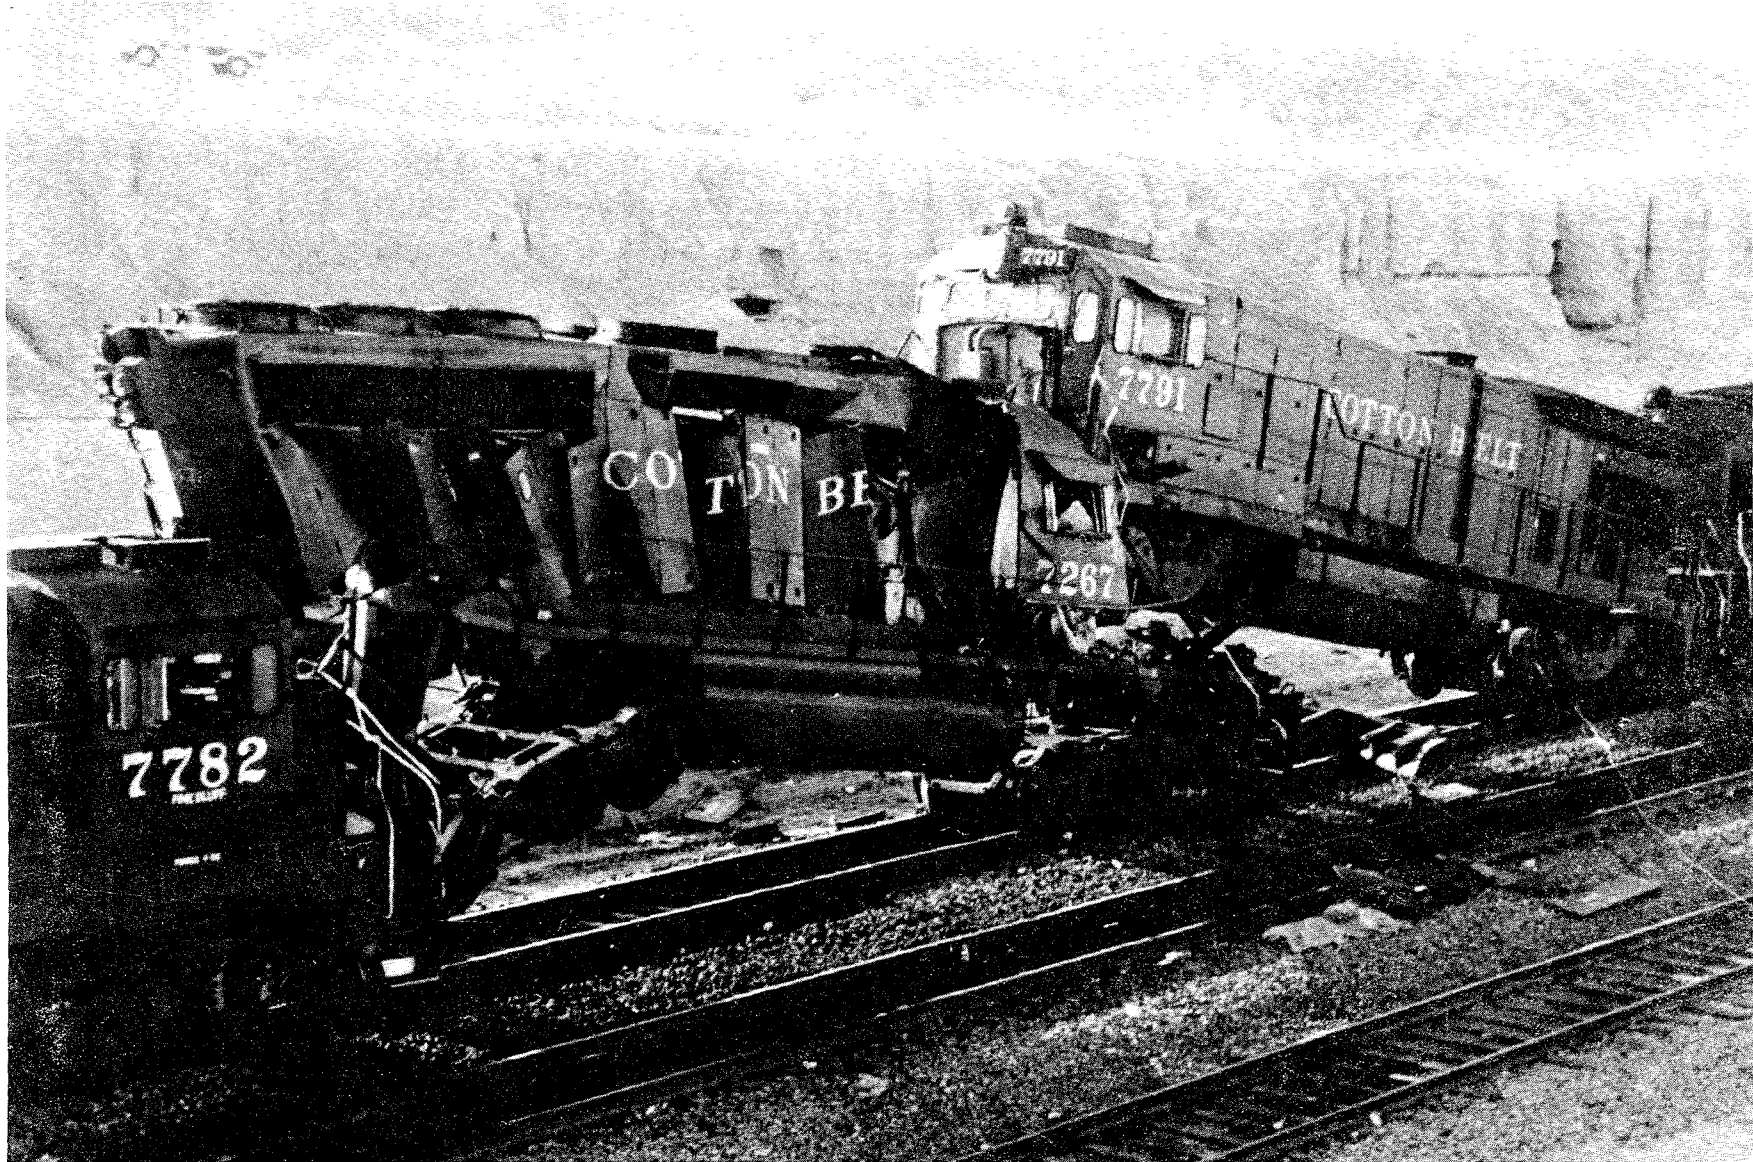
Figure 3.--Point of collision.

SP locomotive unit 7267 was destroyed in the accident. Three other locomotive units sustained moderate to severe damage. The 28th and 29th head cars in train Extra 7267 East were destroyed, the 30th head car was moderately damaged, and the 60th head car derailed one wheel.

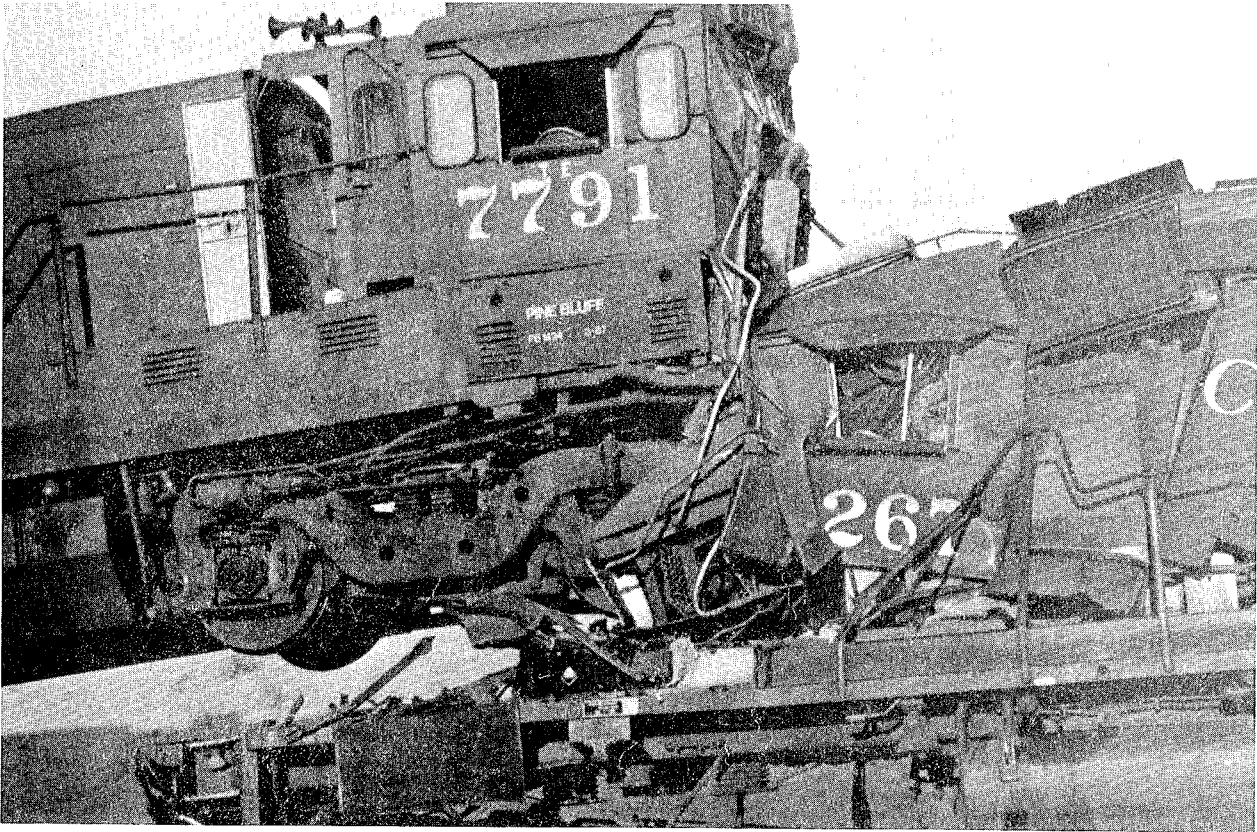
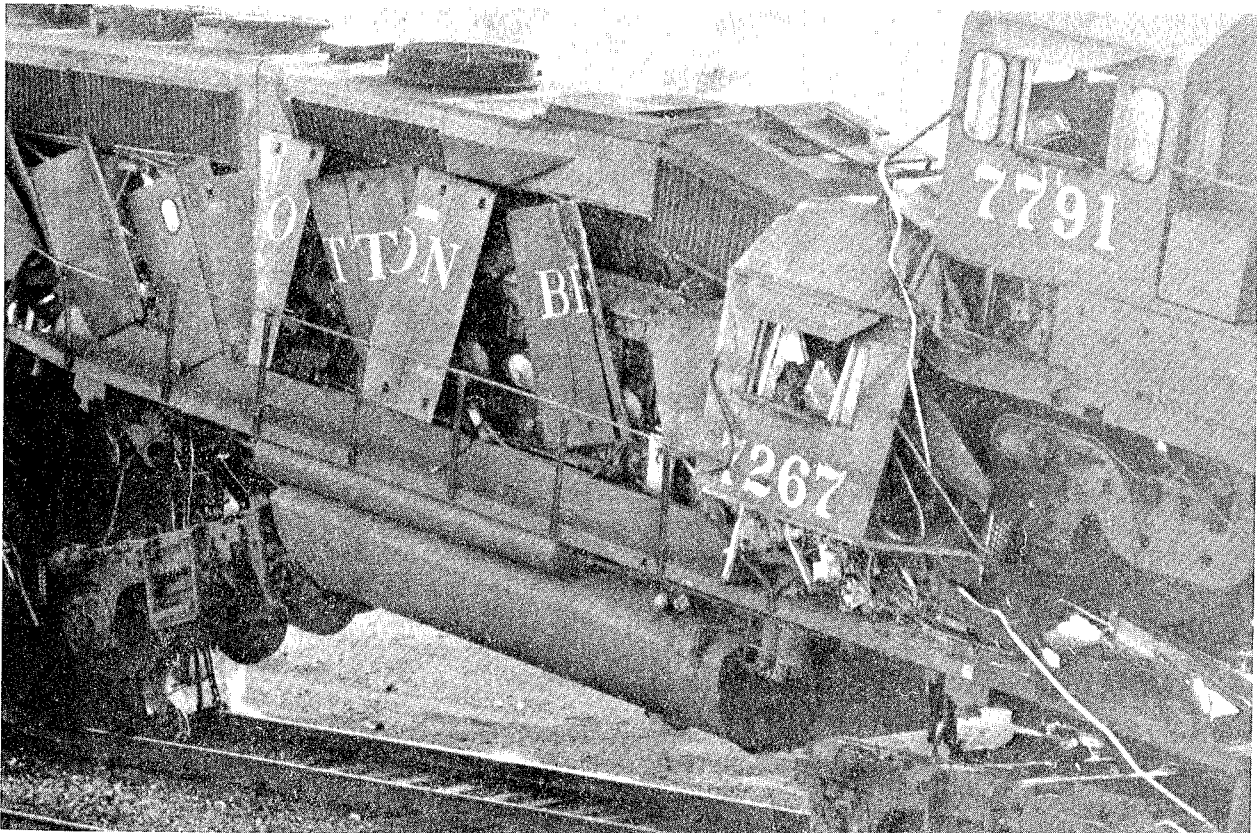
Figure 4.--Over/underride viewed from opposite sides.

Since 1973, however, the Locomotive Control Compartment Committee (LCC) has not published any criteria for the structural design of locomotives. The Safety Board has investigated numerous accidents in which the locomotive control compartments have been identified as inadequate to protect its occupants. There is currently no Federal standard for locomotive sill height nor is the Safety Board aware of any effort by the FRA to establish such a standard. Since the sill is the strongest section in the structural design of a locomotive, the Safety Board believes the FRA should establish a standard for compatible locomotive sill heights.

- 16 Following the collision, there was no survivable space left in the control compartment of Extra 7267
- 17 The crews of both trains involved in this accident were improperly placed according to SP operating rules

The circumstances of the Yuma accident again highlight the need for improved and standardized locomotives designed to provide protection to on-board personnel. Therefore, the Safety Board reiterates its position that the FRA should promptly require locomotive operating compartments to be designed to provide crash protection for occupants of locomotive control compartments. In the meantime, Safety Recommendation R-87-23 is being held in an "Open--Unacceptable Action" status.

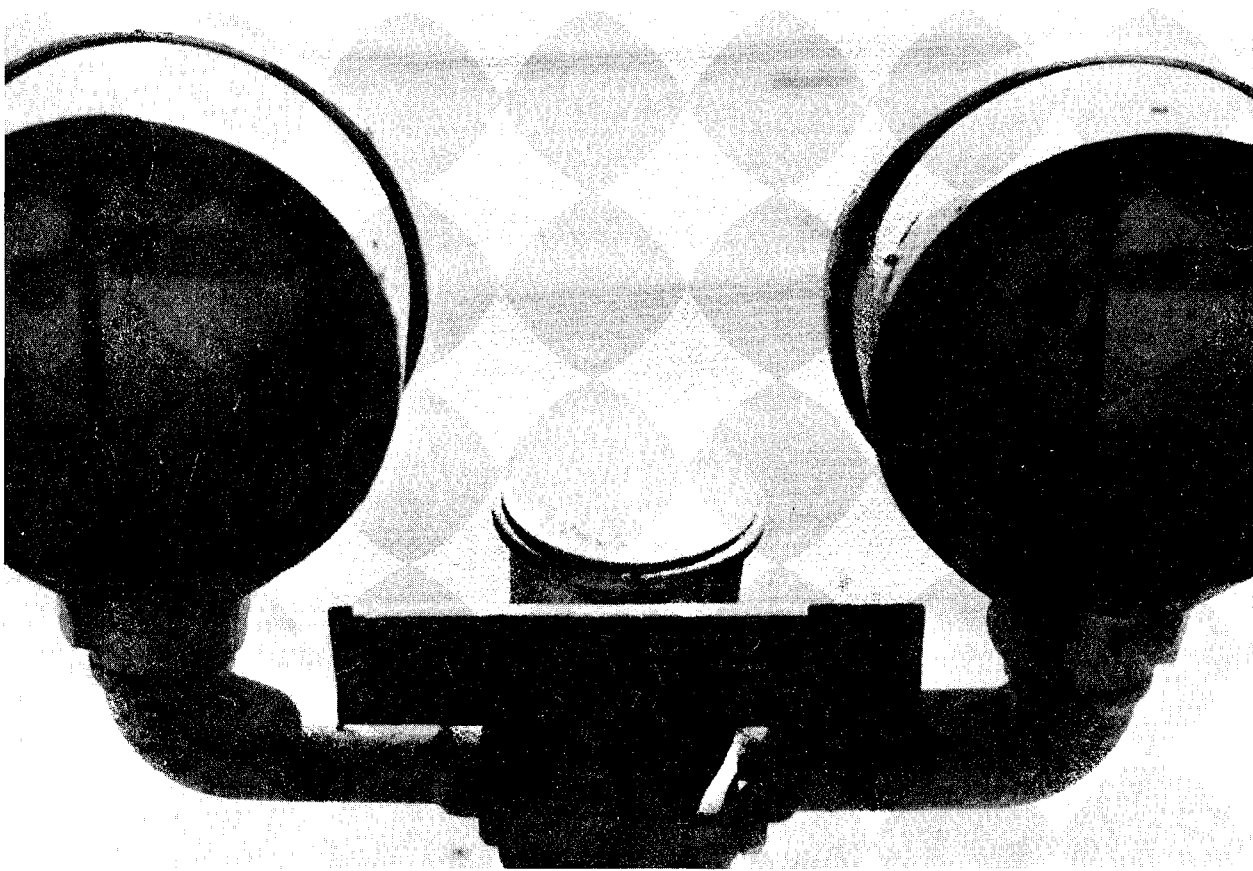
Figure 5---Block occupancy indicator displaying aspects that the track to be entered is occupied in both directions.

values on two relays were off. Both relays were subsequently replaced. Safety Board investigators observed four signals malfunction--7332, 7340, 7342, and 7344. In each instance, the respective signal displayed a more restrictive aspect than actual track conditions required.
