I.C.C. Calls for Switch Locks

A RECOMMENDATION that the Chicago & North Western install electric switch locking at all main-track hand-operated switches in automatic train control territory has resulted from the Interstate Commerce Commission's investigation of a side collision at a crossover at Missouri Valley, Iowa, on that road's double-track Chicago-Omaha main line, in which 9 passengers were killed and 95 injured. According to the report prepared under the supervision of Chairman Patterson, the accident was caused by "failure to provide adequate protection for a crossover movement."

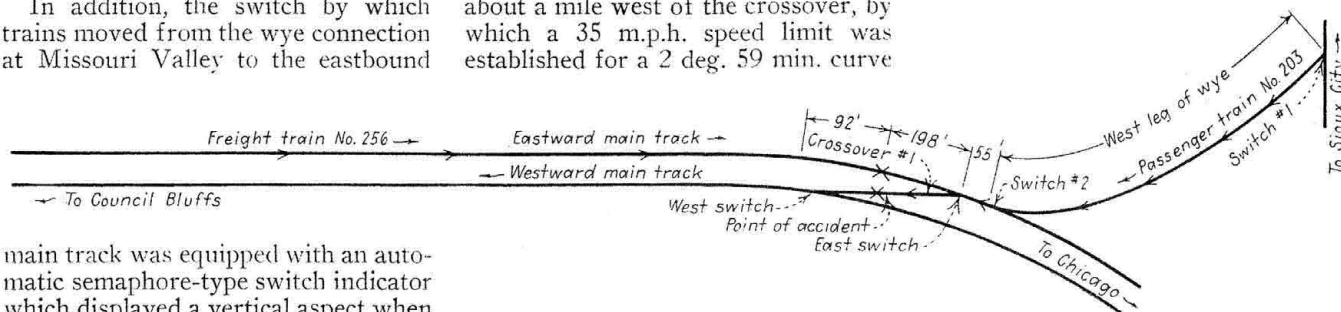
The third to eighth cars, inclusive, of the passenger and the engine and first four cars of the freight were derailed and damaged, the fifth, sixth and seventh cars of No. 203, which were coaches, being badly damaged.

About 4 min. before the collision occurred, the passenger train had stopped on the wye connection, clear of the main track. The front brakeman reported the arrival of the train at that point to the dispatcher by telephone, then set the switches involved so his train could proceed from the wye track to the eastbound main track, then by the adjacent crossover to the westbound main track. He asserted that the switch indicator at the point where the eastbound track was entered displayed a vertical aspect (clear block) when he lined this switch for the movement into the eastbound track. The conductor and other members of the crew of No. 203 were in various cars in the train. Before this train entered the eastbound track its brakeman and fireman observed a train approaching on that track at a distance estimated at $1\frac{1}{2}$ miles, but did not realize it was closely approaching until their engine entered the crossover, at which time it was about 1,200 ft. distant. The engineer of No. 203 endeavored to clear the eastbound track by increasing the speed of his train through the crossover, but its fourth car was struck by the eastbound freight at the fouling point.

to the right which began about 636 ft. west of the point of the accident. The cab signals indicated a clear block until the engine reached a point about 2,800 ft. west of the switch leading from the wye to the eastbound track, at which point they first indicated a restricted speed zone, resulting from movement of the switch, although the block affected by the switch involved extended almost 7,200 ft. further west. The engineer immediately reduced speed to forestall the automatic apparatus. His view ahead was obscured by smoke until he saw the passenger train about 1,500 ft. ahead, when he applied the brakes.

Commenting on the circumstances, the I. C. C. report said: "In view of the high speeds at which trains are authorized to proceed through Missouri Valley and the fact that the only protection provided for the crossover movement of No. 203 was the aspects displayed by switch indicators, additional protection for these movements is required. If the switch connecting the west leg of the wye and the eastward main track had been equipped with electric switch-locking, it would not have been possible to operate the switch to permit a movement to the eastward main track when a train was closely approaching, as in this case, and the accident would not have occurred."
