Australian Government Australian Transport Safety Bureau

Signal irregularity reported by crew of train 5BM7

Culcairn North, NSW | 7 April 2013

ATSB Transport Safety Report Rail Occurrence Investigation RO-2013-013 Final – 5 March 2014 Source: Cover photo supplied by Australian Rail Track Corporation (ARTC).

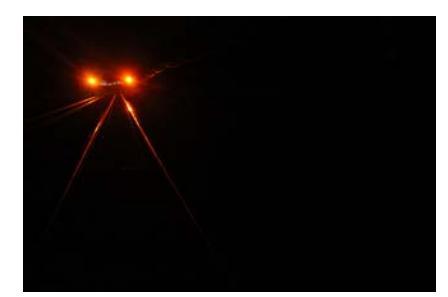
Signal DIS-CN03 (right) and DIS-CN07 (left) from about 350 m

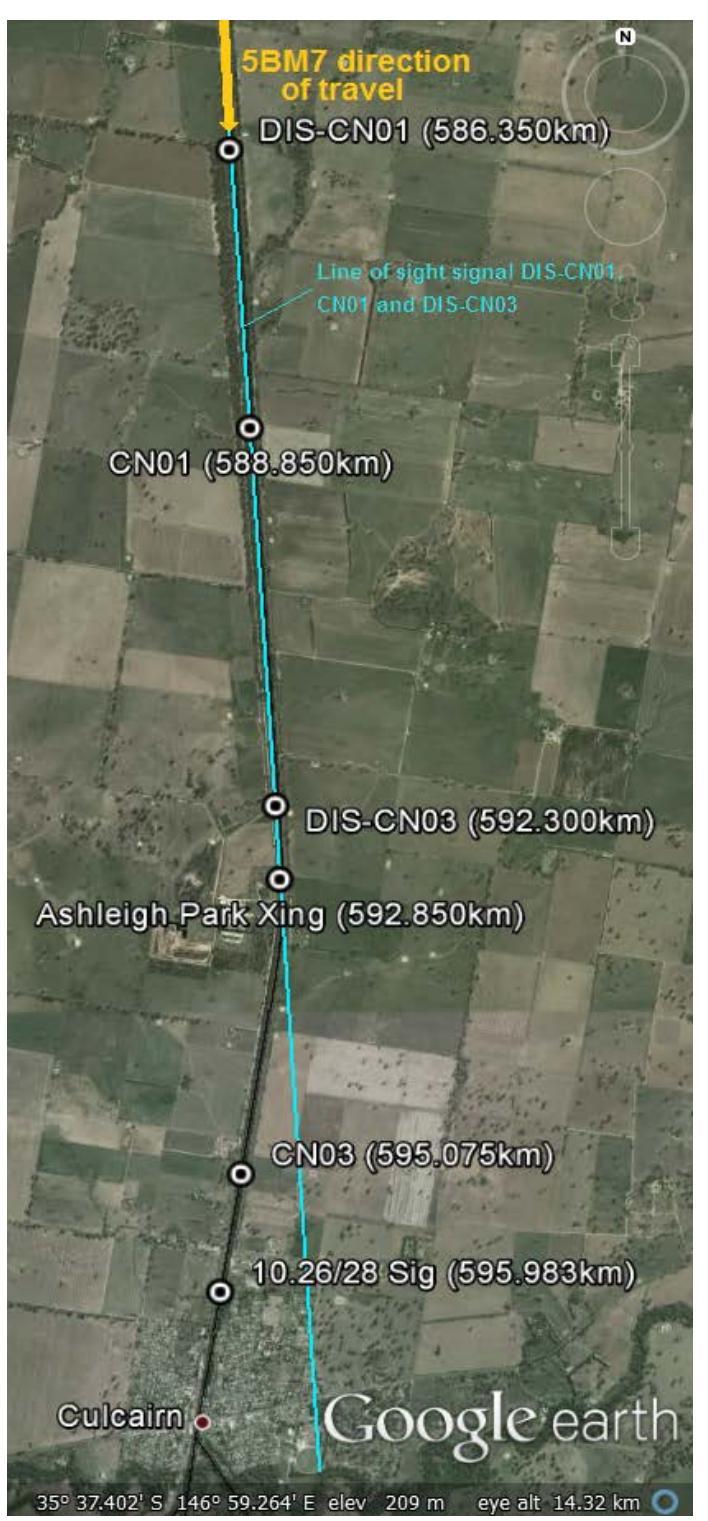
Figure 2: Location of signals approaching Culcairn North passing loop

About 3 minutes after passing through Henty, the driver of 5BM7 saw a series of signals displaying green (Figure 2).

He and the second person cross called³ the signals, DIS-CN01, CN01 and DIS-CN03 as displaying a clear (green) indication when they approached and passed them.

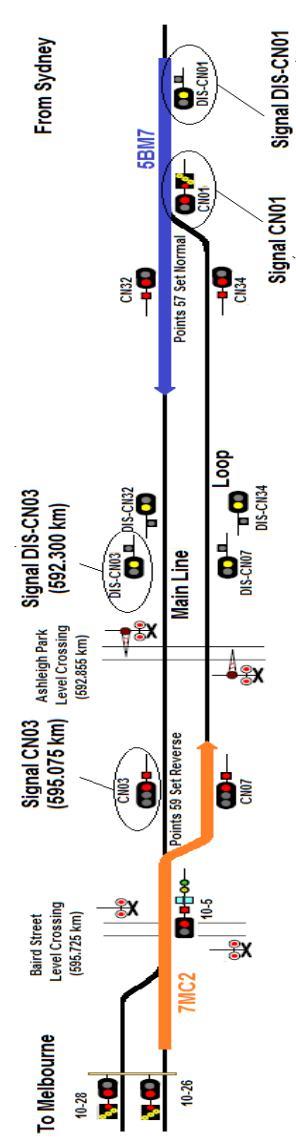
Figure 3: Signal arrangement - Culcairn North, passing loop

The Culcairn North passing loop (Figure 3) is controlled by fixed colour light signals that use Rail Vehicle Detection $(RVD)^4$ and are remotely controlled from a network control centre located in Junee.

The signalling system through Culcairn North provided advance information regarding the status of signal CN03 (Figure 3 and Figure 4) by way of signal DIS-CN03 located 2.775 km before it. Signal DIS-CN03 displays a clear (green) when CN03 displays a caution (yellow) or clear (green) and a caution (yellow) if signal CN03 is at stop (red). The correct display/interpretation of signal DIS-CN03 therefore allows a driver to safely slow their train and bring it to a stand before passing signal CN03, if displaying a stop (red) indication. This becomes critical especially in conditions of restricted visibility (for example fog, rain, etc.).

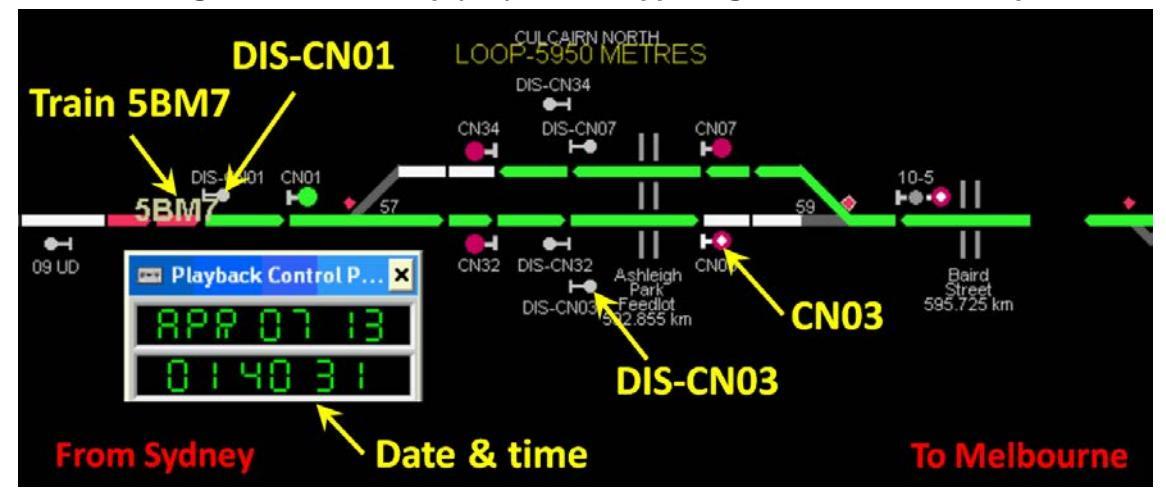
The Phoenix system, by design, does not show the indication displayed by distant signal DIS-CN03. Nonetheless, the Phoenix replay did show that home signal CN03 was at stop (Figure 5) well before train 5BM7 passed the preceding signals DIS-CN01, CN01 and DIS-CN03. The driver of 5BM7 confirmed that home signal CN03 was at stop (red) when he first saw it, just after he observed the headlight of the opposing train 7MC2.

Figure 5: Phoenix display (replay) showing train 5BM7 about to pass signal DIS-CN01. At this time signal CN03 is at stop (red) and the opposing route set into the loop

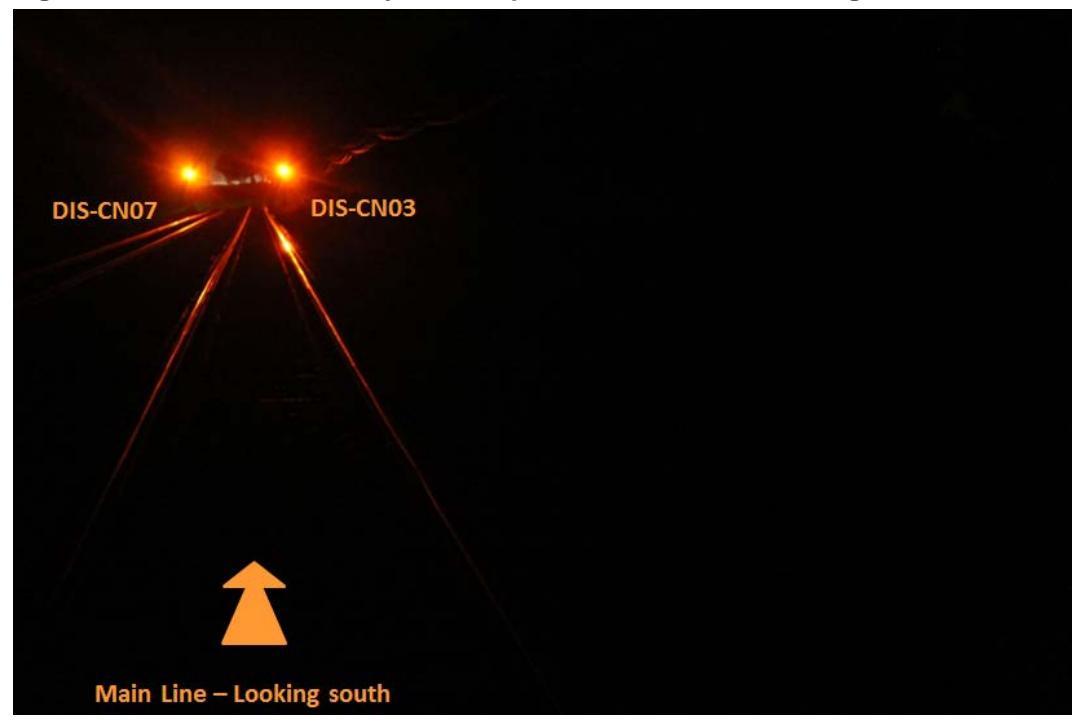
DIS-CN03 was examined for evidence of extraneous lighting or reflections off surfaces that may have been a source of green illumination. None was identified. There was no evidence of trees or other physical obstructions along the track that may have compromised the driver's or second person's view of the signal.

Signal DIS-CN03 was located on the right side of the main line. Signal DIS-CN07 was located on the left side of the loop. Both signals face north and are directly adjacent to one another (Figure 6 and Figure 7).

Figure 6: Photo of DIS-CN03 'yellow' aspect about 350 m before signal

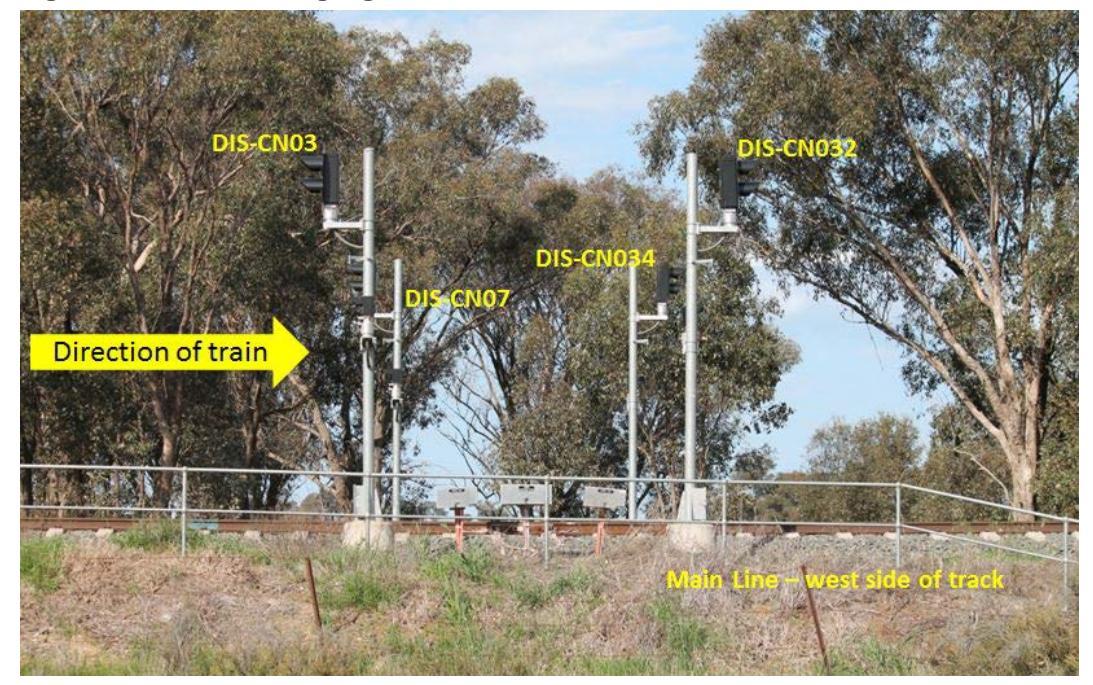
Figure 7: Photo showing signals DIS-CN03, DIS-CN07, DIS-CN32 and DIS-CN34

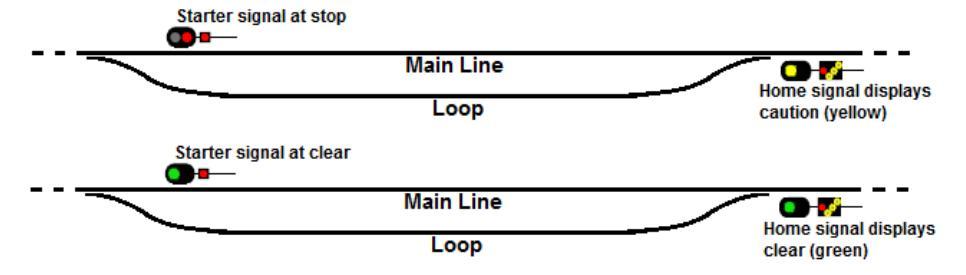
Additionally, the signalling arrangement at longer passing loops like Culcairn North differs from many of the shorter crossing loops on the Melbourne to Sydney (New South Wales) corridor. At the shorter crossing loops (Figure 8) the home signal at the entrance to a crossing loop also serves as the distant signal for the starter signal located at the exit of the crossing loop. For this configuration a driver entering the main line of a crossing loop with the starter signal at stop (red), would encounter the home signal at caution (yellow). When the starter signal is at caution (yellow) or clear (green), the driver would encounter the home signal at clear (green). Thus the indication at the home signal provides key information about the starter signal.

Figure 8: Simplified signal sequence through main line - short passing loop

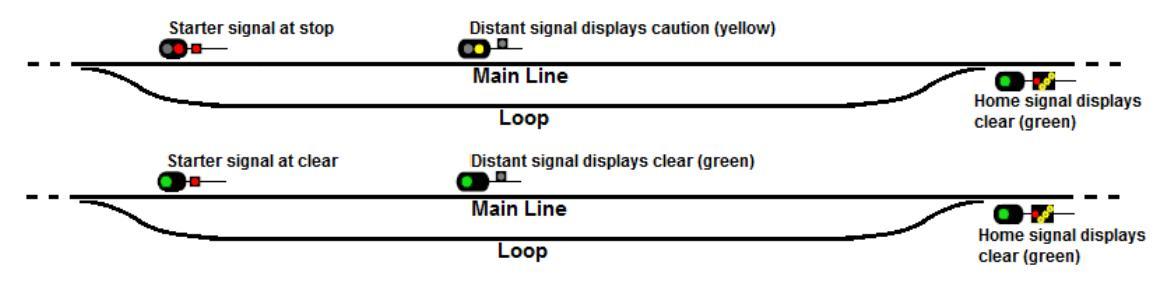
loops will always display a clear (green) indication, unless the main line ahead is occupied in which case they will be at stop (red).

Figure 9: Simplified signal sequence through main line - long passing loop

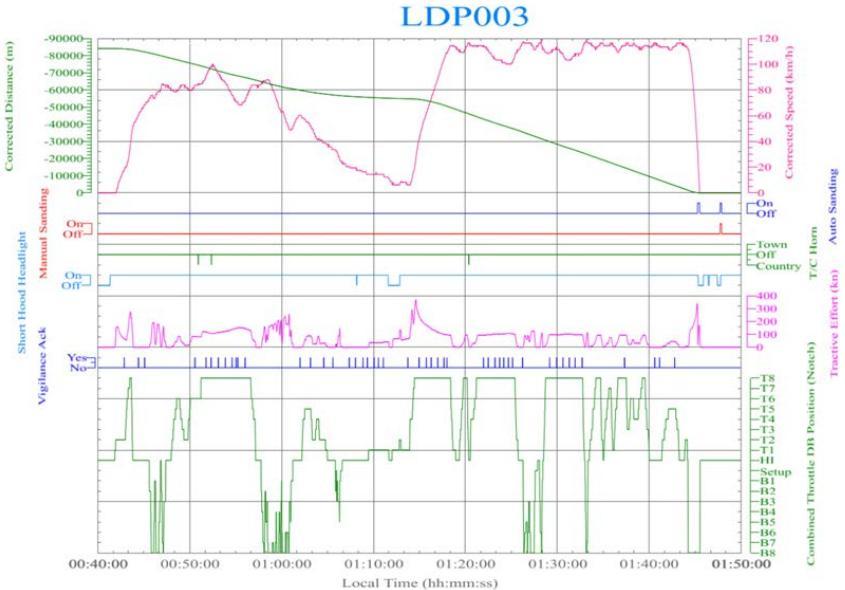
The lead locomotive LDP003 was fitted with an event logger. It records data such as date/time train speed, distance travelled, traction effort, throttle position and operation of the vigilance system.¹⁹ An examination of available evidence and data extracted from the event logger in the minutes before the occurrence (Figure 10) established the following:

• The driver rapidly responded to the headlights of the opposing train (7MC2) and signal CN03 when observed at stop (red). He immediately challenged the approaching train and made the emergency brake application.
