Report on Milwaukee-Omaha Collision

Engineman's failure to control speed responsible for accident on crossing at Camp Douglas, Wis.

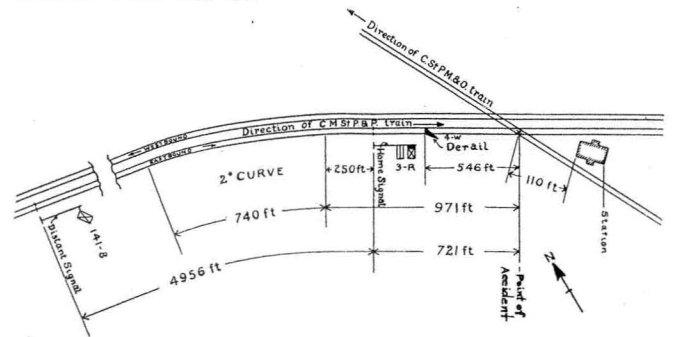
Track and signal plan of Camp Douglas layout

Trains approaching the crossing on the Milwaukee eastbound main track are governed by interlocking distant signal 141-8, a one-arm signal which is also used as an automatic block signal and which is located 4,956 ft. west of home signal 3-R, which is a two-arm signal located 721-ft. west of the crossing. Except for the bottom arm of signal 3-R, which is fixed, these signals are of the 3-position, upper-quadrant type, displaying white, green, and red indications, for proceed, caution, and stop, respectively.

A split-point derail operated in conjunction with the

signals is located in the south rail of the Milwaukee eastbound track between the home signal and the crossing, the point of the derail being 546 ft. west of the crossing. The weather was cloudy at the time of the accident, which occurred about 3:47 a. m.

Eastbound Milwaukee train No. 16 passed Tomah, the last open office, 12.8 miles west of Camp Douglas, at 3:36 a. m., 16 min. late, passed distant signal 141-8 displaying a caution indication, passed home signal 3-R displaying a stop indication, passed over the open derail, and collided with train No. 515 while traveling at a speed estimated to have been from 30 to 40 m.p.h.

Roadmaster McMahon stated that he arrived at Camp Douglas about three hours after the occurrence of the accident and on inspecting the track and derail, he found the derail open and the point still connected. The derail was not broken, but the heel-joint casting and bolts were broken, and the main-track rail at the heel joint also was broken at a point about 14 in. from its receiving end and its end badly battered. The heel of the split-point derail was displaced to the north 4 or 5 in., leaving the receiving end of the main-track rail at gage, which permitted all the wheels, excepting the engine-truck wheels, to be rerailed at that point, and it was his opinion that the flange marks found on the ties and tie-plates on the south side of each main rail between the derail and the crossing, beginning 15 ft. east of the point of derail, were caused by the wheels of the engine truck.
