Reconstruction of an Interlocking*

Track changes on account of building post office over tracks of Chicago Union Station result in extensive reconstruction of interlocking facilities

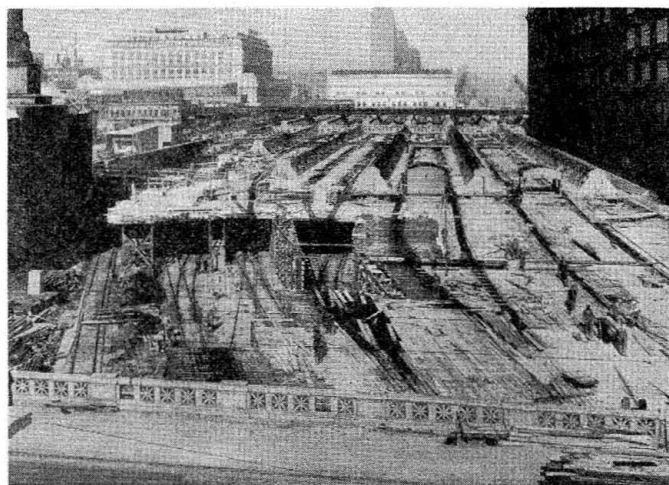
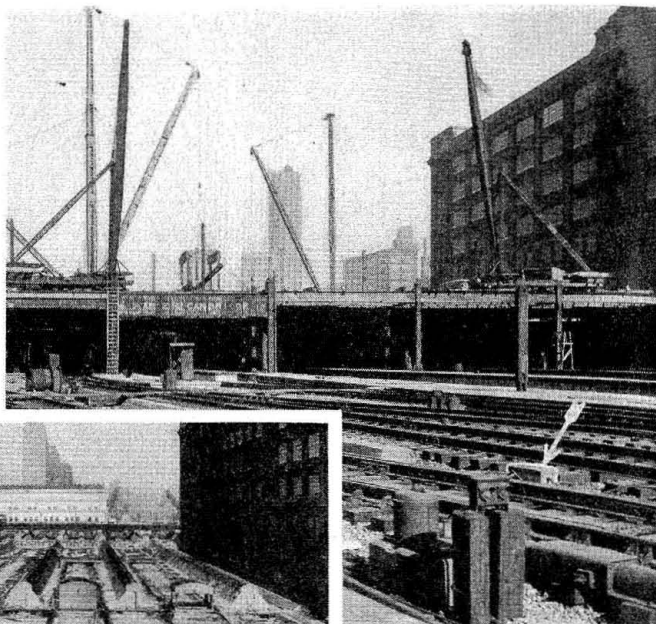
Enclosed-type double-pole snap switch in box marked by arrow was used to control switch operation
