Boston & Maine Flooded Signaling Rehabilitated

New Haven Uses Heating Room to Dry Signal Apparatus

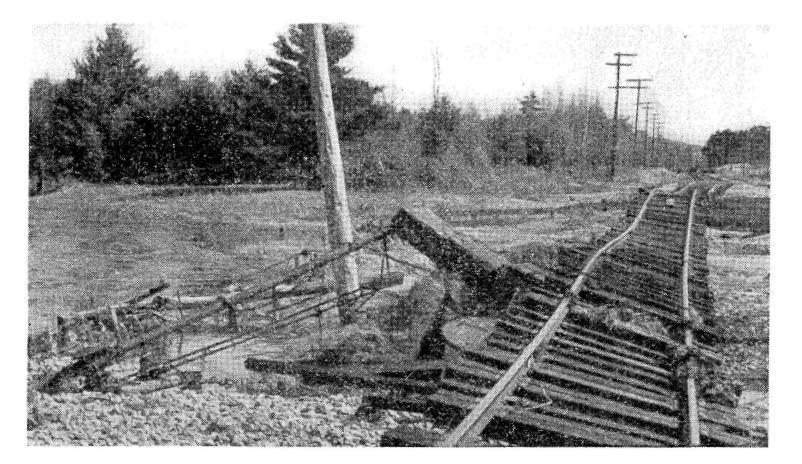
Eight signals were washed away

In the meantime, prior to the reestablishment of wire communications, signal forces had been organized on outlying districts and had proceeded to restore the signaling. On one line, eight automatic signal locations had been demolished or completely washed away by the floods. At these locations the signals were replaced and the pole lines rehabilitated. On an outlying section on the Fitchburg division a temporary means of drying out apparatus was used for about 90 pieces consisting of relays, transformers and rectifiers. This scheme consisted of using a portable drying oven made of a 50-gal. sheet-iron oil drum. The top was cut out and hinged as a cover. Holes were punched in the sides through which 1/2-in. rods were pushed to be used as supports for the relays and coils while being dried. A thermometer was hung inside the drum to indicate the temperature. Then the drum was set up on its end and heated from the outside by means of a portable oil-burning snow-melter device. The heat entered through a hole in the side of the drum and was regulated by the distance of the heating device from this hole. By maintaining a temperature of 200 to 250 deg., the apparatus could be dried in the course of about two hours.

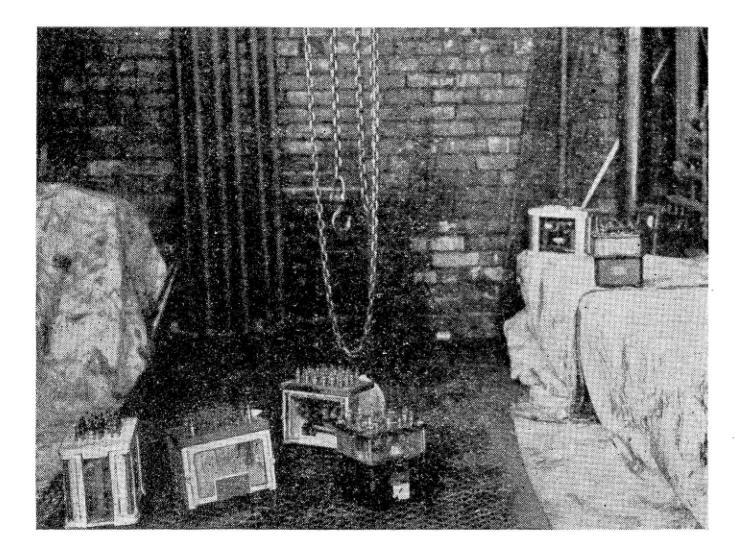
The New Haven drying room solved a serious problem

Anticipating the arrival of watersoaked and damaged apparatus at the shop, a drying kiln was provided. A brick enclosed room, 11 feet by 20 ft. was used for this purpose. Radiators made of 2-in. steam pipes were placed on the floors and walls of the room, with four 1/2-in. bleed pipes extending to separate blow-off cocks on the outside of the building. This special heating system was installed in about six hours. Pieces of locomotive front-end screening were placed over the radiators on the foor on which to place the damaged equipment.

The signal material was delivered by trucks as removed from the flooded territory, dismantled, parts were thoroughly cleaned by the use of water, steam and air, after which they were placed in the heating room. The blow-off cocks were used to drain the steam pipes and to adjust the temperature which was maintained at from 180 deg. to 195 deg. F. A large motor-driven blower was used to keep the air in the drying room circulating and to maintain the same temperature at all levels. A small amount of fresh air was drawn into the room near the floor level, and roof ventilators kept partially open to relieve the water vapor from the drying room. The results were very satisfactory.

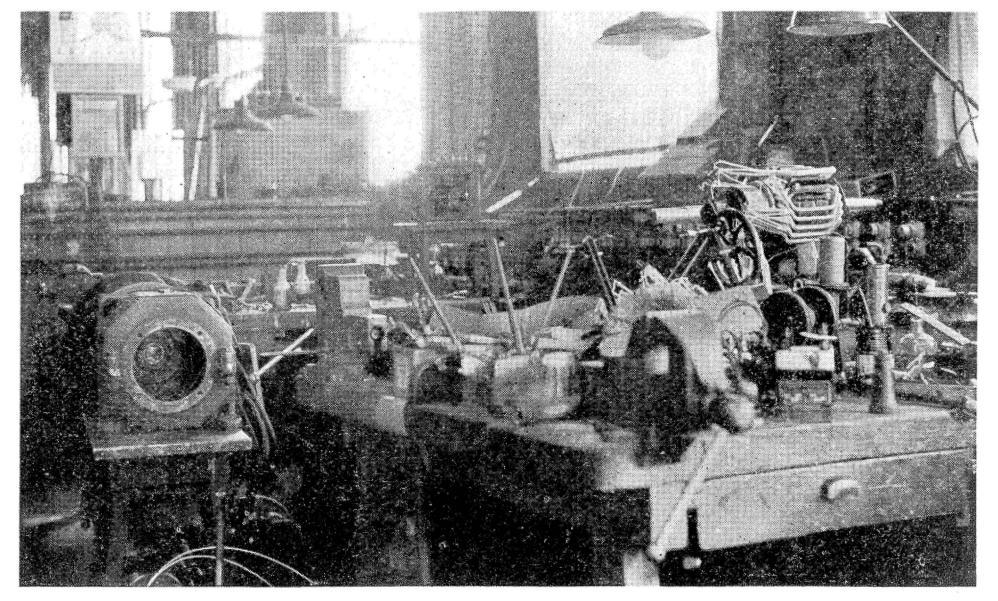
All signal equipment was thoroughly overhauled-View shows retarder motor being rewound

Insulation resistance readings were taken periodically and recorded. Some of the coils, such as for transformers and relays rang clear within 48 hrs., whereas some of the retarder motors, which had been untested carefully and then painted. New relay contacts and ribbons were installed as required, so that the instruments were in first-class condition before being returned to the field. The commutators on all signal, switch and retarder motors were dressed down, and of course all coils were tested. In only one instance was it necessary to rewind a motor.
