# IC4 train set passed signal at danger at Marslev

| <b>HCLJ 611-2011-23.</b> | <b>Incident</b> | SPAD | Train operation |
| Date: | 07.11.2011 | Time: | 15:17 |
| Place: | Marslev | | |

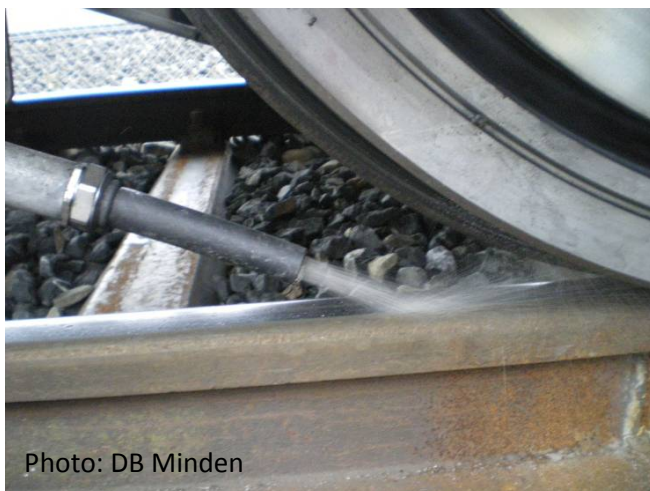
A sanding device functions by discharging quartz/sand from a container via a nozzle onto the rail just in front of the wheel, thereby increasing the friction in connection with start-up and braking. Originally, sanding devices only had the purpose of providing traction in case of slippery rails, i.e. to prevent wheel spin.

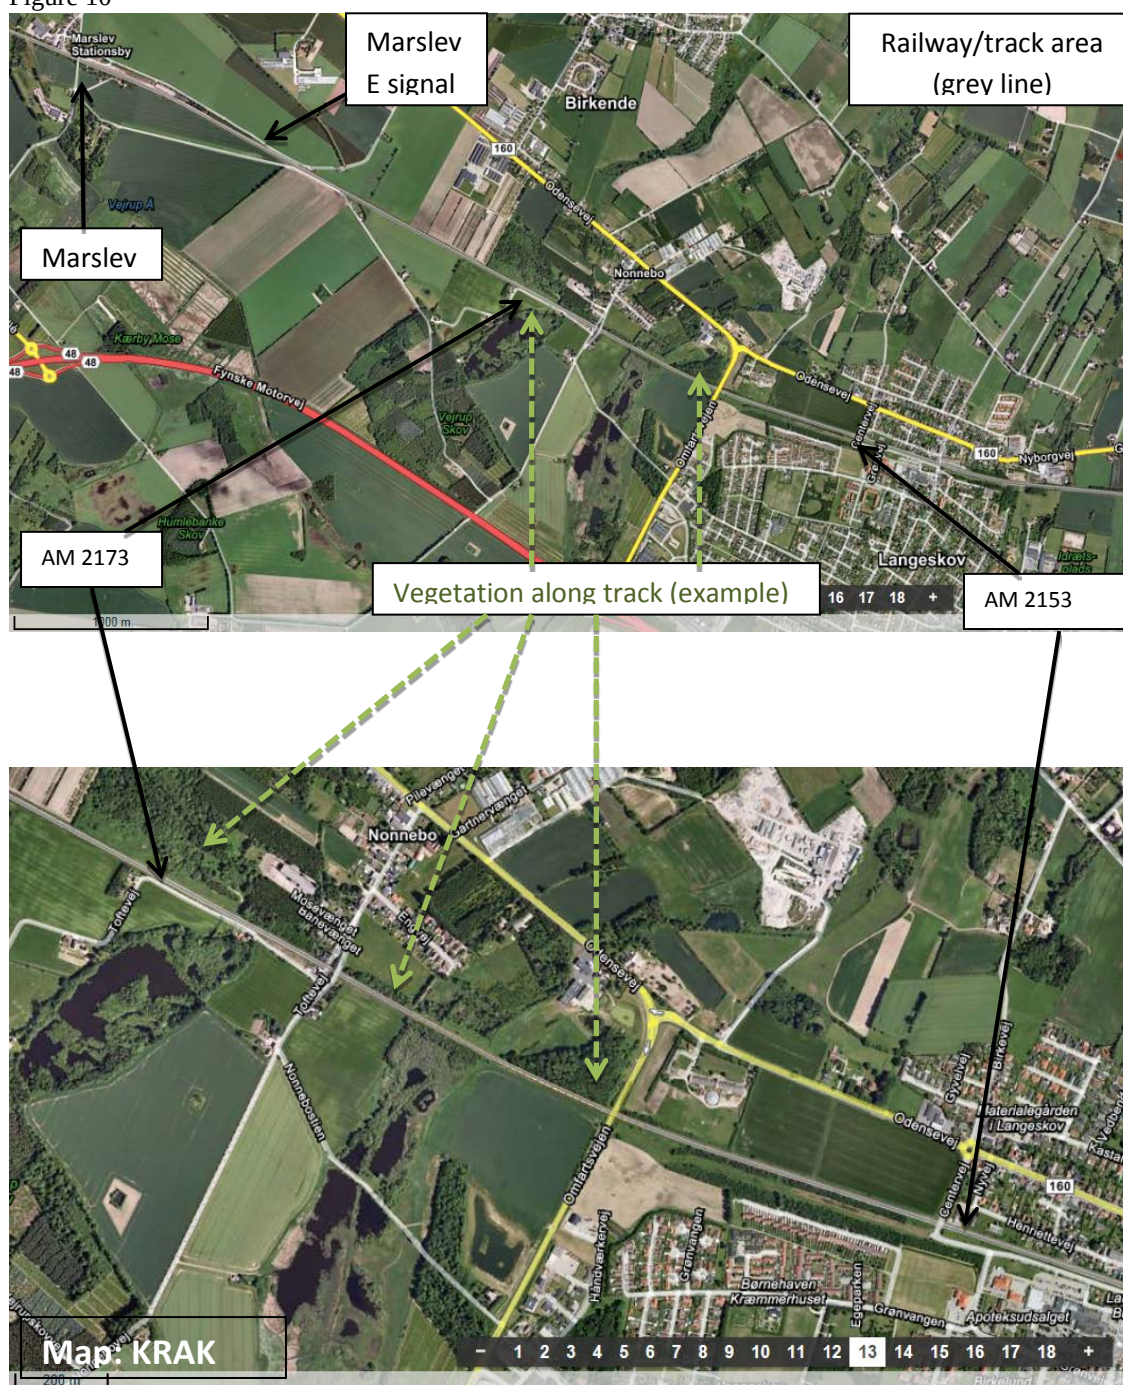
Figure 10

In the morning of 8 November 2011 the line was visually inspected (from the driver's cab of another train). A physical inspection was carried out on Friday 11 November 2011. Only a limited amount of leaves (a few leaves) was found on or near the track. On 11 November 2012 the area was manually inspected without any circumstances being found that could have explained the incident (Memorandum regarding examination of the rails, Appendix 4.1). In the beginning of December, samples were taken of the rail surface. Only a mixture of corrosion (iron oxide), grains of sand and small stones/silicates was found (the Danish Technological Institute, Appendix 4.2).
