Report 99-104

Train 1613

passenger safety incident

Featherston

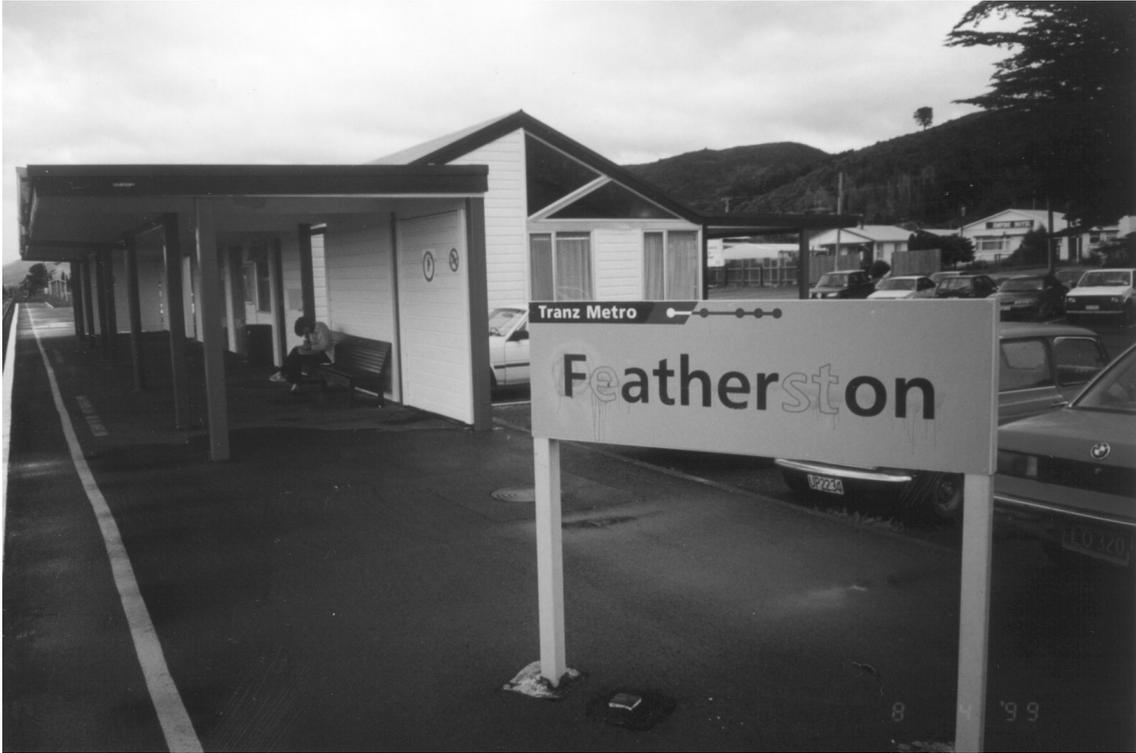
Figure 2
North end of Featherston station
(Looking in direction of travel of Train 1613)

- 1.2.3 The scouts arrived at Featherston station at 1600 hours and gathered at the north end of the platform awaiting the arrival of Train 1613. Their bicycles were leaning on the poles at the north end of the station with their packs on the ground adjacent. Figure 2 is a view of the north end of the station building, looking southwards in the direction of travel of the train and shows 8 columns supporting the veranda over the station platform. The scouts recalled "15 or so people" waiting at the south end of the platform and 2 or 3 half way down, plus a man with a bicycle and pack in the same area as themselves.
