Collision between freight trains 1901S and 5132S

Dry Creek, South Australia | 11 October 2011

ATSB Transport Safety Report

RO-2011-016

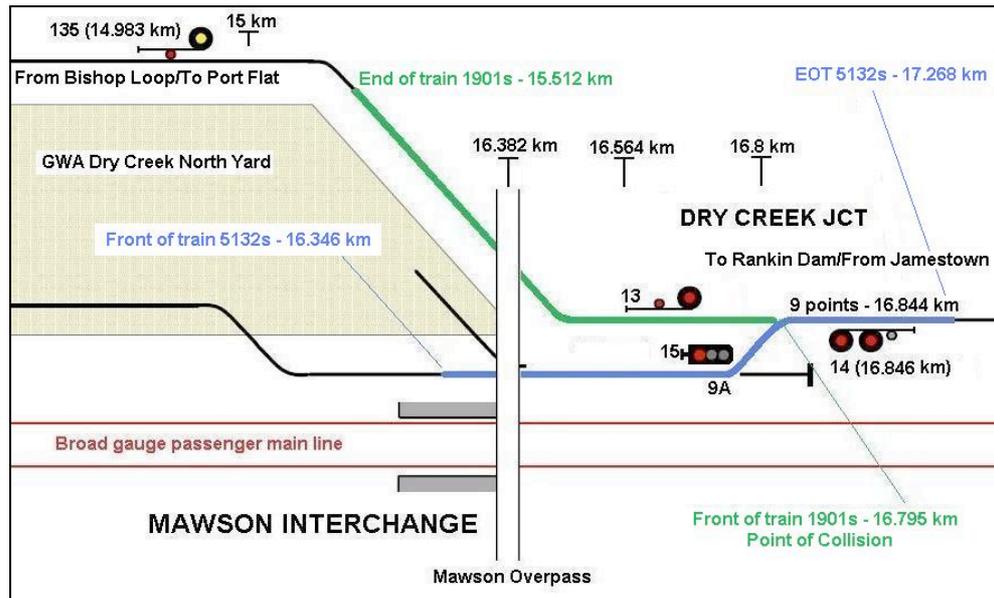
Figure 2: Incident site Dry Creek Junction

At the time of the collision, Dry Creek Junction (Figure 2) comprised two co-acting turnouts (9/9A points) to enable southbound train movements on the DIRN access into the Dry Creek North Yard. The clearance of signal 14 provided the authority to access the Dry Creek North Yard. The clearance of signal 13 provided the authority to proceed through Dry Creek Junction from the southern approach on the DIRN, with the preceding signal 135 providing the train driver with advance warning of the status of the line ahead and whether signal 13 was at stop (red), caution (yellow) or clear (green).

Train 1901S continued towards Dry Creek North passing three signals at proceed before approaching signal 135 (Figure 2). At about this time the driver of train 1901S observed the bright headlights of what he believed to be a locomotive undertaking shunting operations at the northern end of the Dry Creek North Yard which was ahead and slightly to the right of his direction of travel. Train 1901S continued past signal 135, towards signal 13 at Dry Creek Junction, maintaining a speed of about 60 km/h.

Signal 135 was located to the left of the track at the 14.983 track km point and is approximately 1571 m in advance of signal 13 (Figure 2). At 0103, as train 1901S approached signal 135, the moon was at an azimuth of 335 49', an altitude of 46 50' and approaching full moon, but the weather was overcast.
