Safeworking breach involving a Local Possession Authority

Revesby, New South Wales | 10 July 2013

ATSB Transport Safety Report
Rail Occurrence Investigation
RO-2013-017
Final – 19 September 2014

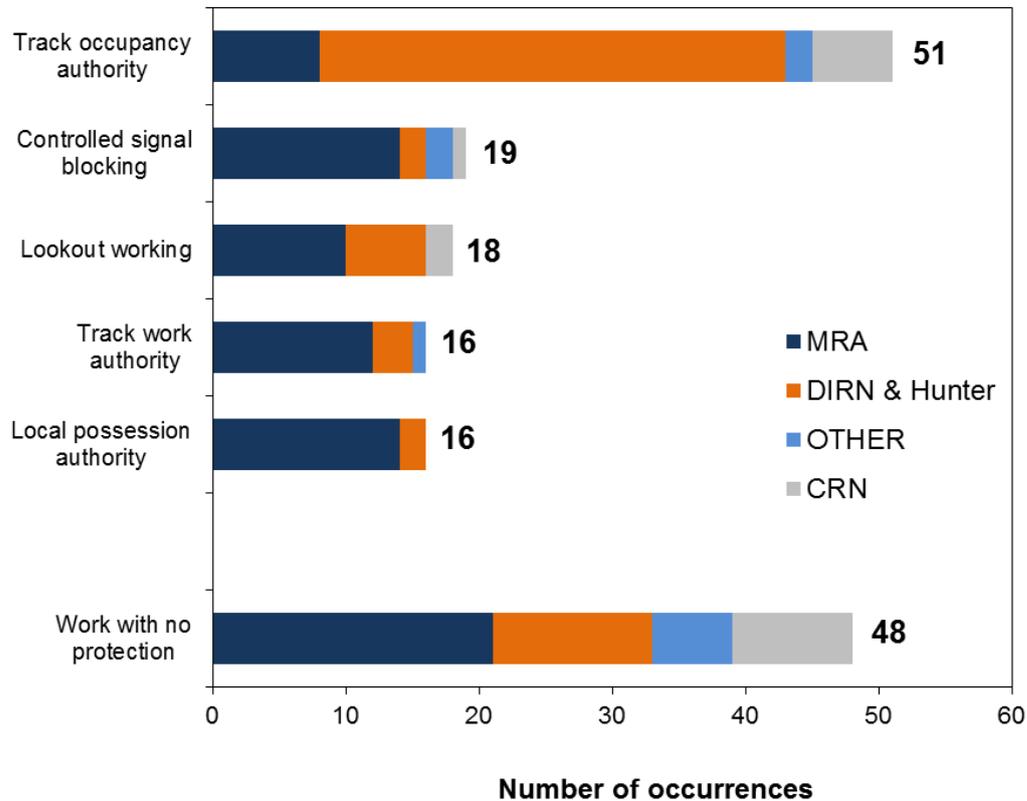
Figure 6: Worksite protection occurrence data on the NSW rail network, 2011-12

Prior to 2012-13, the Independent Transport Safety Regulator of NSW (ITSR) published an annual Rail Industry Safety Report which summarised safety performance and historical trends. Figure 6 shows the number of worksite protection irregularities (occurrence events) in 2011-12.

In NSW in 2011-12, with the exception of track occupancy authority related occurrences, the number of LPA occurrences was similar to those experienced with other types of worksite protection. The proportion of LPA occurrences was comparable over the preceding four 12 month periods.

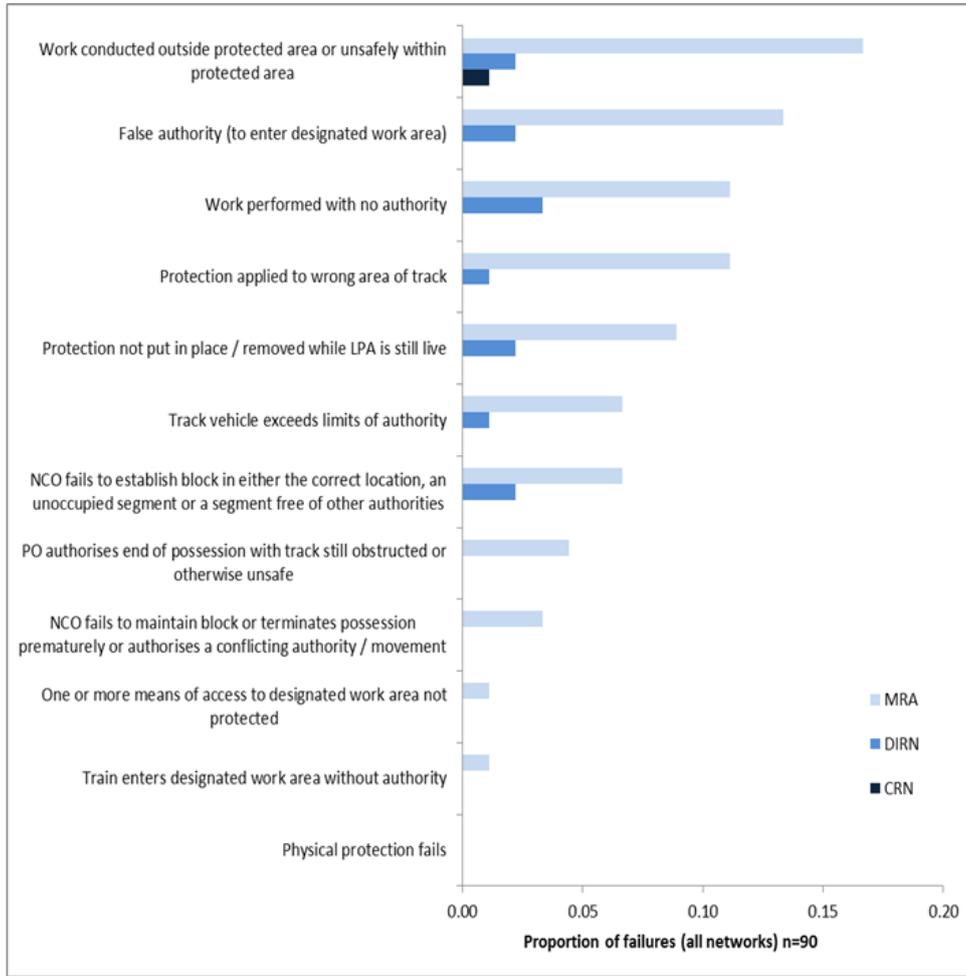
Figure 7: LPA occurrence data on the NSW rail network, 2007-08 to 2011-12¹⁷

For analysis purposes, the ITSR classified LPA specific irregularities (failures) into 12 categories (Figure 7).

The Revesby incident where 709C entered the limits of an LPA has been classified as: ‘NCO (Network Control Officer, in this case the area controller) failed to establish block in either the correct location, an unoccupied segment or a segment free of other authorities’. Despite the apparent predominance of this category of failure to the MRA network, it is not statistically significant as the differences between the failure types are low and relatively minor due to the small number of failures across a large number of categories.
