# Safety Investigation Report

## Double overrunning of signals by an international train Antwerpen-Luchtbal - 1 November 2015

| <b>Basic facts:</b> | at the exit of the Antwerpen-Centraal tunnel, the E9227 train overran the signals G-R.12 and J-R.12, in a closed position, on the L.25. No route was defined towards the L.12: the train continued its journey on the L.4 where it came to a standstill after the intervention of surveillance staff from Block 12 Antwerpen-Berchem. |

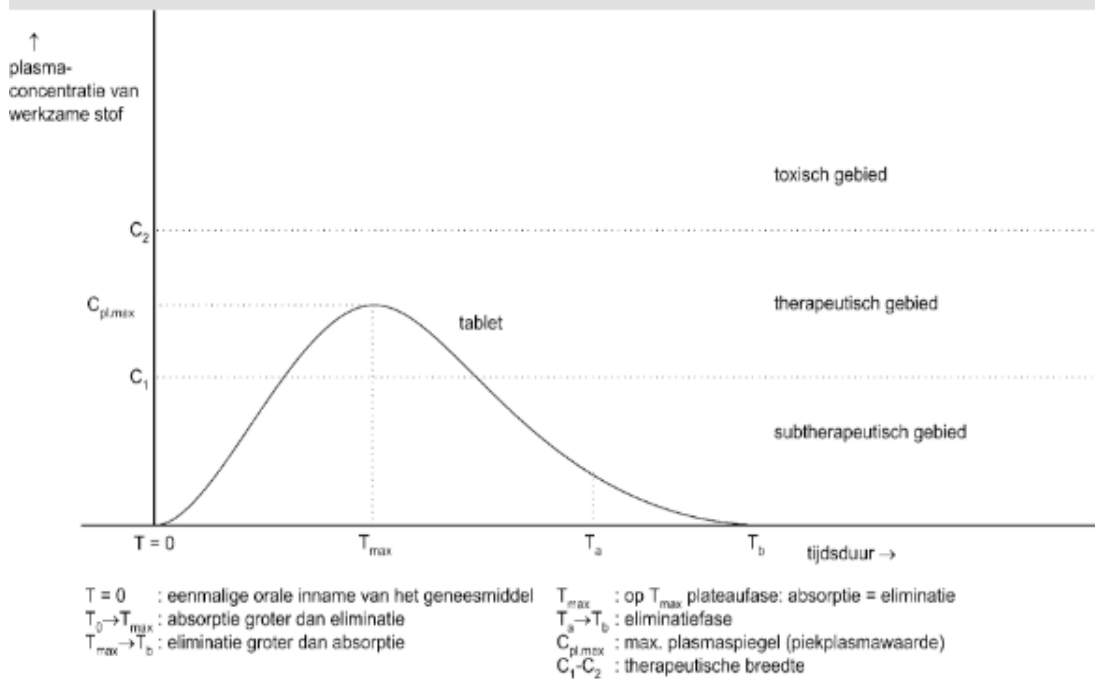
**Figuur 1 : Het verloop van de plasmaconcentratie in de tijd na eenmalige orale toediening**

The graphic below describes generally the effect of oral administration of the '*analgesic and antipyretic*' product over time:  $T_{\max}$  corresponds to the moment that the plasma peak is reached. The therapeutic zone (therapeutic window) gives the concentrations at which the medication is active.

At first glance, there seems to be no problem for the train driver: the medication ingested is permitted! The investigation did however reveal the opposite phenomenon, namely the risk of losing the intended effect of the medication. Once the effect of the medication has passed the plasma peak, it moves towards the under-therapeutic zone where the capacity for concentration reduces progressively towards a state of reduced capacity for concentration or hypovigilance which is difficult to self-diagnose.
