Safety report

SIGNALISATION INCIDENT

OTTIGNIES - 28 JULY 2014

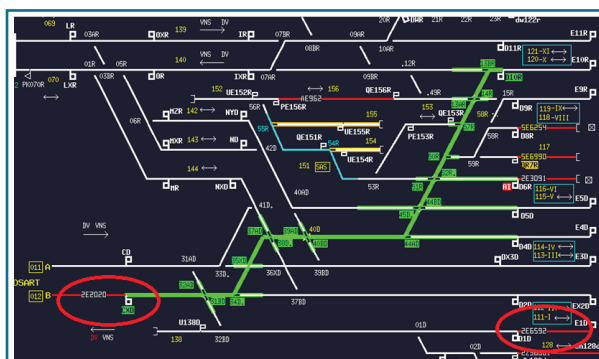
On Monday 28/07/2014 at around 21:21, a train (E2020) is travelling according to a pre-set route which crosses multiple points on the grid of Ottignies station.

As the train has completed its route and leaves the Ottignies grid, the signal box operator notices that the train's route is not released. At around 21:22'24", in accordance with procedures in the Regulations, the operator applies an NT function in the EBP system in order to release the route.

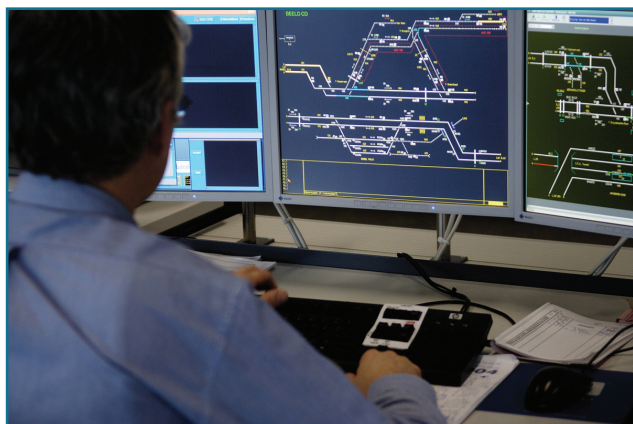
The signal box in Ottignies controls signalling in the Ottignies grid: its role consists, in total safety, of placing the points in the right position and opening the signals ahead of trains so as to direct them towards the tracks they should use.

The signal box ensures this management at 2 levels: the "control" level and the "interlocking" level. The control level is assured by the EBP system as developed by Siemens. It receives requests by signal operators and transmits them to the "interlocking" level which deals with these requests safely.
