Safety Investigation Report

Collision between a passenger train and the rear of a freight train Hermalle-sous-Huy - 5 June 2016

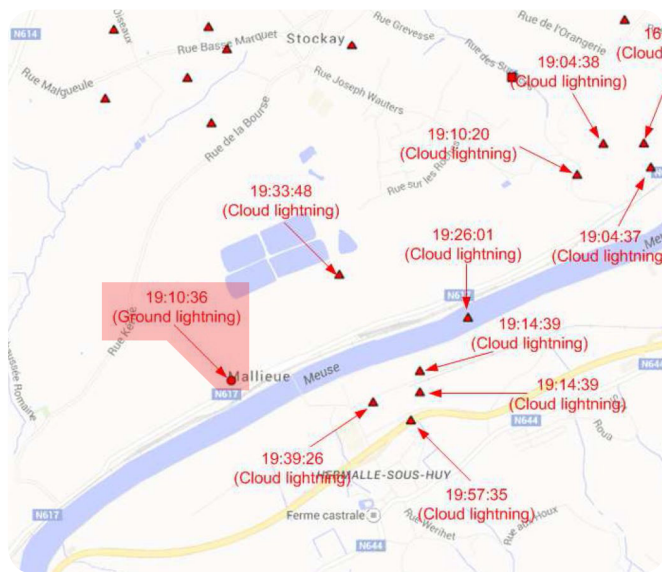
Following storms that occurred on 5 June 2016 around 7 p.m., a lightning strike caused various disturbances to the signals on line 125 at Hermalle-sous-Huy: three track circuits were interrupted. As a result, the signals protecting access to the concerned sections turned red: the three signals involved (B222, K.10 and KX.10) were thus closed.

Figure: location of the lightning strikes registered in the vicinity of the accident site on 5 June 2016 between 7 p.m. and 8 p.m. (source: Elia).
