KÖZLEKEDÉSBIZTONSÁGI  
SZERVEZET  
TRANSPORTATION SAFETY  
BUREAU

**FINAL REPORT**  
**2008-0446-5**  
**SERIOUS RAILWAY ACCIDENT**  
**Monorierdő**  
**6 October 2008**

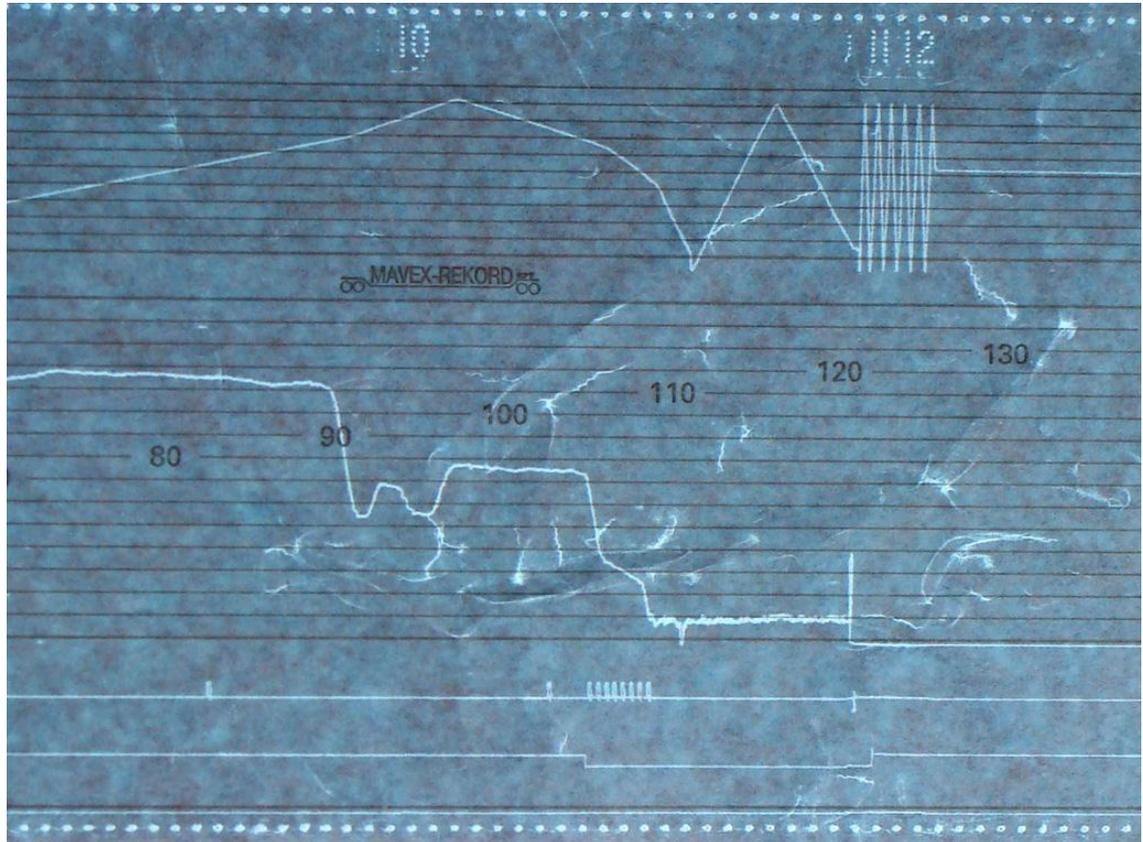
There was a Teloc RT 9 type data recorder on the locomotive (V43,1030) of train IC 560-1 whose measuring limit was 150 km/h so was the measuring limit of the strip chart recorder inside it (see Figure 7).

Figure 7: The strip chart recorder of locomotive V43,1030 of train IC 560-1

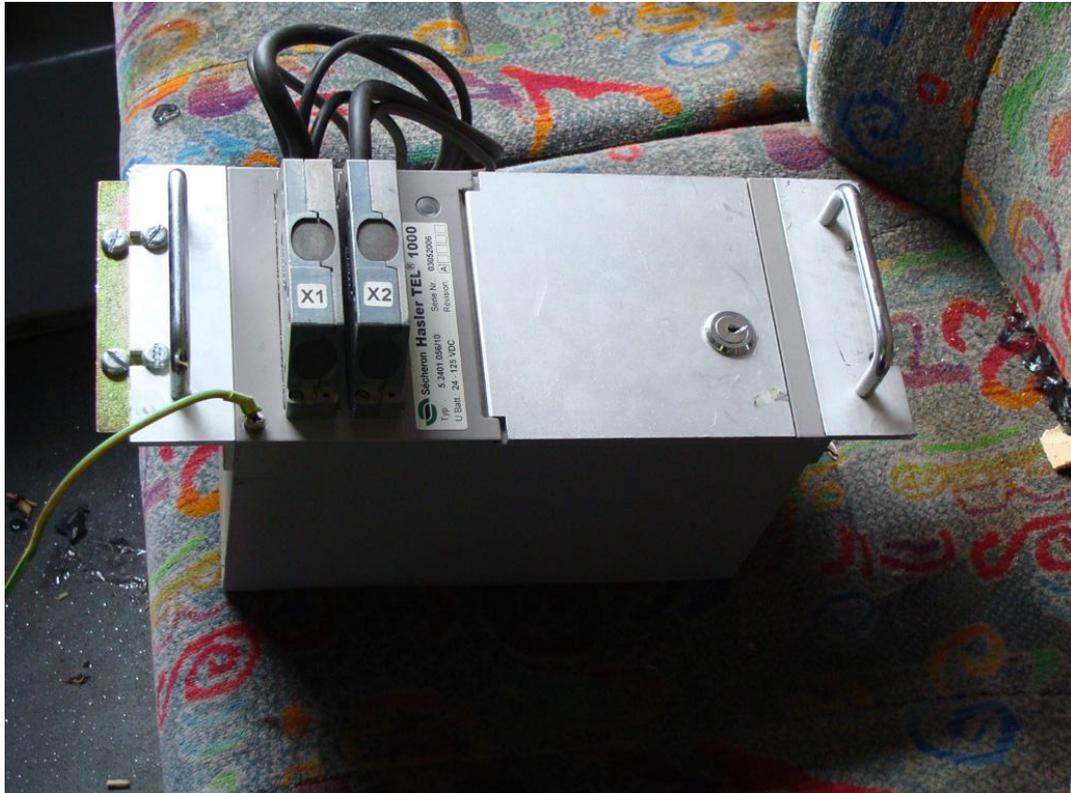
The experts of MÁV Zrt together with the firefighters found the data recorder of the control car among the wreckages and opened it before the police and the IC (see Figure 8).

Figure 8: the data recorder of the control car

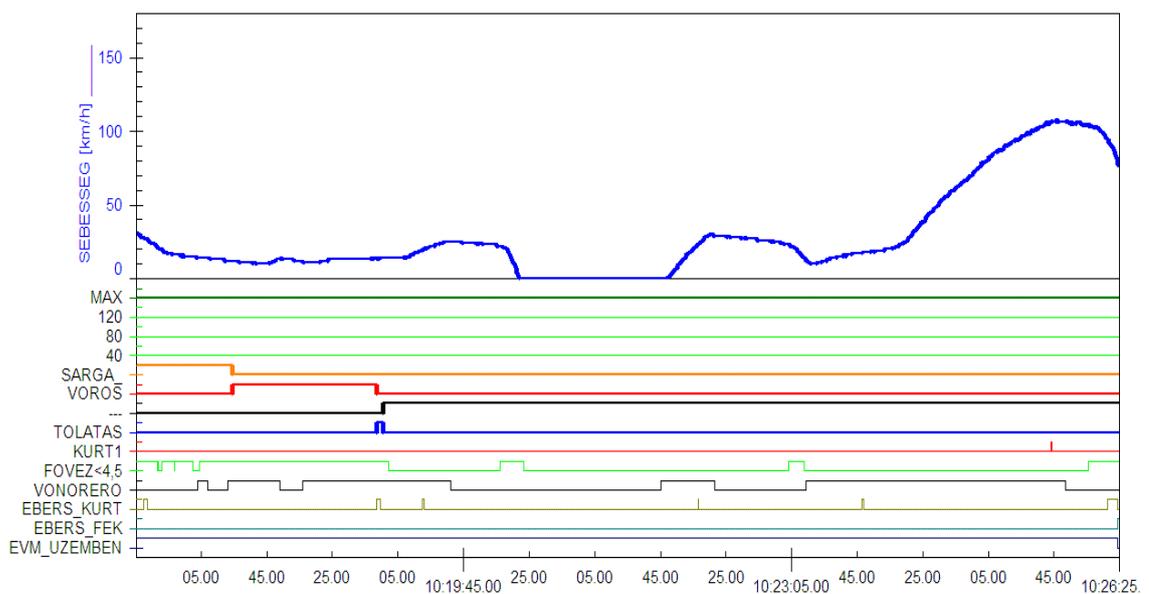
Figure 9: diagram of the BDT 415 control car's data recorder (train 2537)

10:26:22	358,53699	85,000	---	
10:26:22	358,53799	85,000	---	
10:26:23	358,56099	84,000	---	
10:26:24	358,58299	80,000	---	
10:26:24	358,60099	78,000	---	last signal, vigilance brake

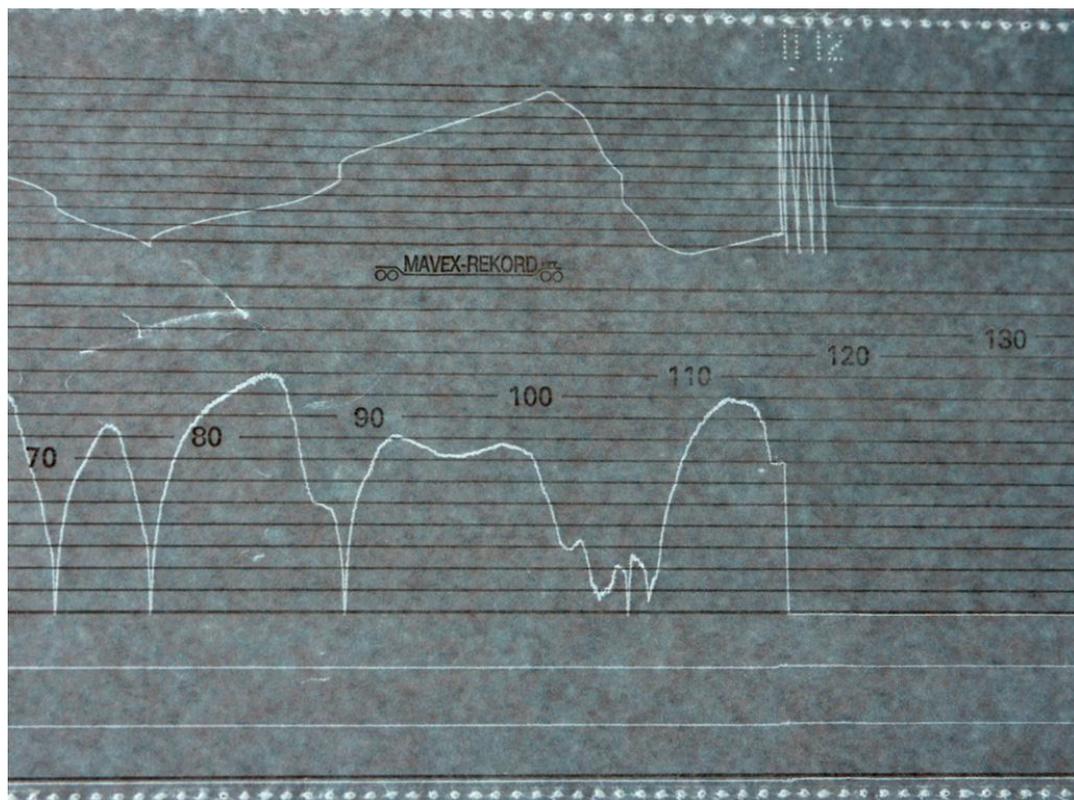
Figure 10: the strip chart recorder of locomotive V43, 2318 (train 2537)

The recordings on the strip chart do not contain the signals of the EÉVB as they can only be detected on the first vehicle. However, the irregular sign due to the collision can be seen on the strip chart recording.

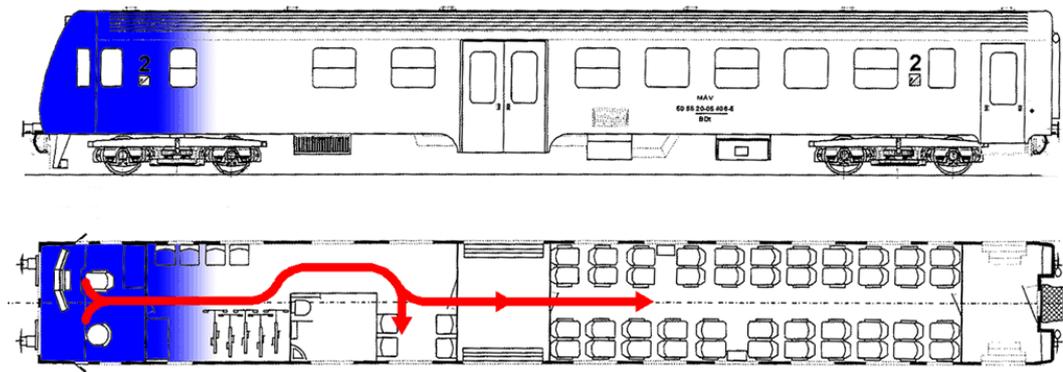
In this case, the people in the driver's cab ran backwards to the luggage room of the carriage and through it to the passenger compartment (see Figure 12).

Having made all efforts he could in order to reduce the collision speed, the engine-driver went backwards and waited behind the toilet (in the control car), lying with his back against the wall. He did not suffer injuries. The ticket inspector ran from the driver's cab to the passenger compartment, warned the passengers of the collision and then fell over when the collision occurred and suffered minor injuries. The other ticket inspector in the driver's cab (not on duty) got to the hallway where he suffered injuries at the collision.

Figure 12: escape from the driver's cab

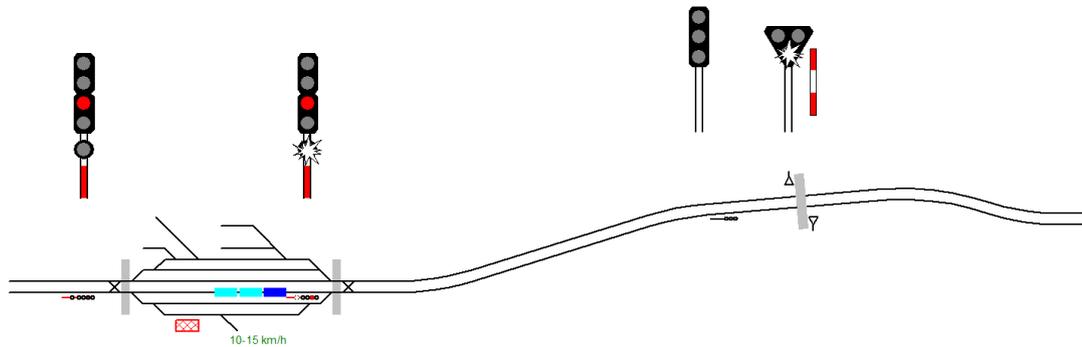
Figure 14: 10:13 hrs

At 10:13 hrs: train IC 560-1 departed from Pilis station onto the left track under subsidiary signal.

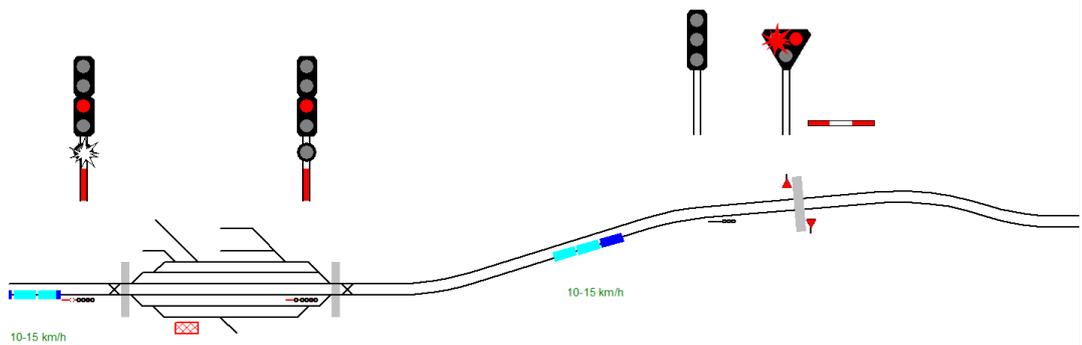
Figure 15: 10:17 hrs

At 10:17 hrs: the passenger train received subsidiary signal on the entry signal and while approaching the station, the train control device of the control car was deactivated. In the meantime, IC train was running slowly on the open track towards Monor, having closed LC AS 450 by this time.

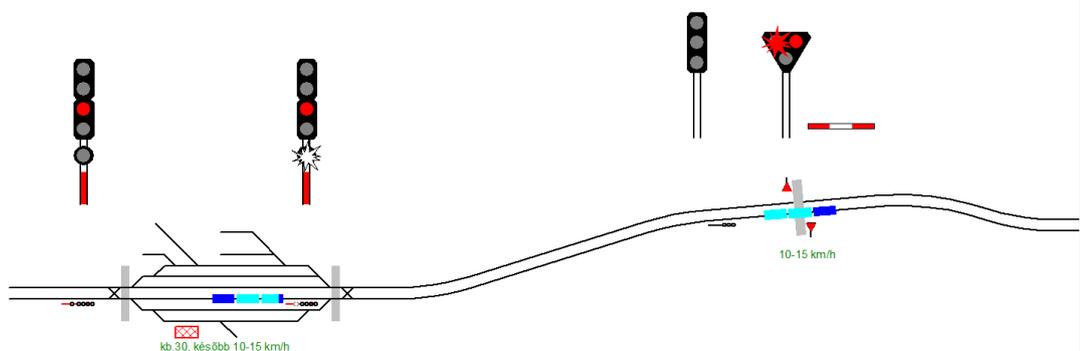
Figure 16: 10:22 hrs

At 10:22 hrs: the passenger train departed from Pilis station onto the left track, also under subsidiary signal while the IC train was passing LC AS 450. However, by this time the LC (its warning lights) became inoperative as the train was running too slowly (the LC was closed for too long time), but it still indicated Stop towards the road due to the so called “red extension” (see 1.8.3.)

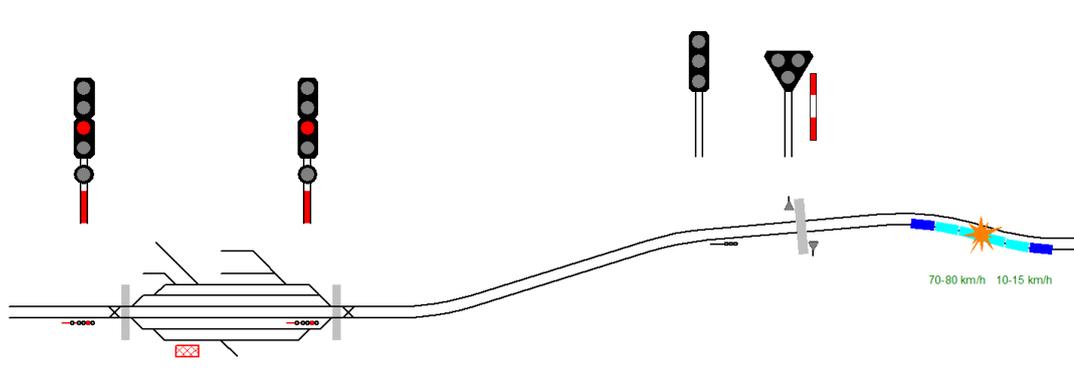
**Figure 18: 10:26 hrs**

At 10:26 hrs: the trains collided with each other.

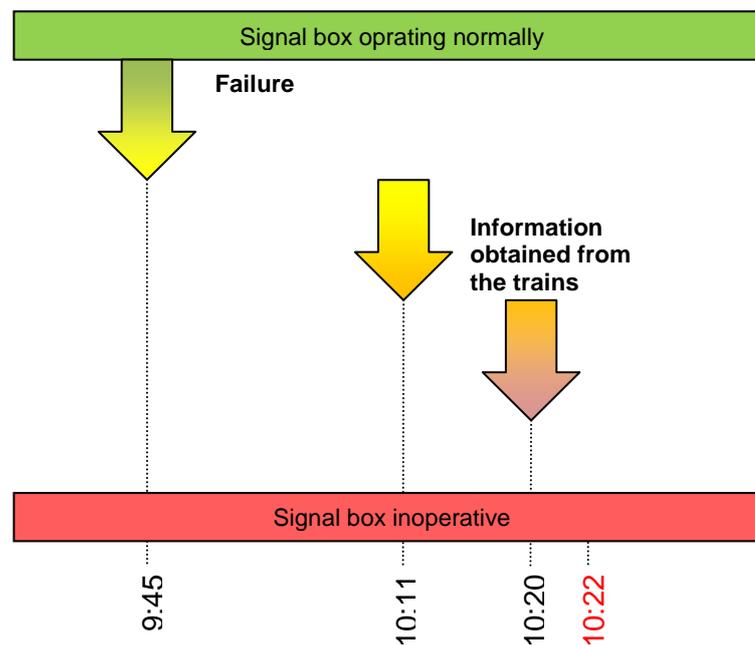
**Figure 21: changing information on the status of the signal box (10:22 – train 2537 departs)**

The staff was uncertain whether the line signal box failed completely or only parts of it became inoperative. In such an uncertain situation, to assume the worst and act accordingly is the safest until one can ascertain the actual facts. The traffic regulations however, do not prescribe the above, and the staff did not act accordingly, therefore they applied the usual technology and procedures.

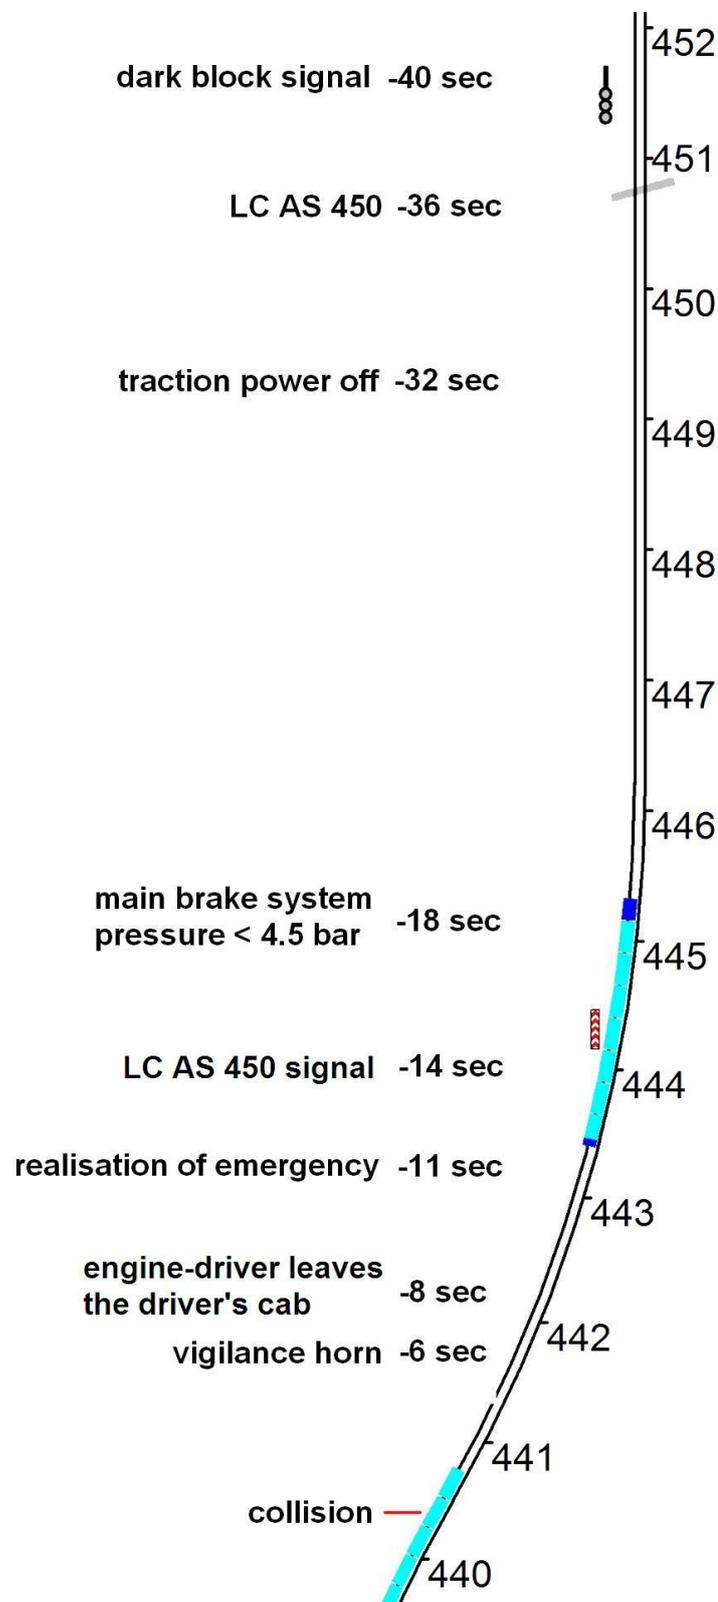
The below figure shows the moments before the collision. The trains are shown (with light blue colour) in the position when the engine-driver noticed the IC train in front of him.

Figure 22: the moments before the collision and the actions/events of train 2537

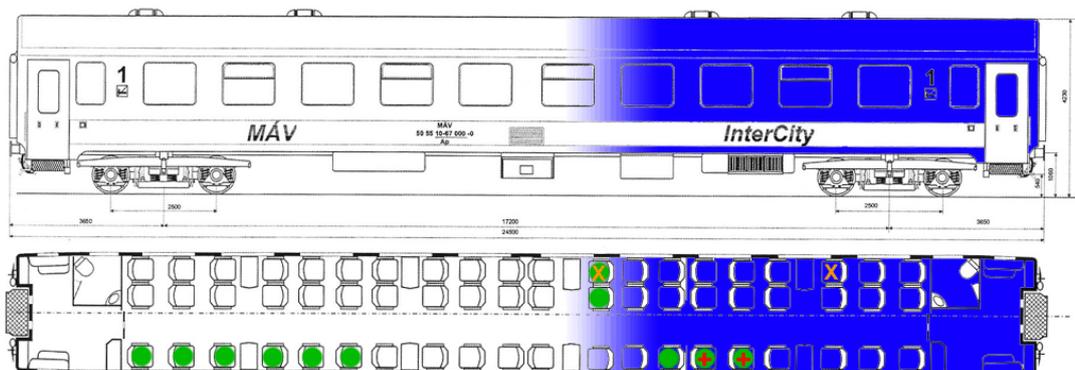
- The green points indicate the seat reservations (sold tickets), however the actual position of the passengers may have been different (they do not always sit where their tickets indicate).
- Orange X indicates where the passengers who answered to the IC's questionnaire were sitting.
- Red + indicates the seats where the two deceased persons most likely sat. As the part of the passenger compartment indicated with blue colour was destroyed, the IC only assumes the seating arrangements based on the injuries to the deceased passengers and their position in the damaged compartment. It was not possible to make such assumptions with regard to the other two victims.

**Figure 26: the position of the passengers in the last carriage of train IC 560-1**

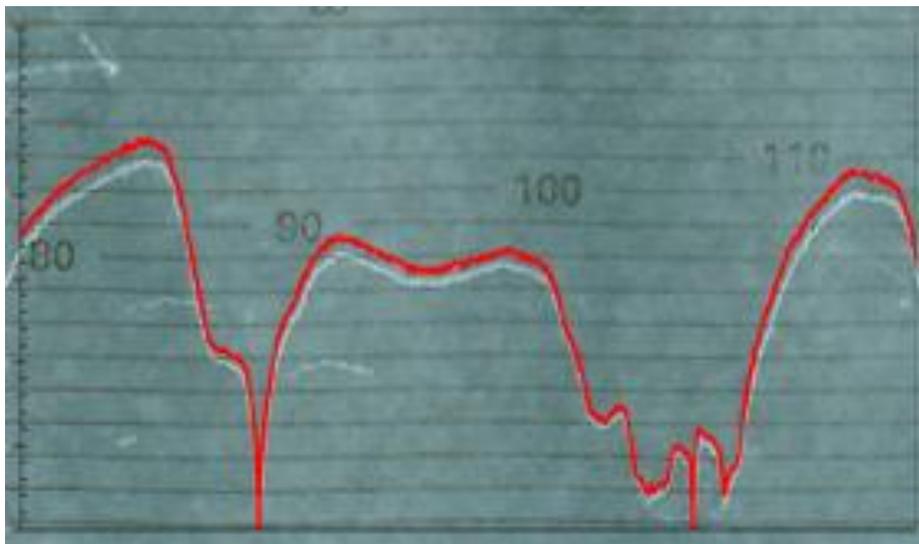
The wheels of the locomotive through which the traction is transferred to the track always slip (it is called microslip). This slip can result in a 1% difference between the theoretical speed measured on the driven wheels of the locomotive and the actual travelling speed (which is lower). The effect of microslip makes the recorded speed values for the locomotive even lower. However, this error does not have effect on the results of the analysis and does not diminish the effect of the fact that the train was travelling with high speed at the time of the collision.

The superimposed recordings of the two data recorders are shown in Figure 27. The two stopping locations, the scales of the strip chart data recorder and the digital data recorder and the zero-point error were considered while compiling the diagram.

**Figure 27: the recordings of the two data recorders of train 2537 (red line: the digital data recorder)**
