Railway Accident Investigation Unit

INVESTIGATION REPORT

Operational incidents at
Ardrahan on the 23rd October 2015
& Spa on the 28th November 2015

RAIU Report Number: R2016 – 03
Published: 20th October 2016

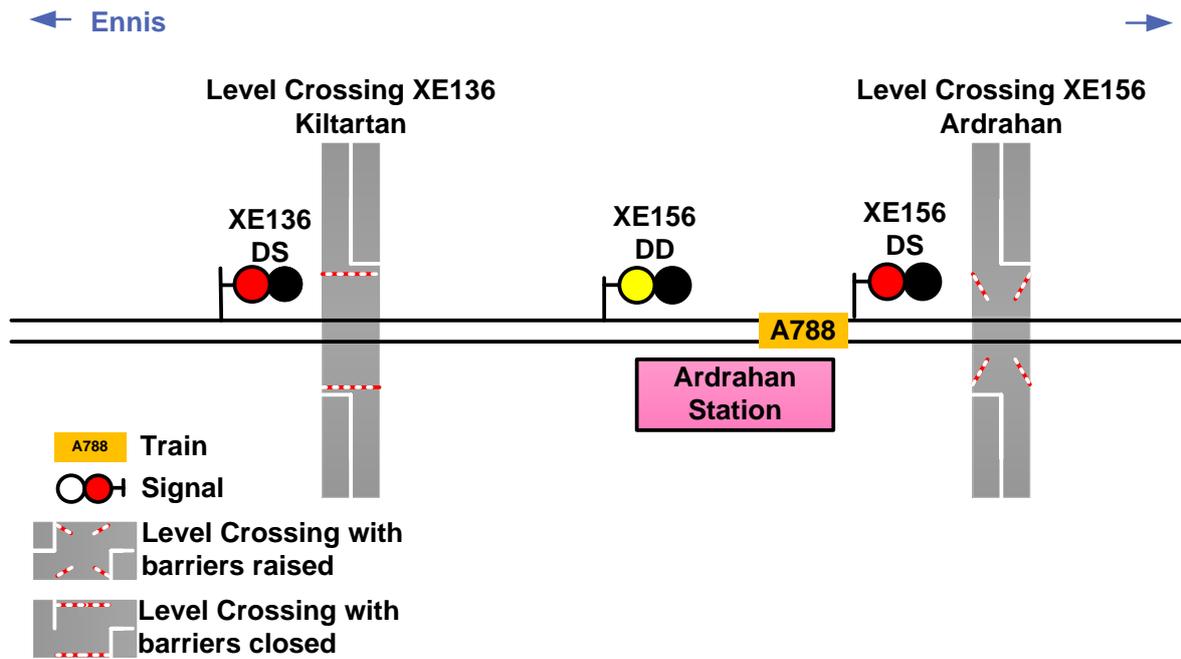
Figure 14 – Train A788 passing through Ardrahan Station

56 At 19:52:00 the train passes through Ardrahan Station, that it was due to stop at and serve, see Figure 14.

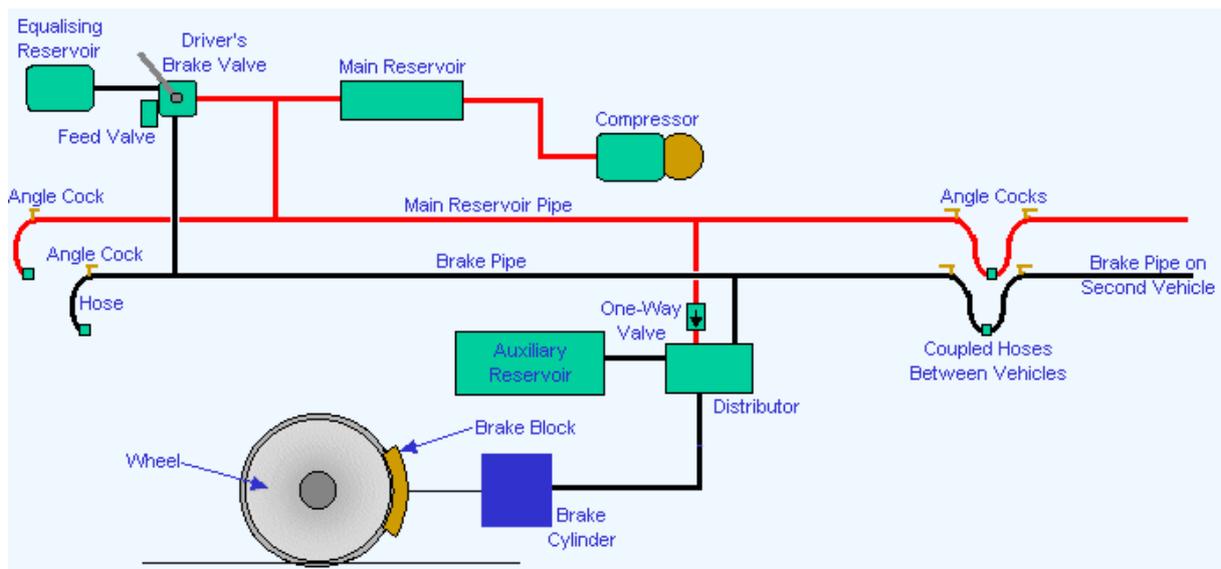
Figure 27 – Block diagram of two-pipe air brake system

138 The brake is graduated in steps from initial application to full service; as can be seen in Figure 27, the driver command is translated through a series of valves and pipe work. This can lead to a system delay also known as *hysteresis*. When the driver requests full service it can take a number of seconds for the clamping force to build and begin retarding the train.
