RAILWAY OCCURRENCE REPORT

05-124 express freight Trains 834 and 841, collision, Cora Lynn 20 October 2005

**TRANSPORT ACCIDENT INVESTIGATION COMMISSION
NEW ZEALAND**

Report 05-124
express freight Trains 834 and 841
collision
Cora Lynn
20 October 2005

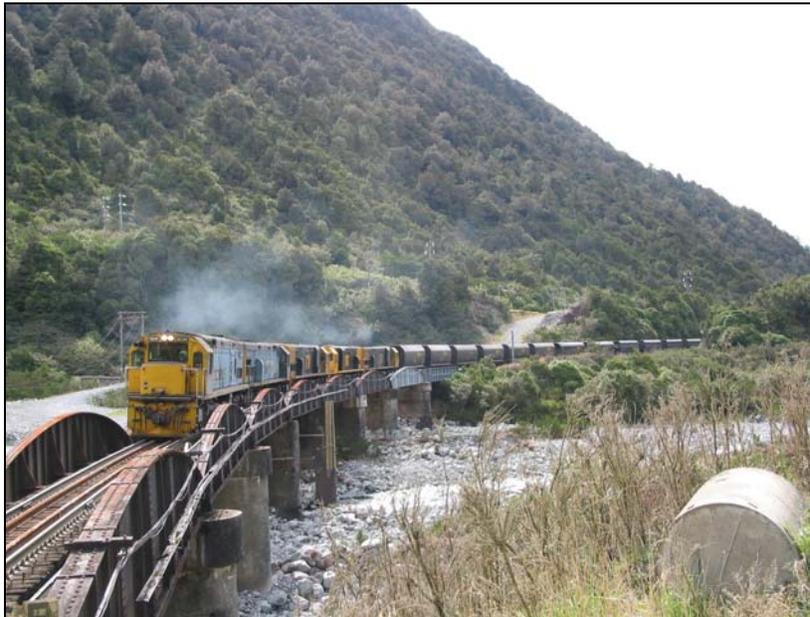
Figure 1
A loaded eastbound coal train approaching the western portal of the Otira Tunnel

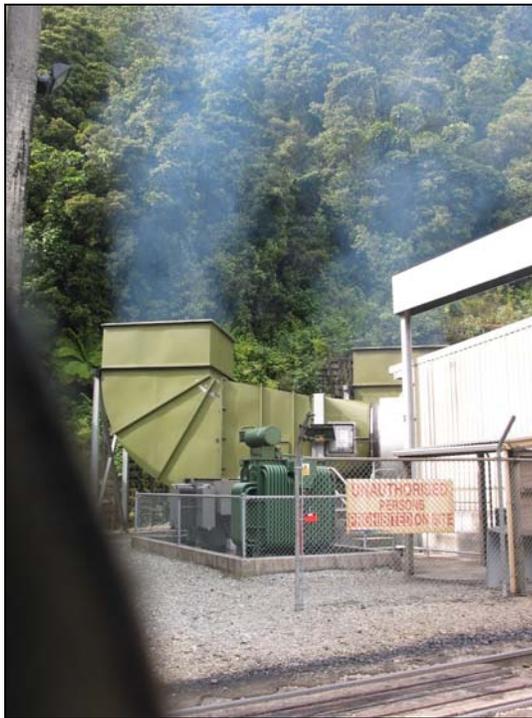
- 1.2.11 After a westbound train had cleared the Tunnel, the door closed and both extractor fans started and ran for 11 minutes to purge the Tunnel of exhaust fumes. When the fans stopped, the door reopened. Figure 2 shows the extractor fan outlets.

Figure 2
The extractor fan exhaust outlets at the western portal of the Otira Tunnel

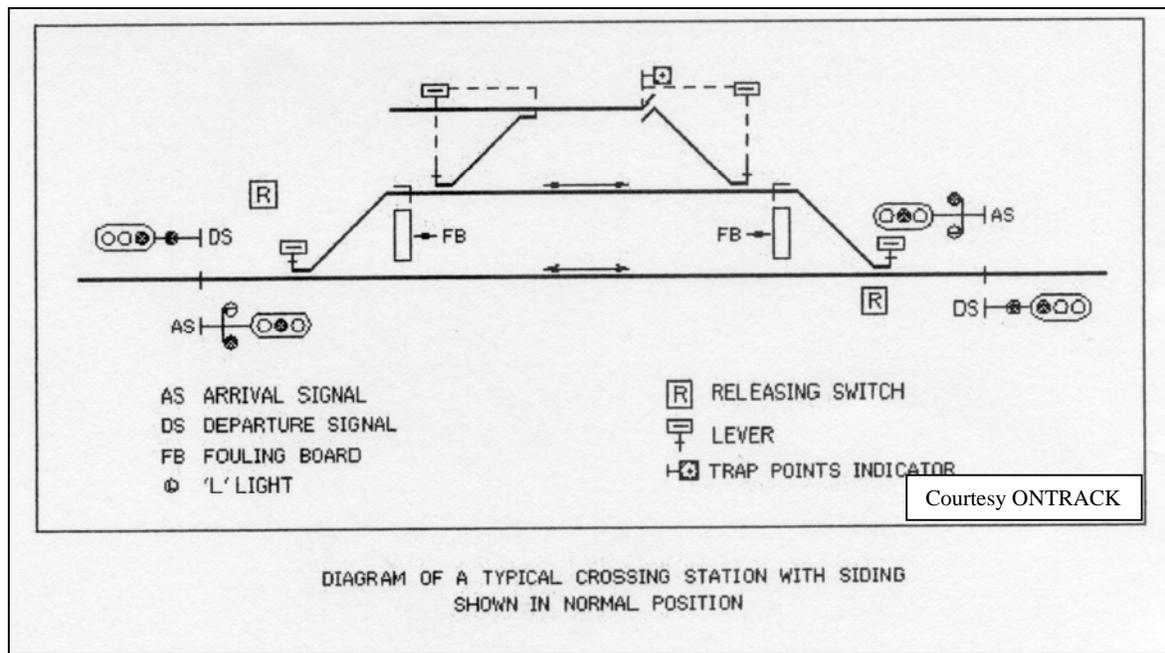
Figure 5
Typical layout of a crossing station in SLAS territory (not to scale)

- 1.3.5 The arrival signal and the departure signal in SLAS were positioned adjacent to each other, either on opposite sides of the main line (see Figure 5) or back to back. The design of the signalling did not provide for an overrun of either signal.

- 1.3.10 The departure signal controlled the exit from the station and the entrance to the next single line block section. In SLAS territory, there was only one departure signal at each end of the station and this controlled the departures of trains from either the loop or the main line (see Figure 5).

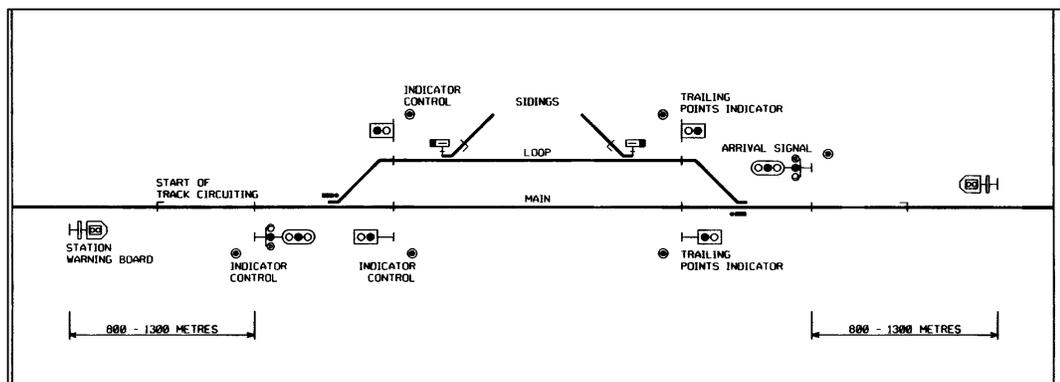
Figure 8
TWC crossing station (courtesy ONTRACK)

- 1.4.5 When the first train to arrive for a crossing was to berth on the loop, the locomotive engineer operated the designated "loop" button in the control box at the arrival signal. After the points had reversed, the "L" light on the arrival signal illuminated and the train entered the loop. Once the rear of the train cleared the points, track circuiting at that end automatically restored the points to the normal position (see Figure 8).

- 1.4.7 TWC was referred to as “dark territory” and the route was not track circuited as in SLAS. As a result, track circuiting and interlocking applied only in the immediate vicinity of the crossing stations and track detection did not extend beyond 1300 m into the single line section at either end (see Figure 8). In SLAS, track circuiting extended through the single line section to the next crossing station in advance.

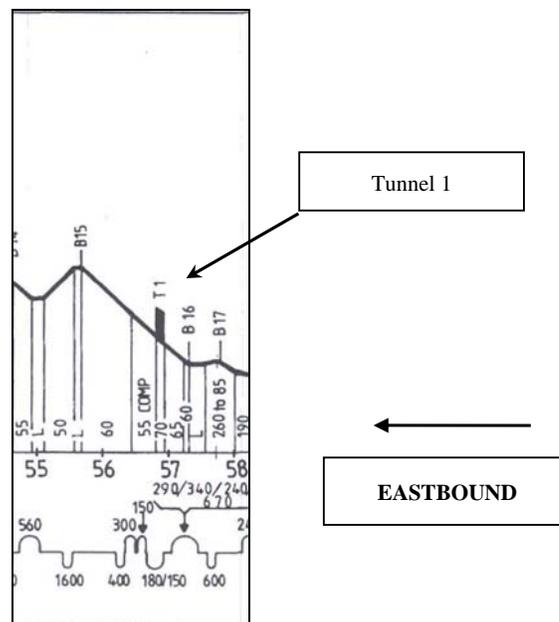
- 1.10.20 Tunnel 1 was about 80 m long and was situated between Staircase and Springfield. The track was on a gradient of 1 in 70 (see Figure 10) which continued for a further 350 m after exiting the Tunnel before the gradient steepened to 1 in 55 for a further 450 m.

Figure 10
Gradient diagram for Tunnel 1
(courtesy ONTRACK)

- 1.10.21 Eastbound trains negotiated a 180 m radius right-hand curve as they proceeded through the Tunnel, followed by a 150 m radius reverse curve.
- 1.10.22 The transition lengths¹⁴ for the curves approaching and leaving the Tunnel were a minimum design length of 35 m. This meant that the cant¹⁵ runoff was at the absolute maximum of 2 mm/m. The standard transition length was 70 m, which gave a design runoff of 1 mm/m.
- 1.10.23 ONTRACK’s Rail Operating Procedures, Local Network Instruction Section L6 specified a permanent speed restriction of 25 km/h through the Tunnel. This was because of substandard tops and bottoms of cab clearances in the Tunnel for DX class locomotives (and derivatives).
