Inquiry RO-2012-105: Unsafe recovery from wrong-route
at Wiri Junction, 31 August 2012

Final Report

Rail inquiry RO-2012-105
Unsafe recovery from wrong-route at Wiri
Junction, 31 August 2012

Transport Accident Investigation Commission

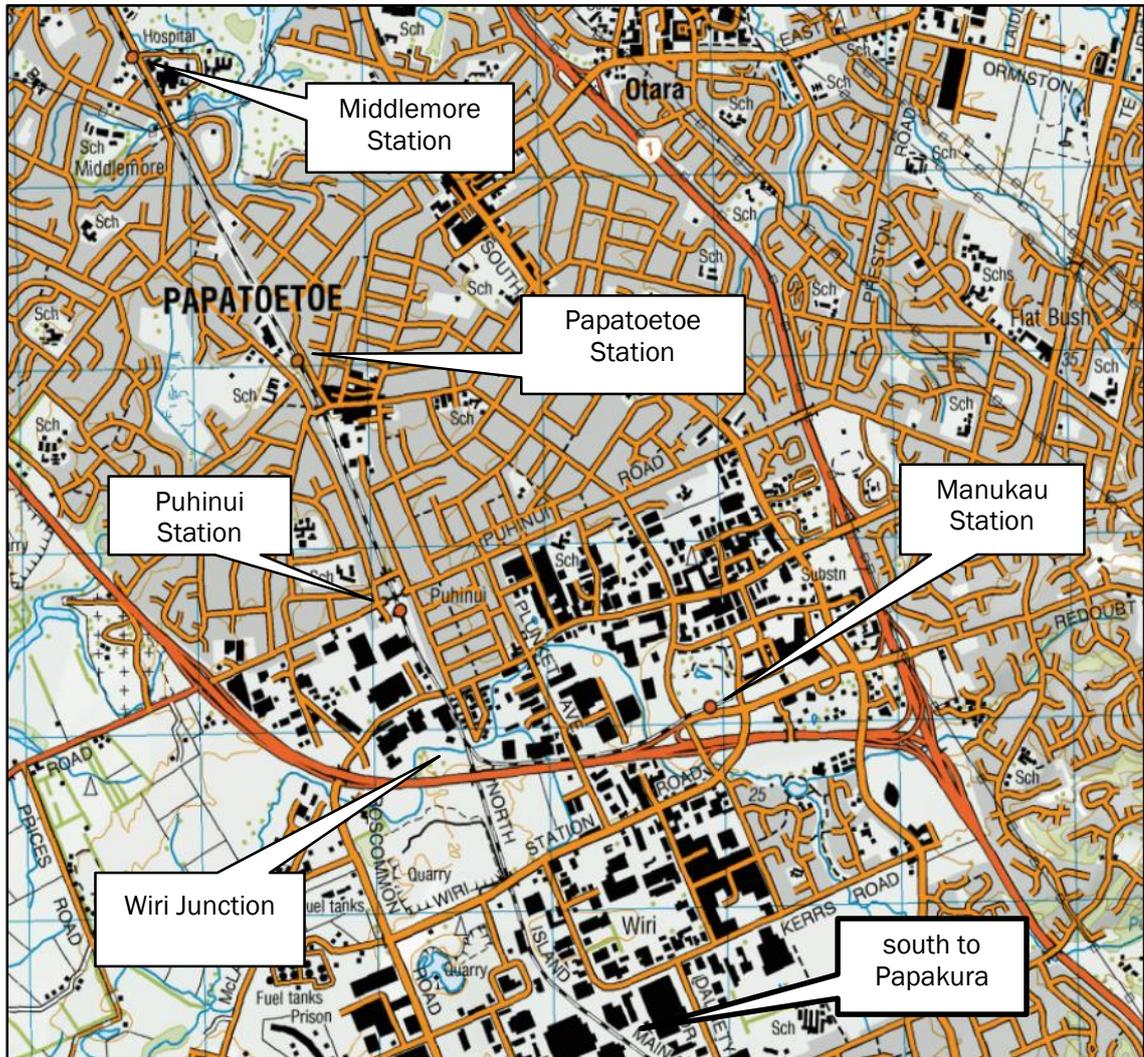
Figure 1
Area map

- 3.1.2. After the train passed through Middlemore Station (see Figure 1), three of the next four automatic signals along this straight displayed a 'flashing yellow over red' to indicate to the driver that there was a train ahead travelling in the same direction, but far enough ahead so that he could proceed at 'normal speed'². The fourth and last automatic signal before Puhinui Station was a steady 'yellow over red', indicating that the next signal, past Puhinui Station (signal 1803) would be at 'stop' (displaying 'red over red'). The train stopped at Puhinui Station to exchange passengers. Signal 1803 indicated the direction in which the train would be routed through Wiri Junction and the speed at which it was permitted to travel. It was about 170 metres ahead and visible to the driver when his train was berthed at the Puhinui Station platform (see Figure 2).
