Final report RO-2016-102: Train 140 passed Signal 10R at 'Stop'  
Mission Bush Branch line, Paerata, 25 October 2016

Rail inquiry RO-2016-102  
Train 140 passed Signal 10R at 'Stop'  
Mission Bush Branch line, Paerata  
25 October 2016

Approved for publication: August 2017

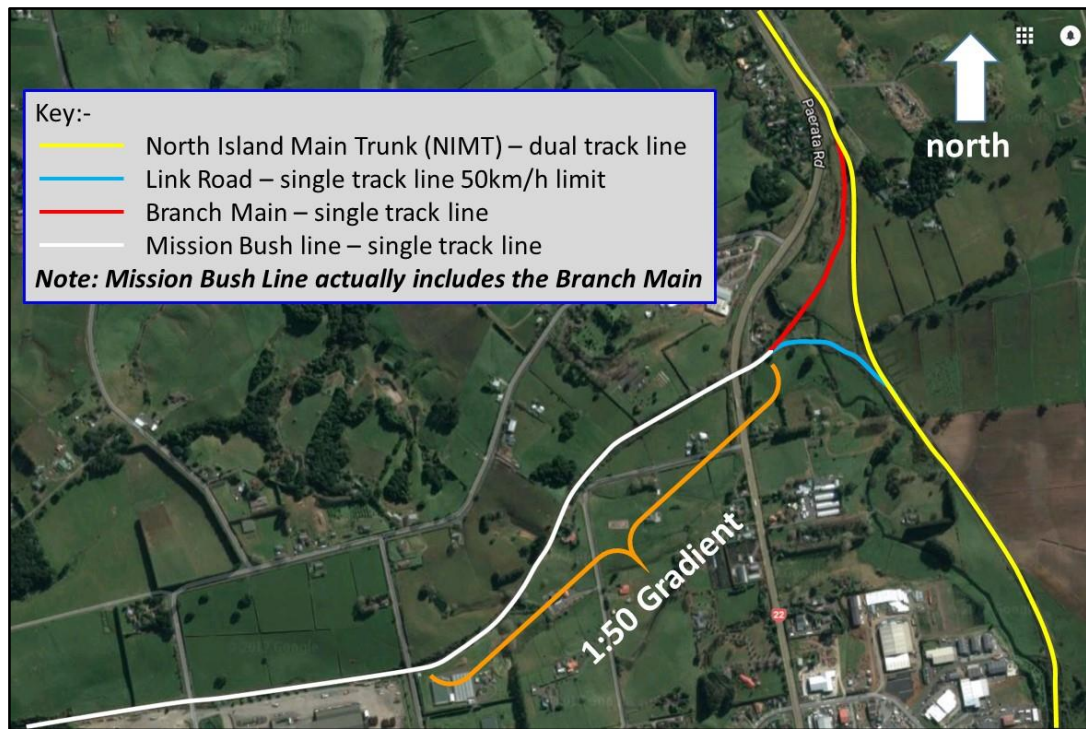
Figure 1  
Location of the incident

- 3.1.1. On 25 October 2016, the train was conveying 22 loaded coal wagons. The route was set for the train to travel from the North Island Main Trunk line (NIMT) to the Mission Bush line via the Link Road<sup>2</sup> at Paerata (see Figure 1).
- 3.1.2. The weather was overcast when the train entered the Link Road at 0843. The Link Road track alignment was a tight radius curve with a rising gradient of 1 in 50. Trains were restricted to a maximum line speed of 50 kilometres per hour (km/h) through the Link Road.

- 3.1.3. The train was travelling at 45 km/h<sup>3</sup> when it entered the Link Road. As the train travelled across Bridge 2 the locomotive developed wheelslip<sup>4</sup> and sand was applied automatically<sup>5</sup> to improve traction (see Figure 2). The train driver made a brake application and progressively reduced the power demand from the maximum notch 8 to notch 6 to maintain traction.
