Final report RO-2017-101: Signal Passed at Danger 'A' at compulsory stop boards protected
worksite, Pongakawa, Bay of Plenty, 7 February 2017

Rail inquiry RO-2017-101
Signal Passed at Danger 'A' at
compulsory stop boards protected worksite
Pongakawa, Bay of Plenty
7 February 2017

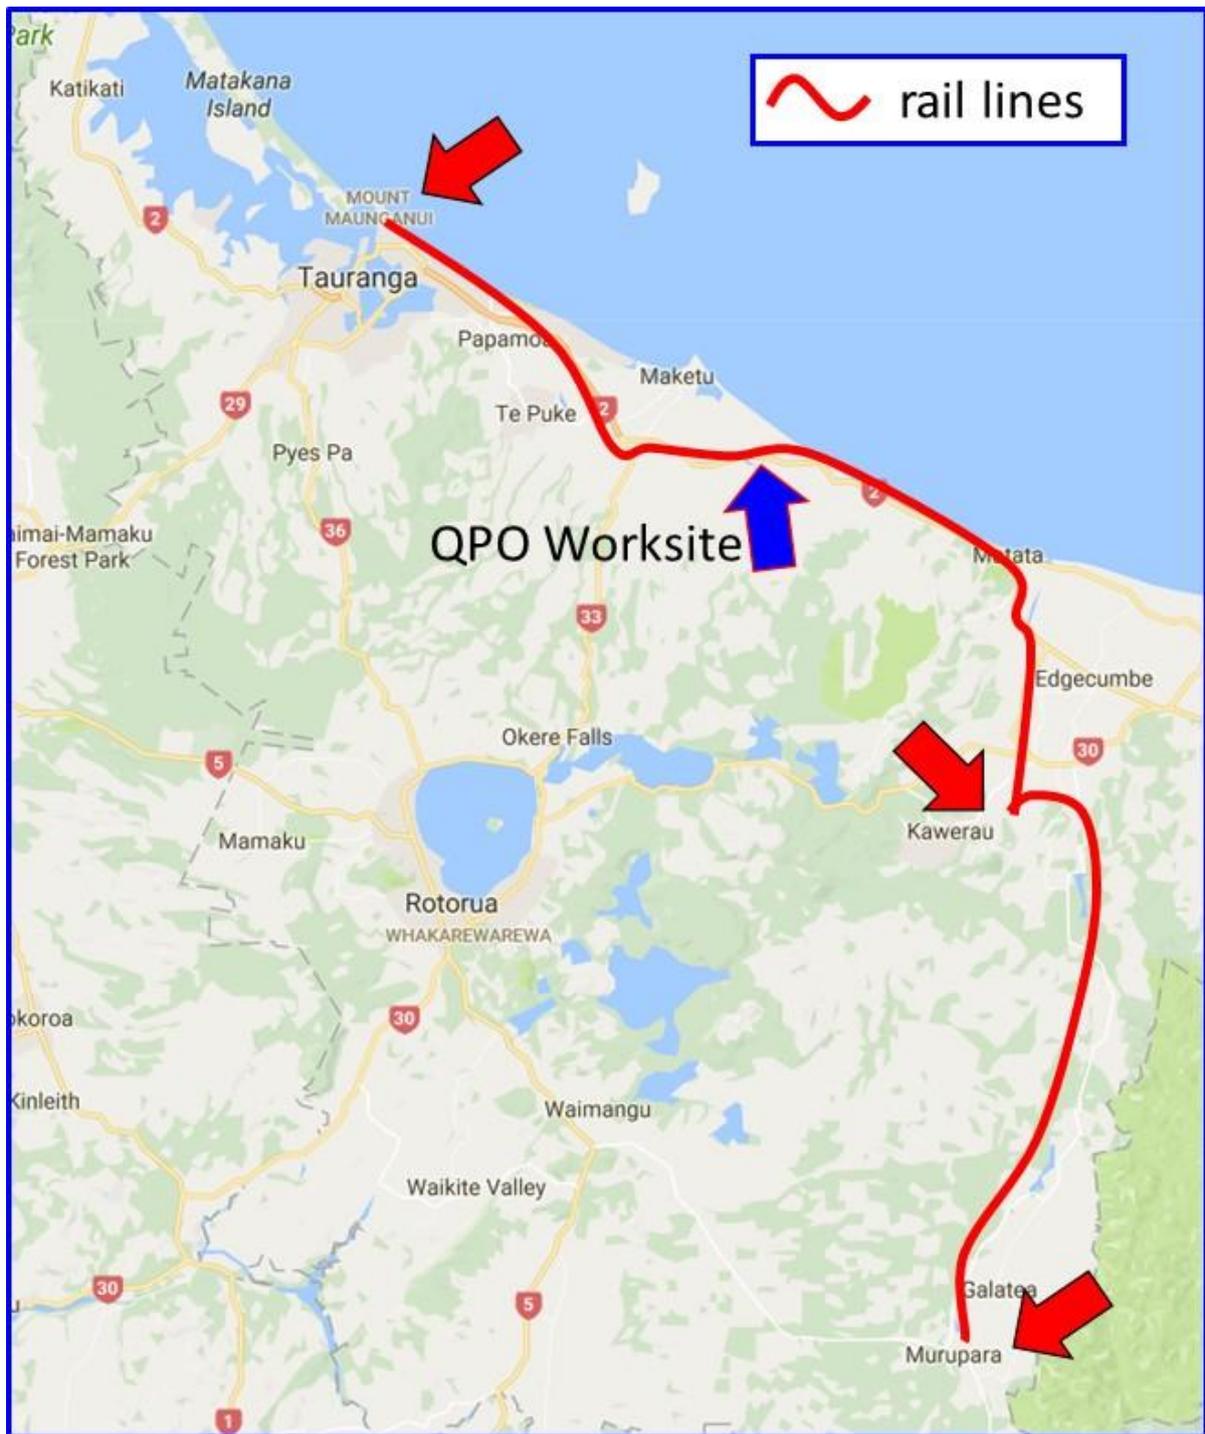
Figure 3
Map of key journey locations (Image source – Google Maps)

- 3.1.3. On the same day the train driver involved in the incident started a shift in Kawerau at 0115. The driver took an empty freight train from Kawerau to Murupara and then took a loaded log train from Murupara to Mount Maunganui, which involved crossing Bridge 107 before the worksite had been established. The driver then departed Mount Maunganui on Train 371 (the train) bound for Kawerau, which was scheduled to pass over Bridge 107 after the worksite had been established (see Figure 3).

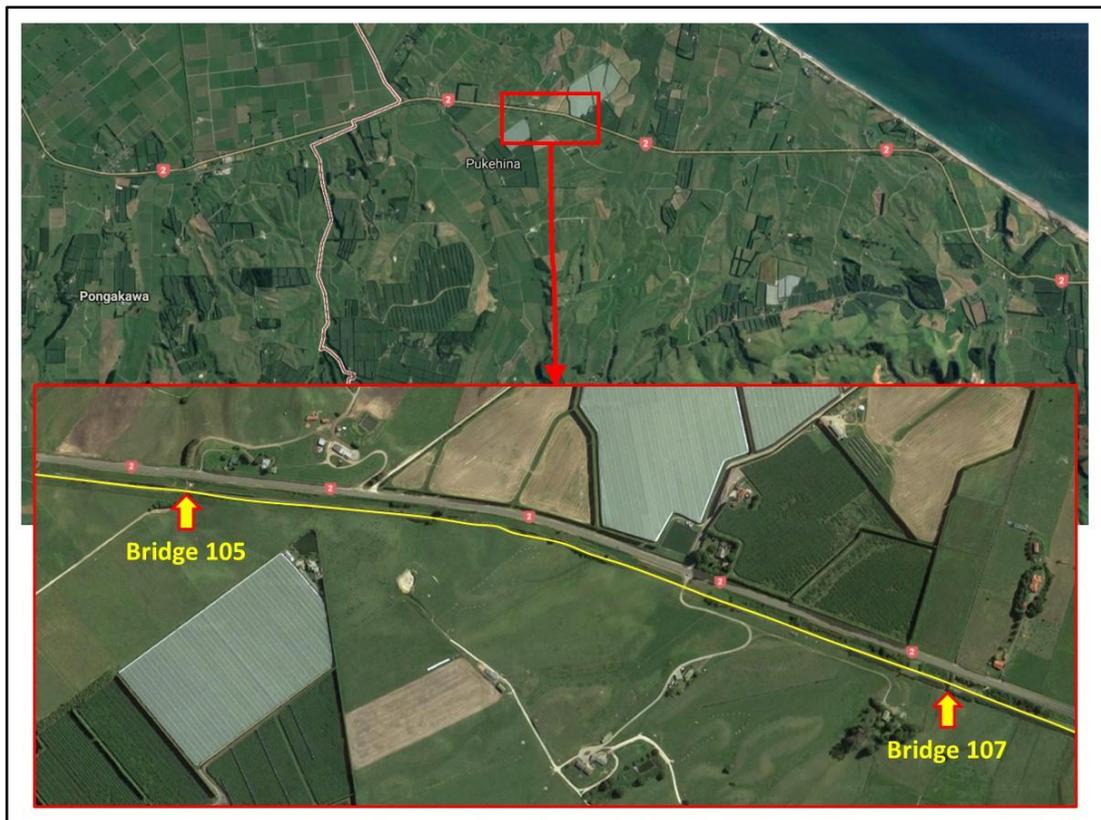
Figure 5
Location of Bridges 105 and 107
(Image source – Google Maps)

- 3.2.2. Train Control advised the work group that the first train through the worksite would arrive at approximately 0935, heading south.
- 3.2.3. At approximately 1000 the train comprising a single locomotive hauling 30 empty wagons approached Bridge 105 on the East Coast Main Trunk line (see Figure 5).
- 3.2.4. The driver slowed the train for the longstanding 40-kilometre-per-hour (km/h) speed restriction⁷ over Bridge 105.

- 3.2.5. After crossing Bridge 105 the train was allowed to gather speed before the driver started to slow again for another longstanding 40 km/h speed restriction over Bridge 107.

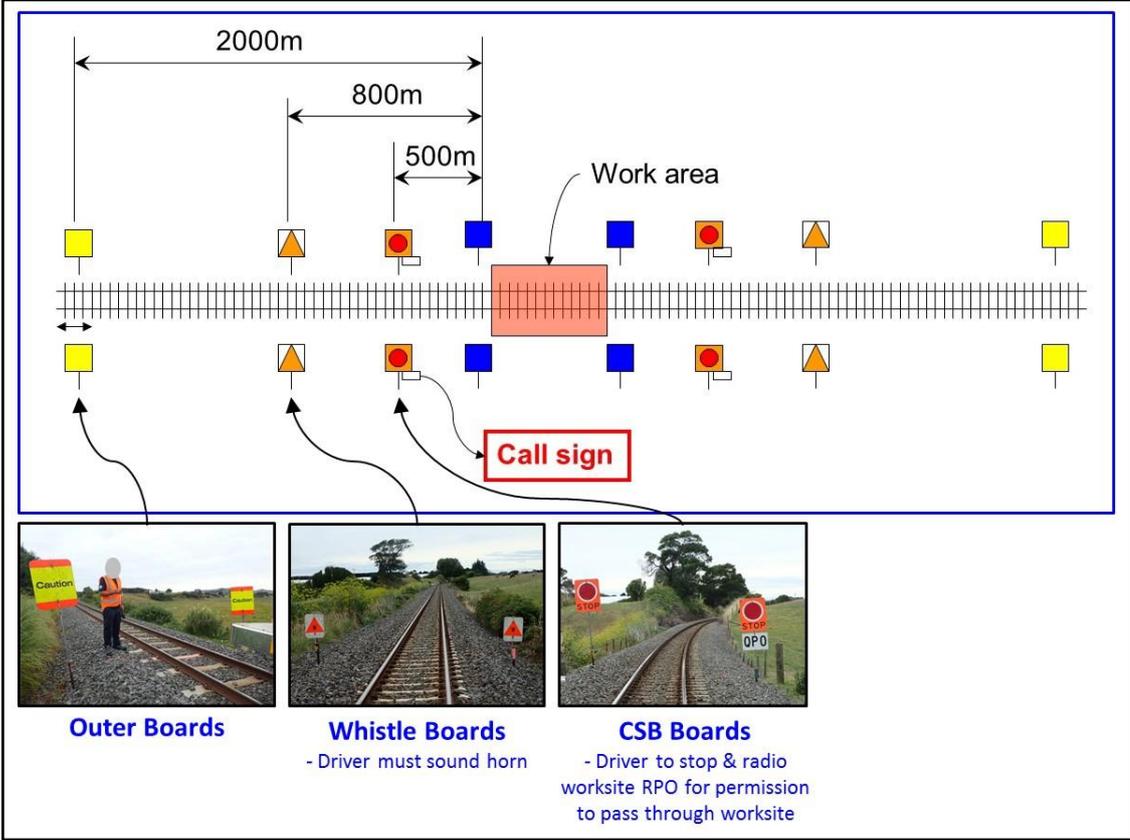
Figure 8
Relative position of Rule 905 boards to actual worksite

3.3.3. On the day of the incident the worksite was protected using KiwiRail Rule 905 – Compulsory Stop Protection. The rule required two sets of warning boards to be erected alongside the track to warn all train drivers that they are approaching a set of compulsory stop boards. The train is required to stop at the compulsory stop boards (see Figure 8). The worksite was also protected by the eProtect system, as indicated by the

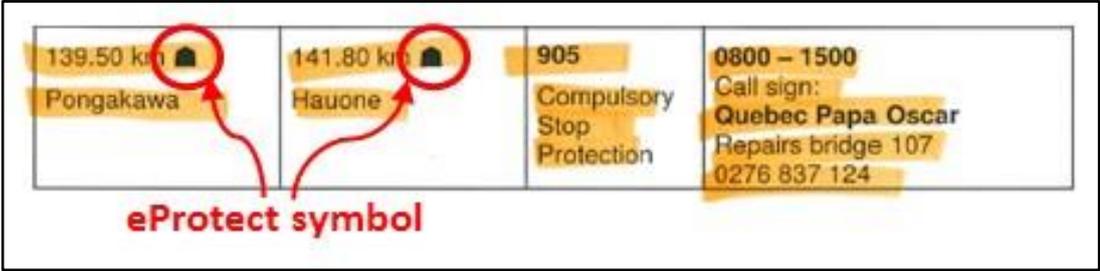
Figure 9
Extract from daily information bulletin, 7 February 2017

icon on the daily information bulletin (see Figure 9).

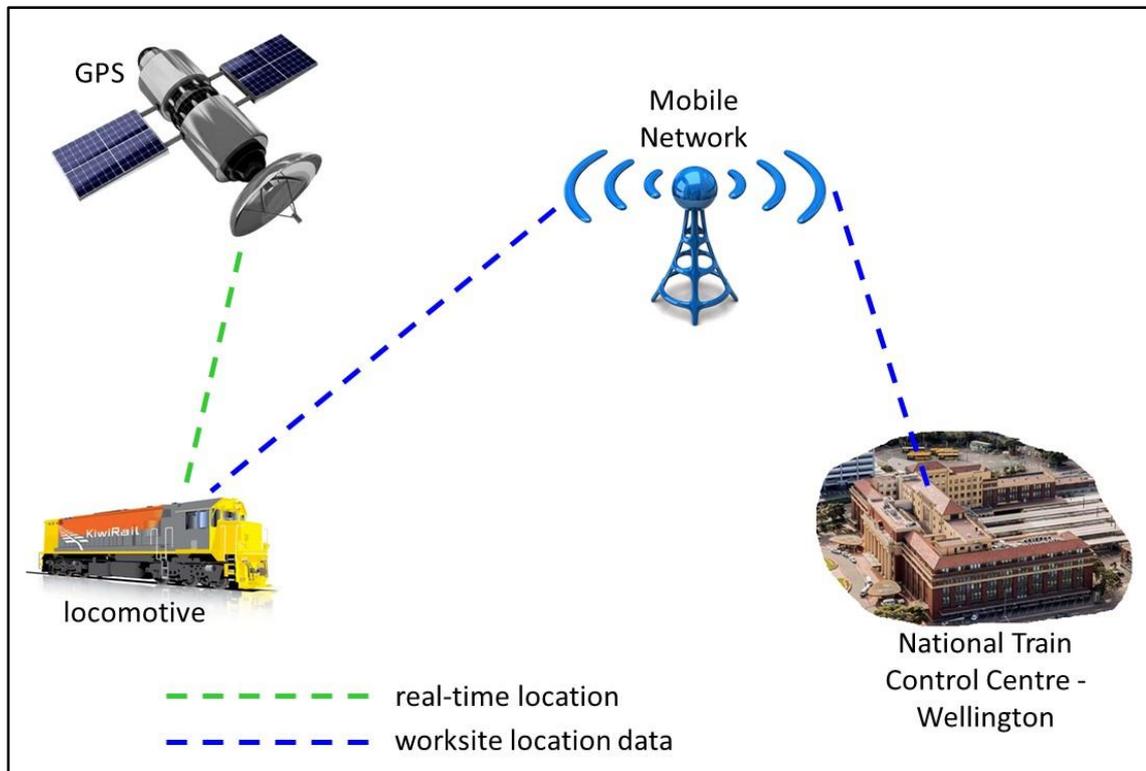
Figure 10
eProtect system data diagram

3.4.3. The eProtect system utilises existing technology on board KiwiRail's locomotives, taking the trains' real-time GPS positions and comparing them with the latest information on worksite locations around New Zealand. The locations of the worksites are sent to all locomotives over the mobile phone network (see Figure 10).
