**Report 07-110, collision, express freight Train MP2 and Work Train 22, Ohinewai,  
19 June 2007**

On Tuesday 19 June 2007 at about 1105, express freight Train MP2 was travelling between Huntly and Te Kauwhata when it struck a gantry crane from Work Train 22. Work Train 22 was stationary and was working on the adjacent Down Main line with its cranes fouling the Up Main line. The gantry swung around and struck one of the crane operators, knocking him from the wagon and under the passing train. The operator was fatally injured.

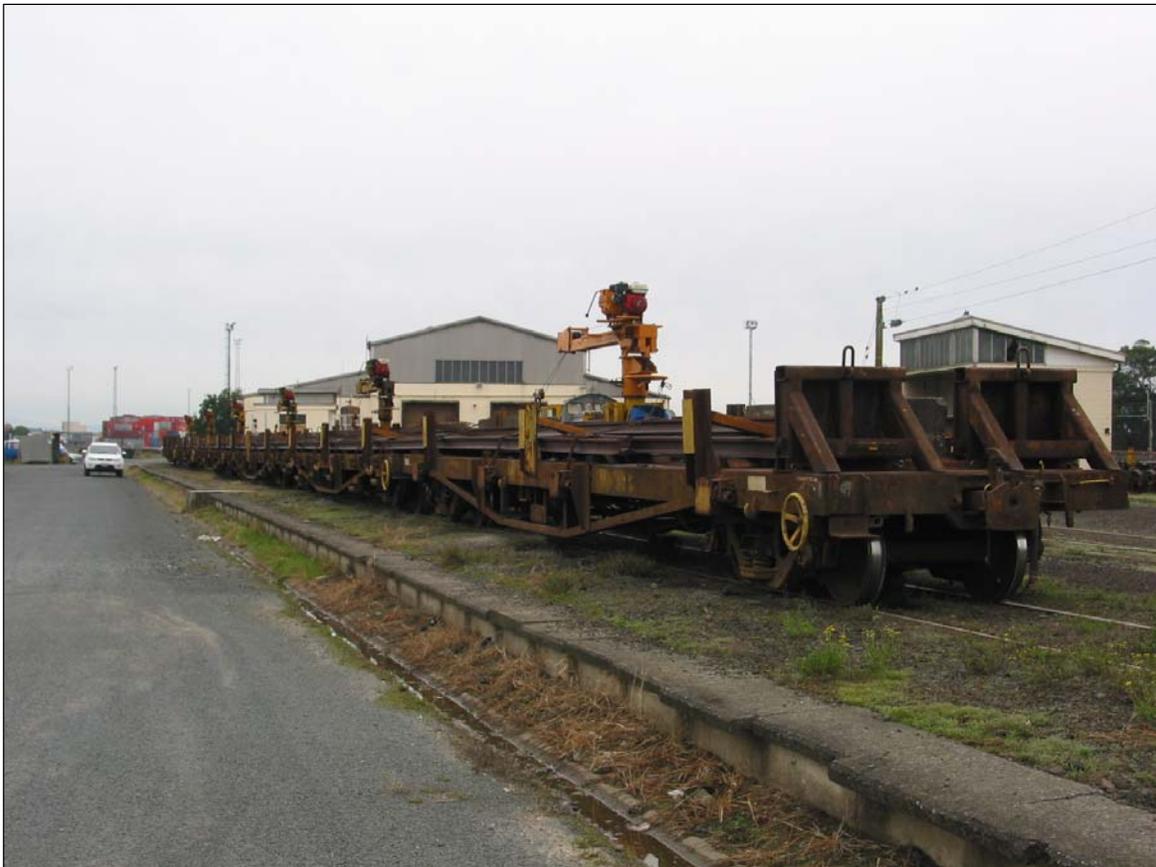
**Figure 6**  
**The rake of EWR wagons**

- 1.5.4 The EWR class wagons of the rail recovery unit were owned by Ontrack and had been modified from standard US class flat deck wagons (see Figure 6). There was a total of 37 wagons in the class, all of which had been fitted with centrally mounted cranes to load and unload lengths of rail.

1.16.6 Figure 6 shows how protection in accordance with Rule 905 could have been positioned on the Up Main line in relation to the work area. The yellow board is the Advance Warning Board and the red board is the Compulsory Stop Board.
