DEPARTMENT OF TRANSPORT

RAILWAY ACCIDENT

Report on the Collision that occurred on 11th November 1976 at Melton Lane near Ferriby

IN THE
EASTERN REGION
BRITISH RAILWAYS

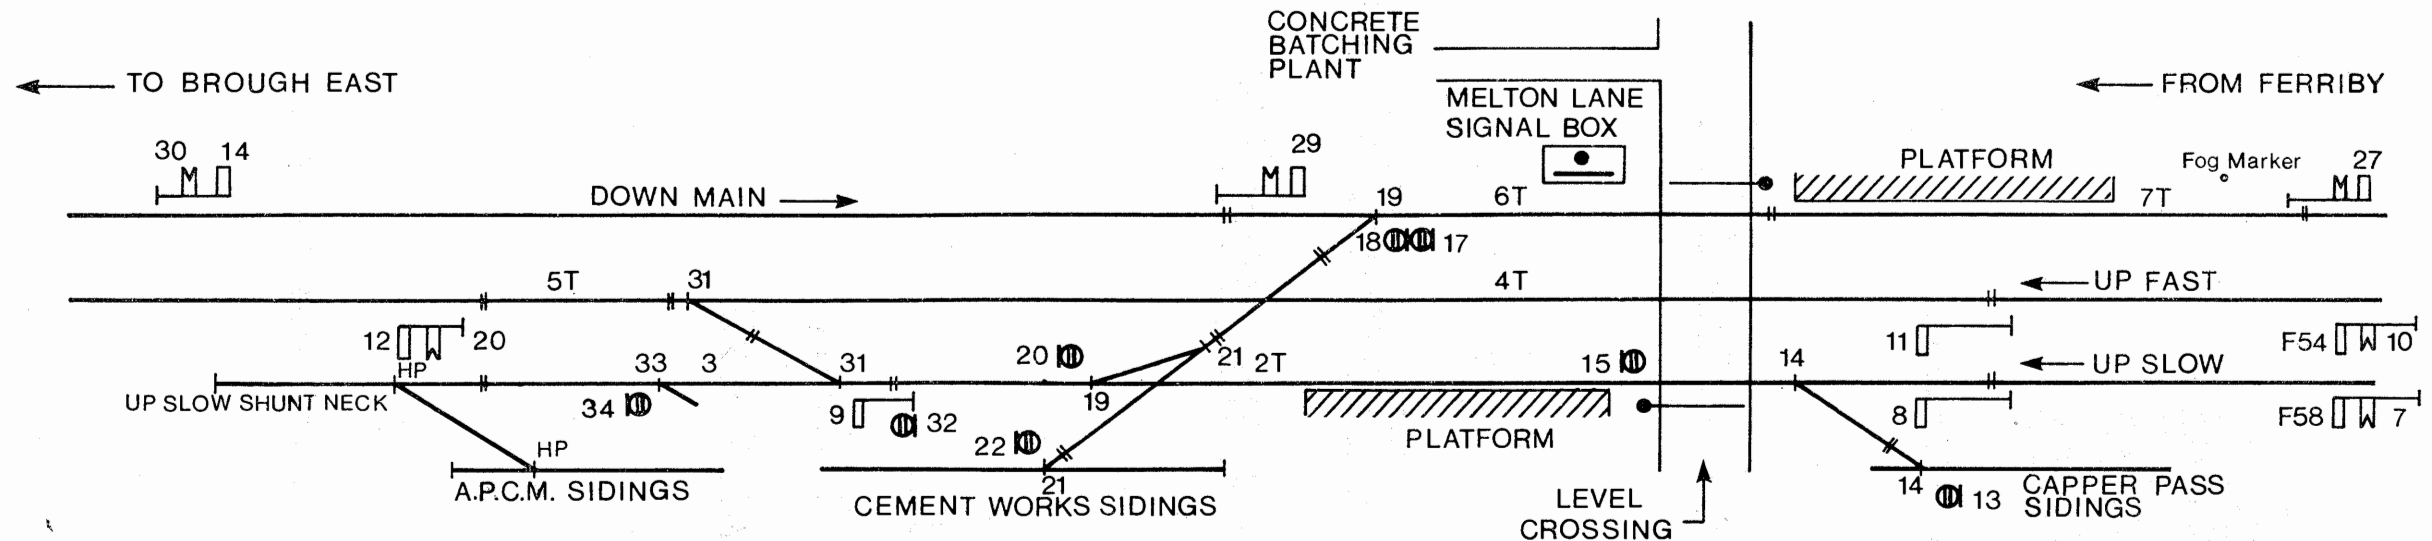
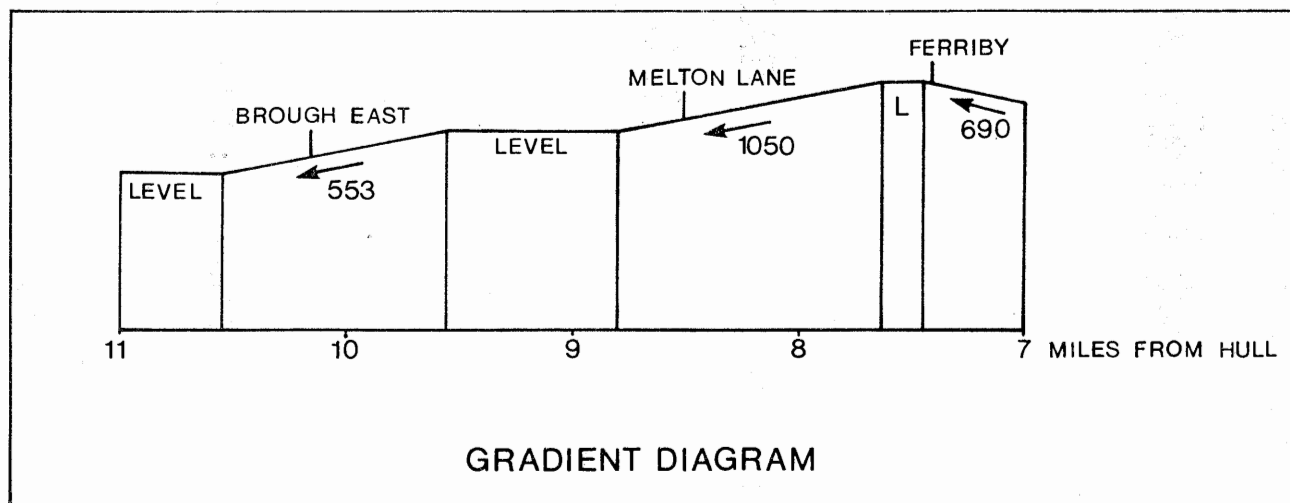
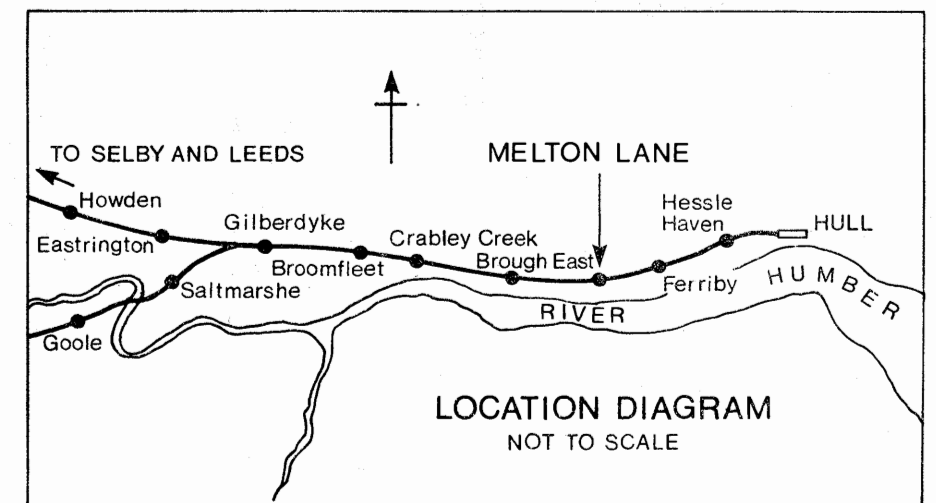
PLAN SHOWING POINTS AND SIGNALS - NOT TO SCALE

3. Melton Lane Signal Box is a 31 lever mechanical-frame box. The Absolute Block Regulations apply on all lines, signalling of trains being by upper quadrant semaphore signals situated on the left of the line to which they apply. The box has an illuminated diagram showing occupation of track circuits. Details of the track circuits, together with other features of the layout and signalling, are shown on the Diagram at the front of the report: it will be noted that, at the time of the accident, there was no track circuit in rear of Signal No. 8, the Up Slow Home signal.
