RAILWAY ACCIDENT

Report on the Collision that occurred on 11th December 1981 near Seer Green

IN THE
LONDON MIDLAND REGION
OF BRITISH RAILWAYS

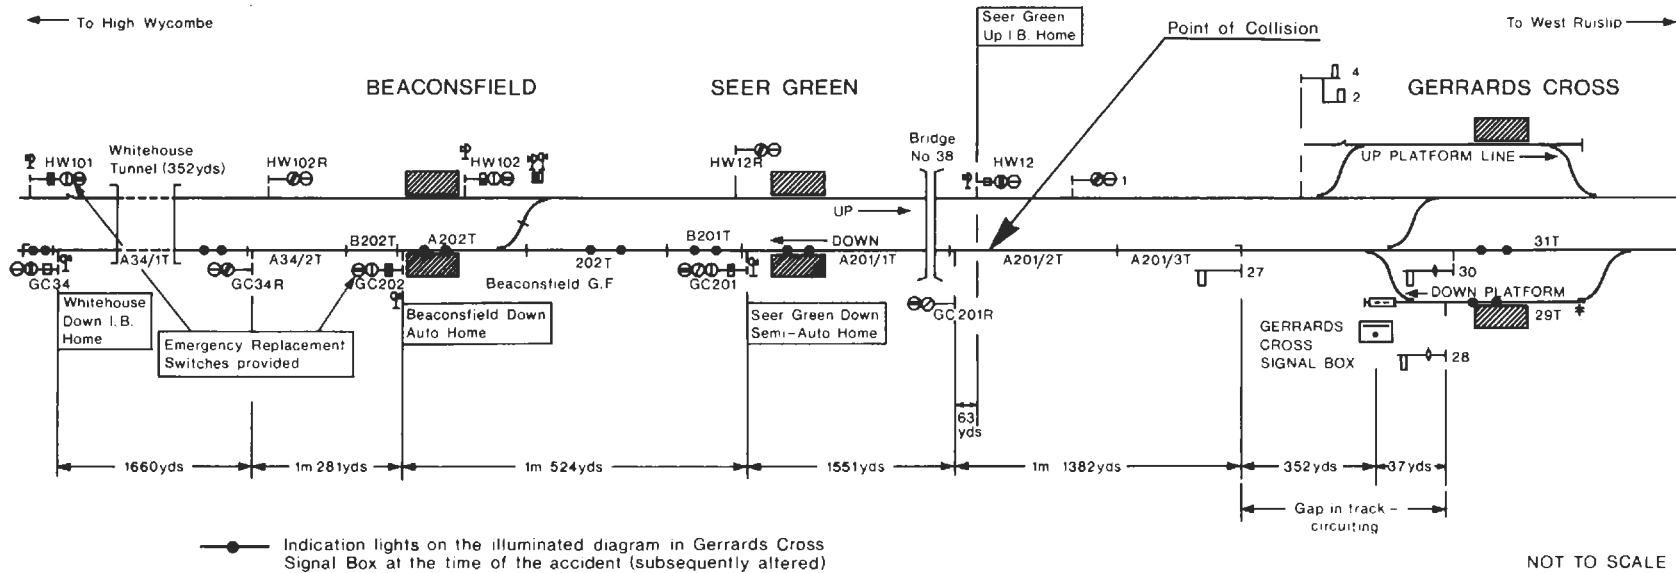
FIGURE 1

4. Gerrards Cross Signal Box has a former GWR mechanical stud frame converted to vertical tappet locking. There are 33 levers, of which 29 are working. Standard WR pegging block is provided on the Up and Down lines and there is a block switch. An illuminated track-circuit diagram is provided, mounted above the block shelf. At the time of the accident, the lights showing track circuit occupation were situated as shown in Figure 1.

SEER GREEN: 5B61 0725 MARYLEBONE TO PRINCES RISBOROUGH
AND 2B64 0731 MARYLEBONE TO BANBURY IN
COLLISION: 11 DECEMBER 1981

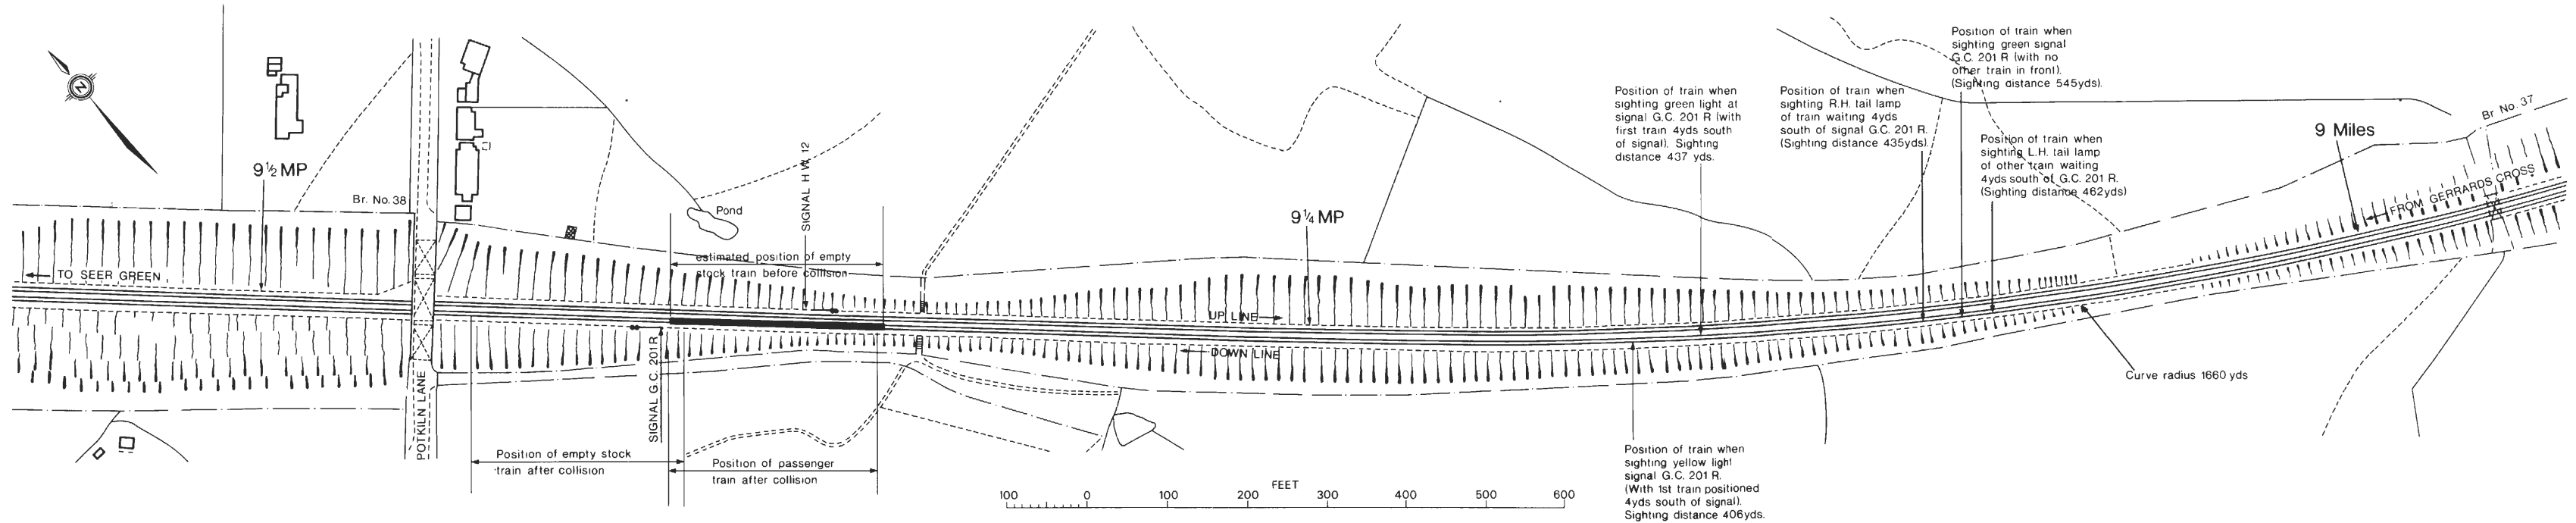
2. Gerrards Cross Signal Box is not continuously manned and when it is closed Absolute Block working applies on the Up and Down lines between West Ruislip and High Wycombe, the signal boxes to the south and north respectively. With Gerrards Cross Signal Box in operation, Absolute Block working applies between West Ruislip and Gerrards Cross, and between Gerrards Cross and High Wycombe. On the Down line, between the latter two signal boxes, there is an Intermediate Block section which extends from the automatic Signal GC 202 to the IB Home Signal GC 34, and to the rear of this section there are two other signal sections the entrances to which are controlled by Gerrards Cross Starting signal (27) and semi-automatic Signal GC 201; the whole of the area being under the control of the Gerrards Cross signalman. There are similar sections on the Up line under the control of the signalman at High Wycombe. The Down line is continuously track-circuited from West Ruislip as far as the overlap of Signal GC 34, apart from a short gap between Signals 28/30 and Signal 27 at Gerrards Cross. Standard BR AWS is fitted on both lines. All the Stop signals are provided with telephones, those on the Down line communicating with Gerrards Cross and those on the Up line with High Wycombe. Figure 1 at the back of the report shows the line between Gerrards Cross and High Wycombe in diagrammatic form together with the location of the signals, track circuits, etc. Figure 2 shows the detailed layout in the area of the collision.

PLAN SHOWING THE POSITION OF THE TRAINS BEFORE AND AFTER THE COLLISION
