HM Railway Inspectorate

RAILWAY ACCIDENT AT COWDEN

A report of the Inquiry into the
collision between two passenger
trains which occurred at Cowden
on 15 October 1994

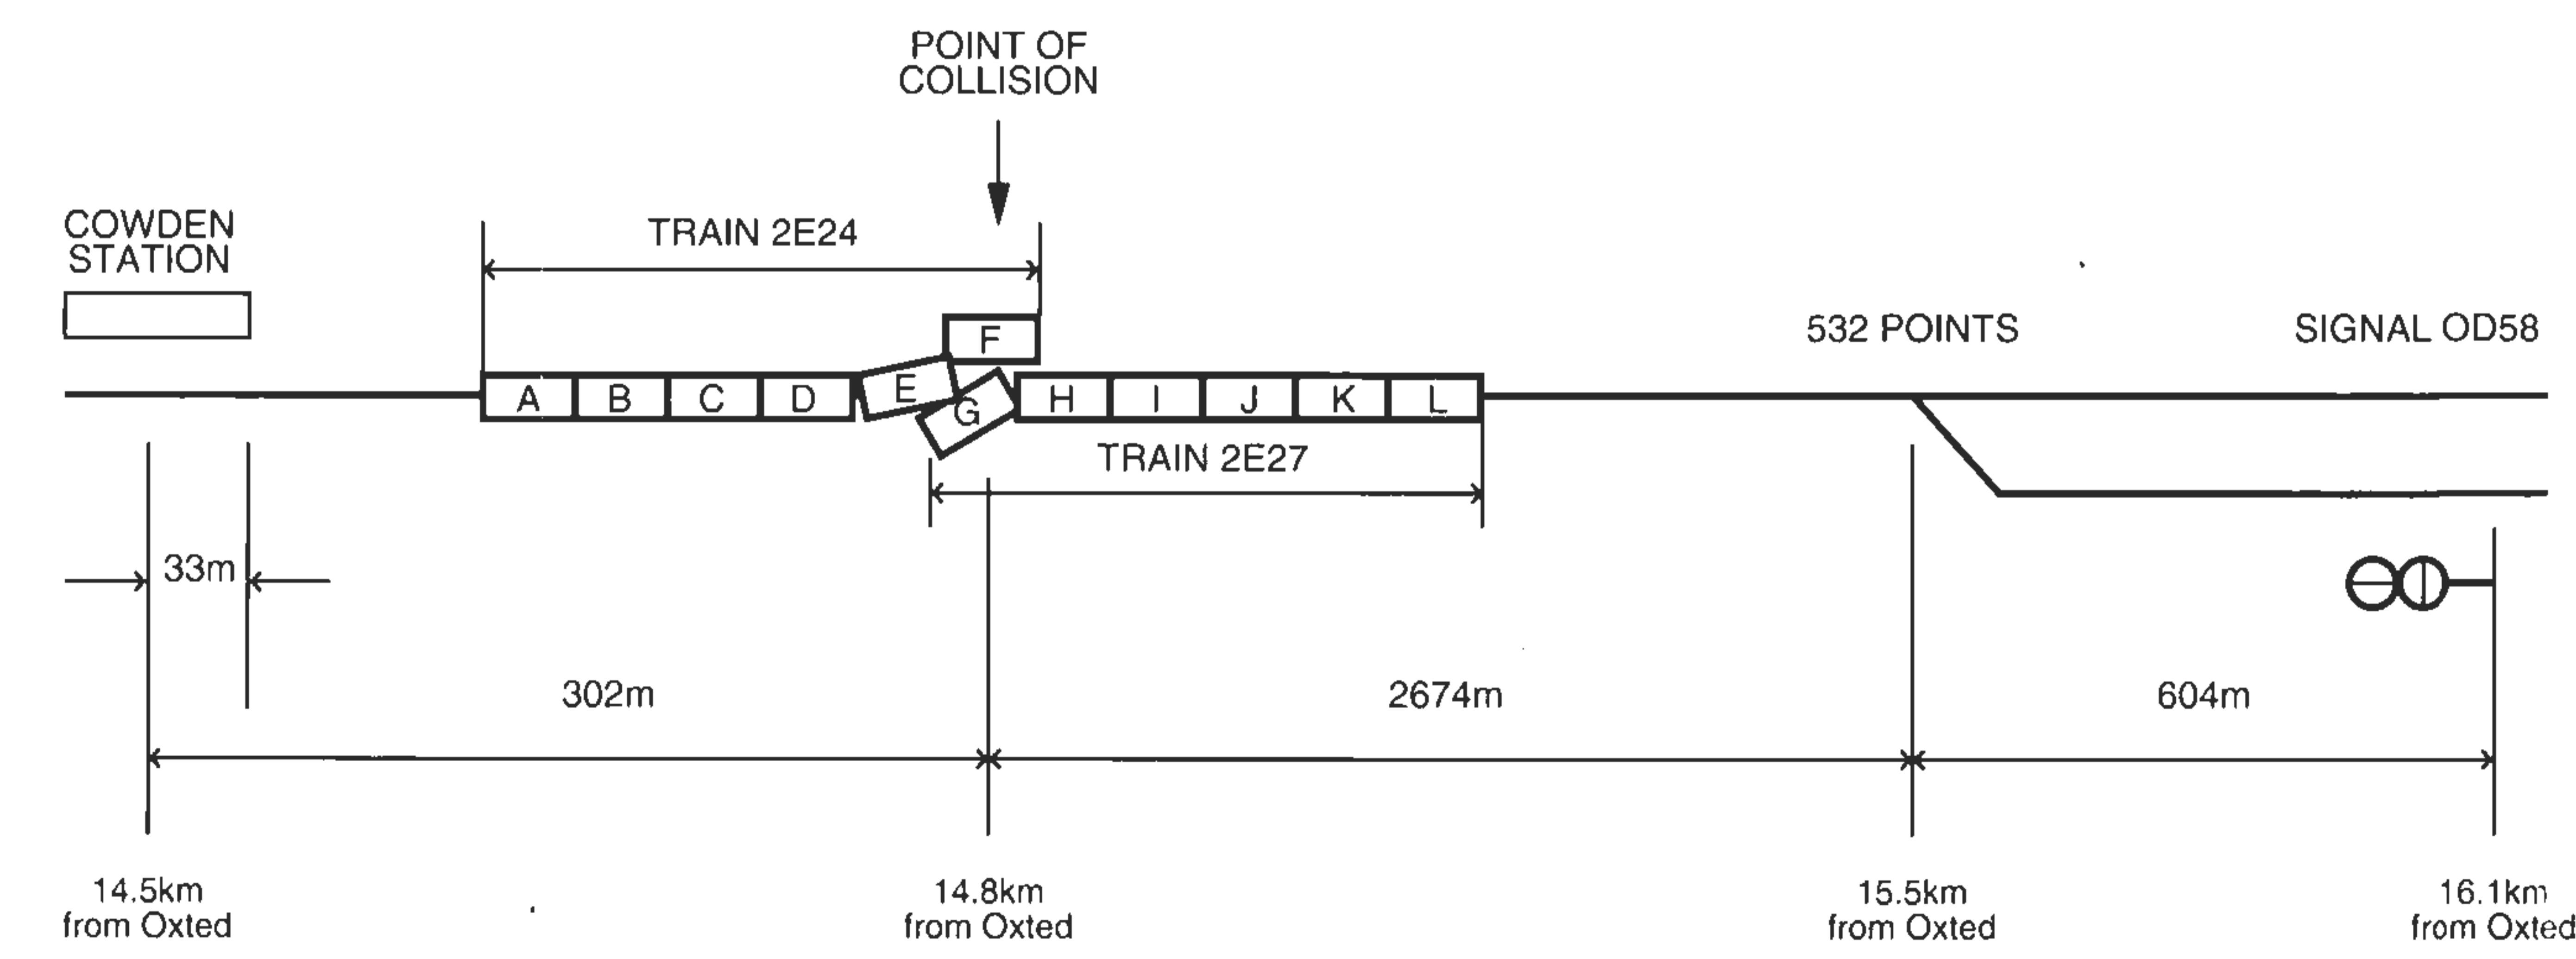
Figure 2 The site of the accident (not to scale)

- LEGEND:**
- A - 60831
 - B - 60677
 - C - 60150 Driving Motor Coach
 - D - 60828
 - E - 60674 (trailing bogie on track)
 - F - 60147 Driving Motor Coach (lying on side on embankment)
 - G - 60817 (totally destroyed above floor level)
 - H - 60667
 - I - 60117 Driving Motor Coach
 - J - 60800
 - K - 60650
 - L - 60154 Driving Motor Coach
- } Set 205 032
 } Set 205 029
 } Set 205 018
 } Set 205 001
