HM Railway Inspectorate

## **RAILWAY ACCIDENT AT HOLTON HEATH**

A report on a collision that occurred  
on 20 April 1989

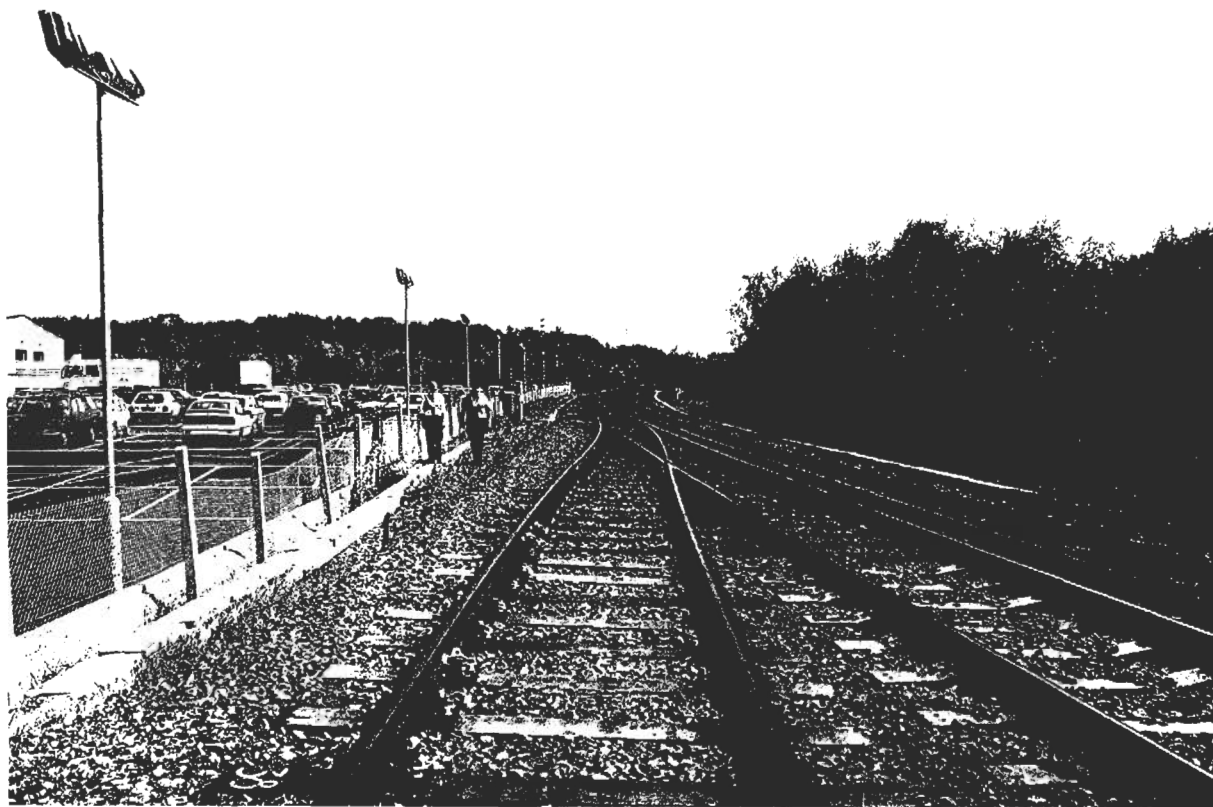
**Figure 6** View from Holton Heath Siding looking east towards Hamworthy
