## **RAILWAY ACCIDENTS**

## **REPORT ON THE COLLISION**

20th May 1958

ARKLESTON JUNCTION SIGNAL BOX

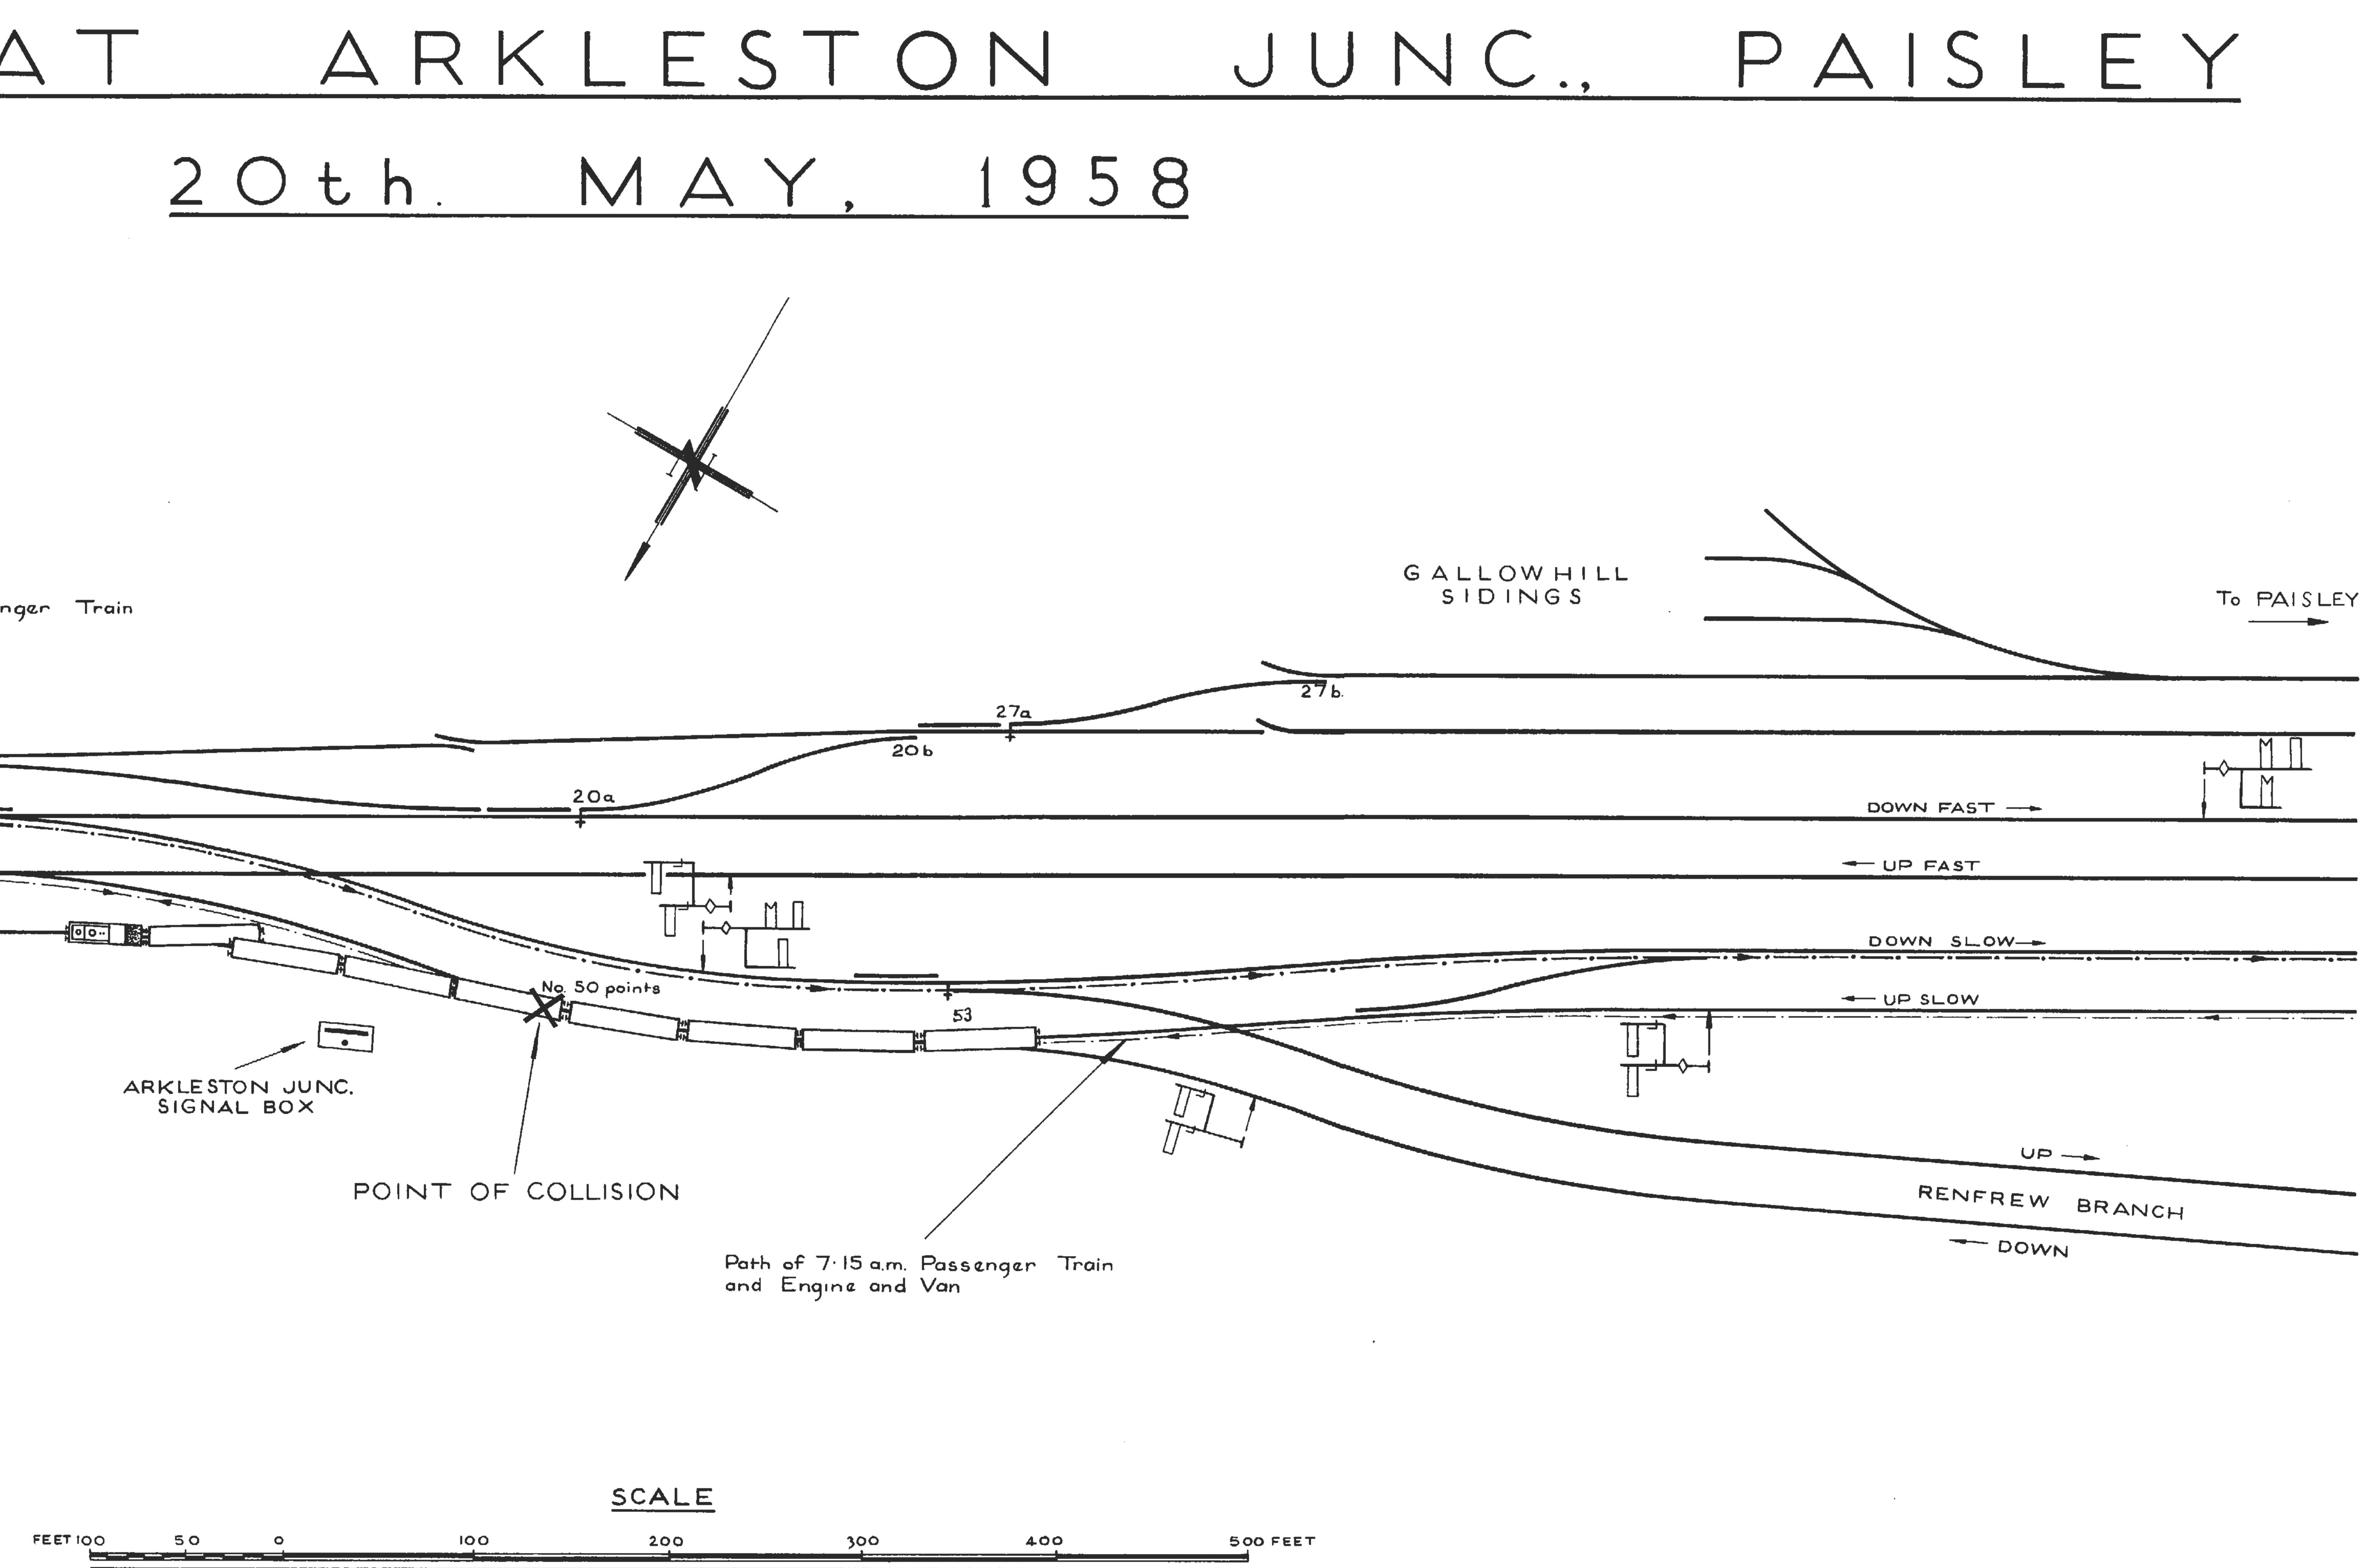
6. The drawing attached shows diagrammatically the arrangement of the lines and the relevant signals, which are all semaphores, and the route followed by the engine and van and the passenger train. It also shows the route set by the signalman for a Down passenger train which had been accepted at the same time; this affected the lie of the facing points over which the engine and van travelled into the path of the passenger train. It will be noted from the diagram that the direction of running changes at the signal box; on the Glasgow side the two Up lines are to the North and the two Down lines to the South, whereas on the Paisley side the direction of running from North to South is Up Slow, Down Slow, Up Fast and Down Fast.

26. The movement which the engine with van was carrying out on this occasion is a frequent one, and since it crosses running lines and begins at an appreciable distance from the box, I recommend that a fixed signal should be provided to control it.
