MINISTRY OF TRANSPORT & CIVIL AVIATION

REPORT ON THE COLLISION

which occurred on
2nd December 1955

BARNES STATION

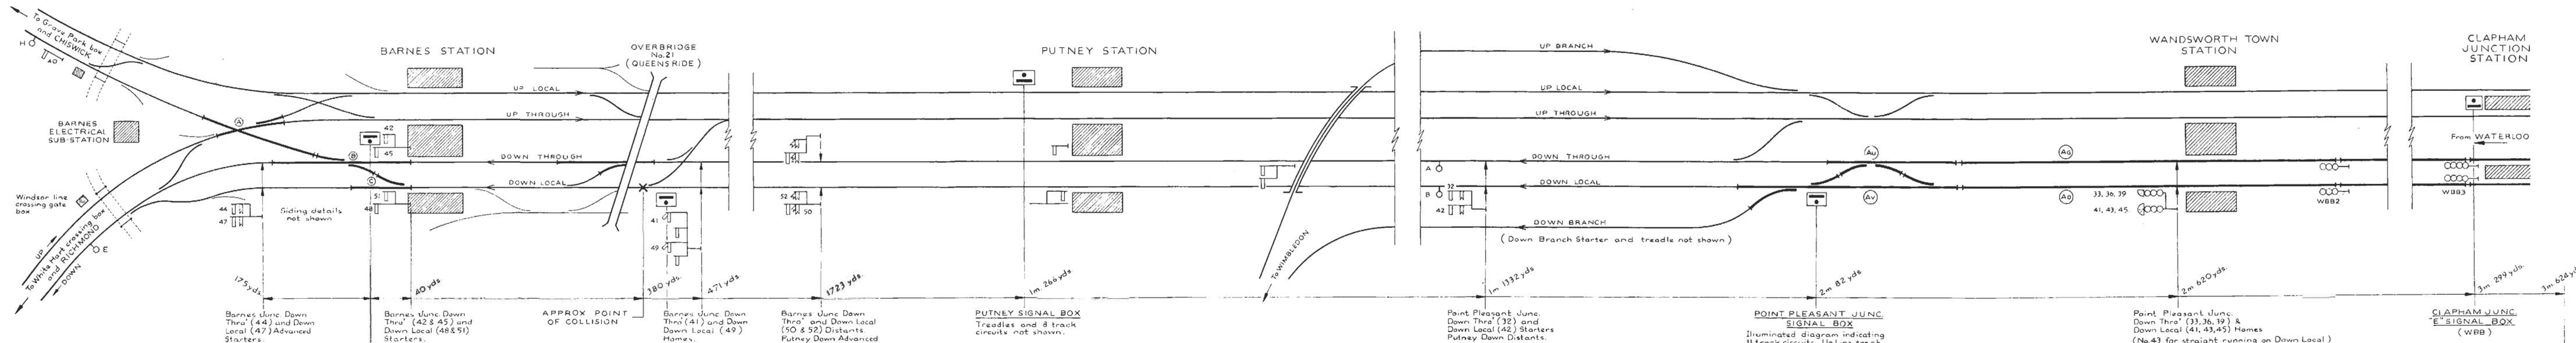
FIG. 3 GENERAL SIGNALLING DIAGRAM
 NOT TO SCALE
 UP SIGNALS NOT SHOWN SYKES TREADLES

11. The signalling arrangements for Down traffic between Clapham Junction and Barnes Junction, together with the relevant distances, are shown by the general diagram, Fig. 3.

19. With Putney and Barnes East boxes switched out, the block section concerned was from Point Pleasant Junction to Barnes Junction, approximately two miles in length. The next block posts beyond Barnes Junction in the Richmond and Chiswick directions respectively were White Hart Crossing ($\frac{1}{2}$ mile) and Grove Park ($1\frac{1}{2}$ miles). There are "gate boxes" at the two level crossings (see Fig. 3) and their levers are released from Barnes Junction.

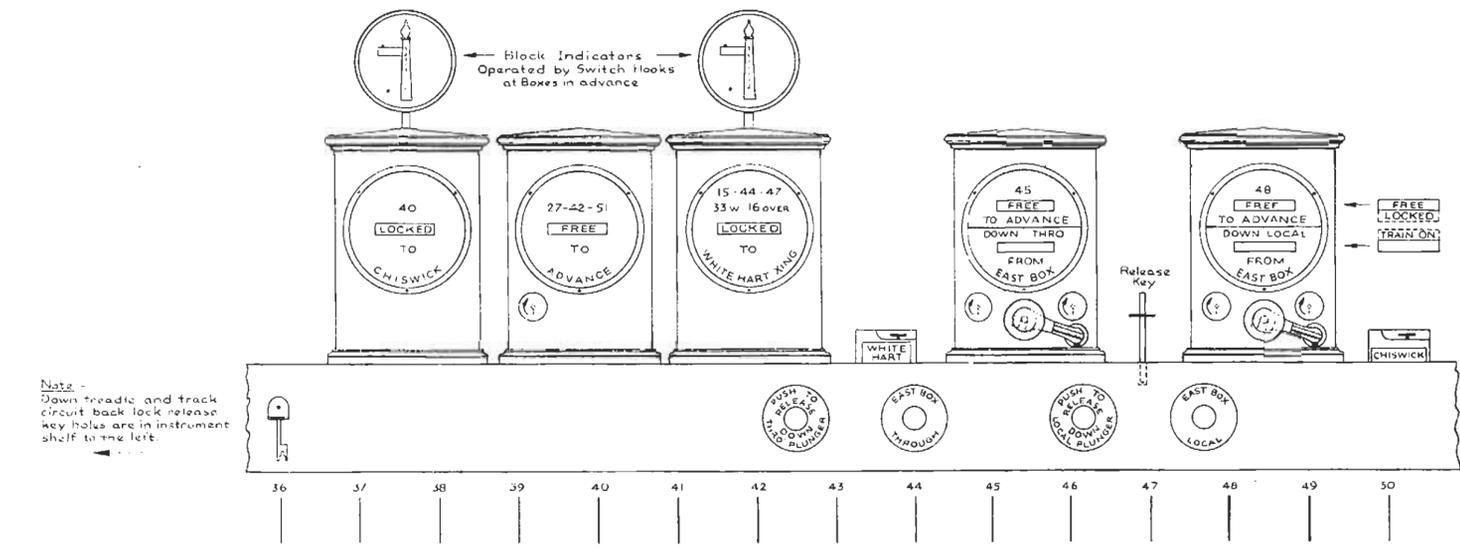
FIG. 5 BARNES JUNCTION DOWN SYKES INSTRUMENTS
 NOT TO SCALE

34. Fig. 5 shows the Down Sykes instruments at Barnes Junction, and their working follows the same principles. The *Down Local plunging instrument* is the one mainly concerned, and the signals associated with the re-setting of its plunger for a second acceptance are Nos. 48 and 47, or No. 51.

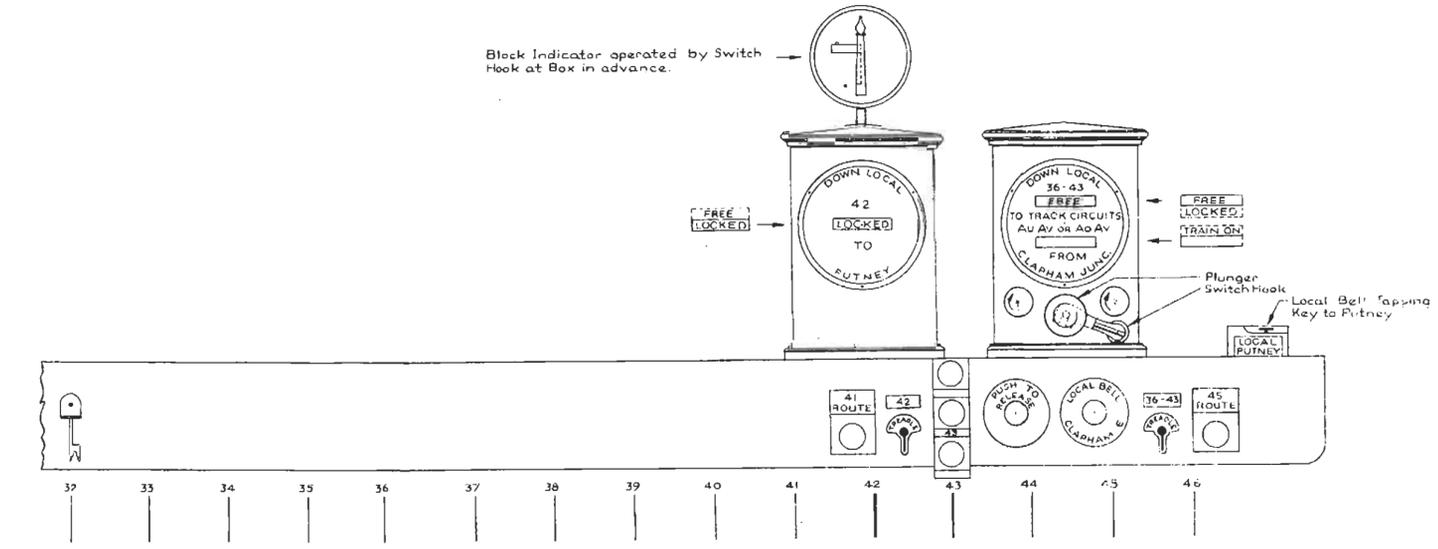
FIG. 4 POINT PLEASANT JUNCTION DOWN LOCAL SYKES INSTRUMENTS
 NOT TO SCALE

29. The Sykes instruments concerned are shown by Fig. 4. The Down Local "plunging" instrument to Clapham Junction 'E' is associated with No. 43 lever, which controls the Down Local home for straight running. (It is also associated with levers 41 and 45 which control this signal for divergence to the Down Through or to the branch and with lever 36 controlling the Down Through home for divergence to the Down Local.) The upper of the two indicators on the face of the instrument indicates the Sykes locks on lever No. 43 and others, and displays LOCKED in black letters on a red ground or FREE in white letters on a green ground.
