RAILWAY ACCIDENTS

**REPORT
ON THE DOUBLE COLLISION**

28th January 1960

BOROUGH MARKET JUNCTION

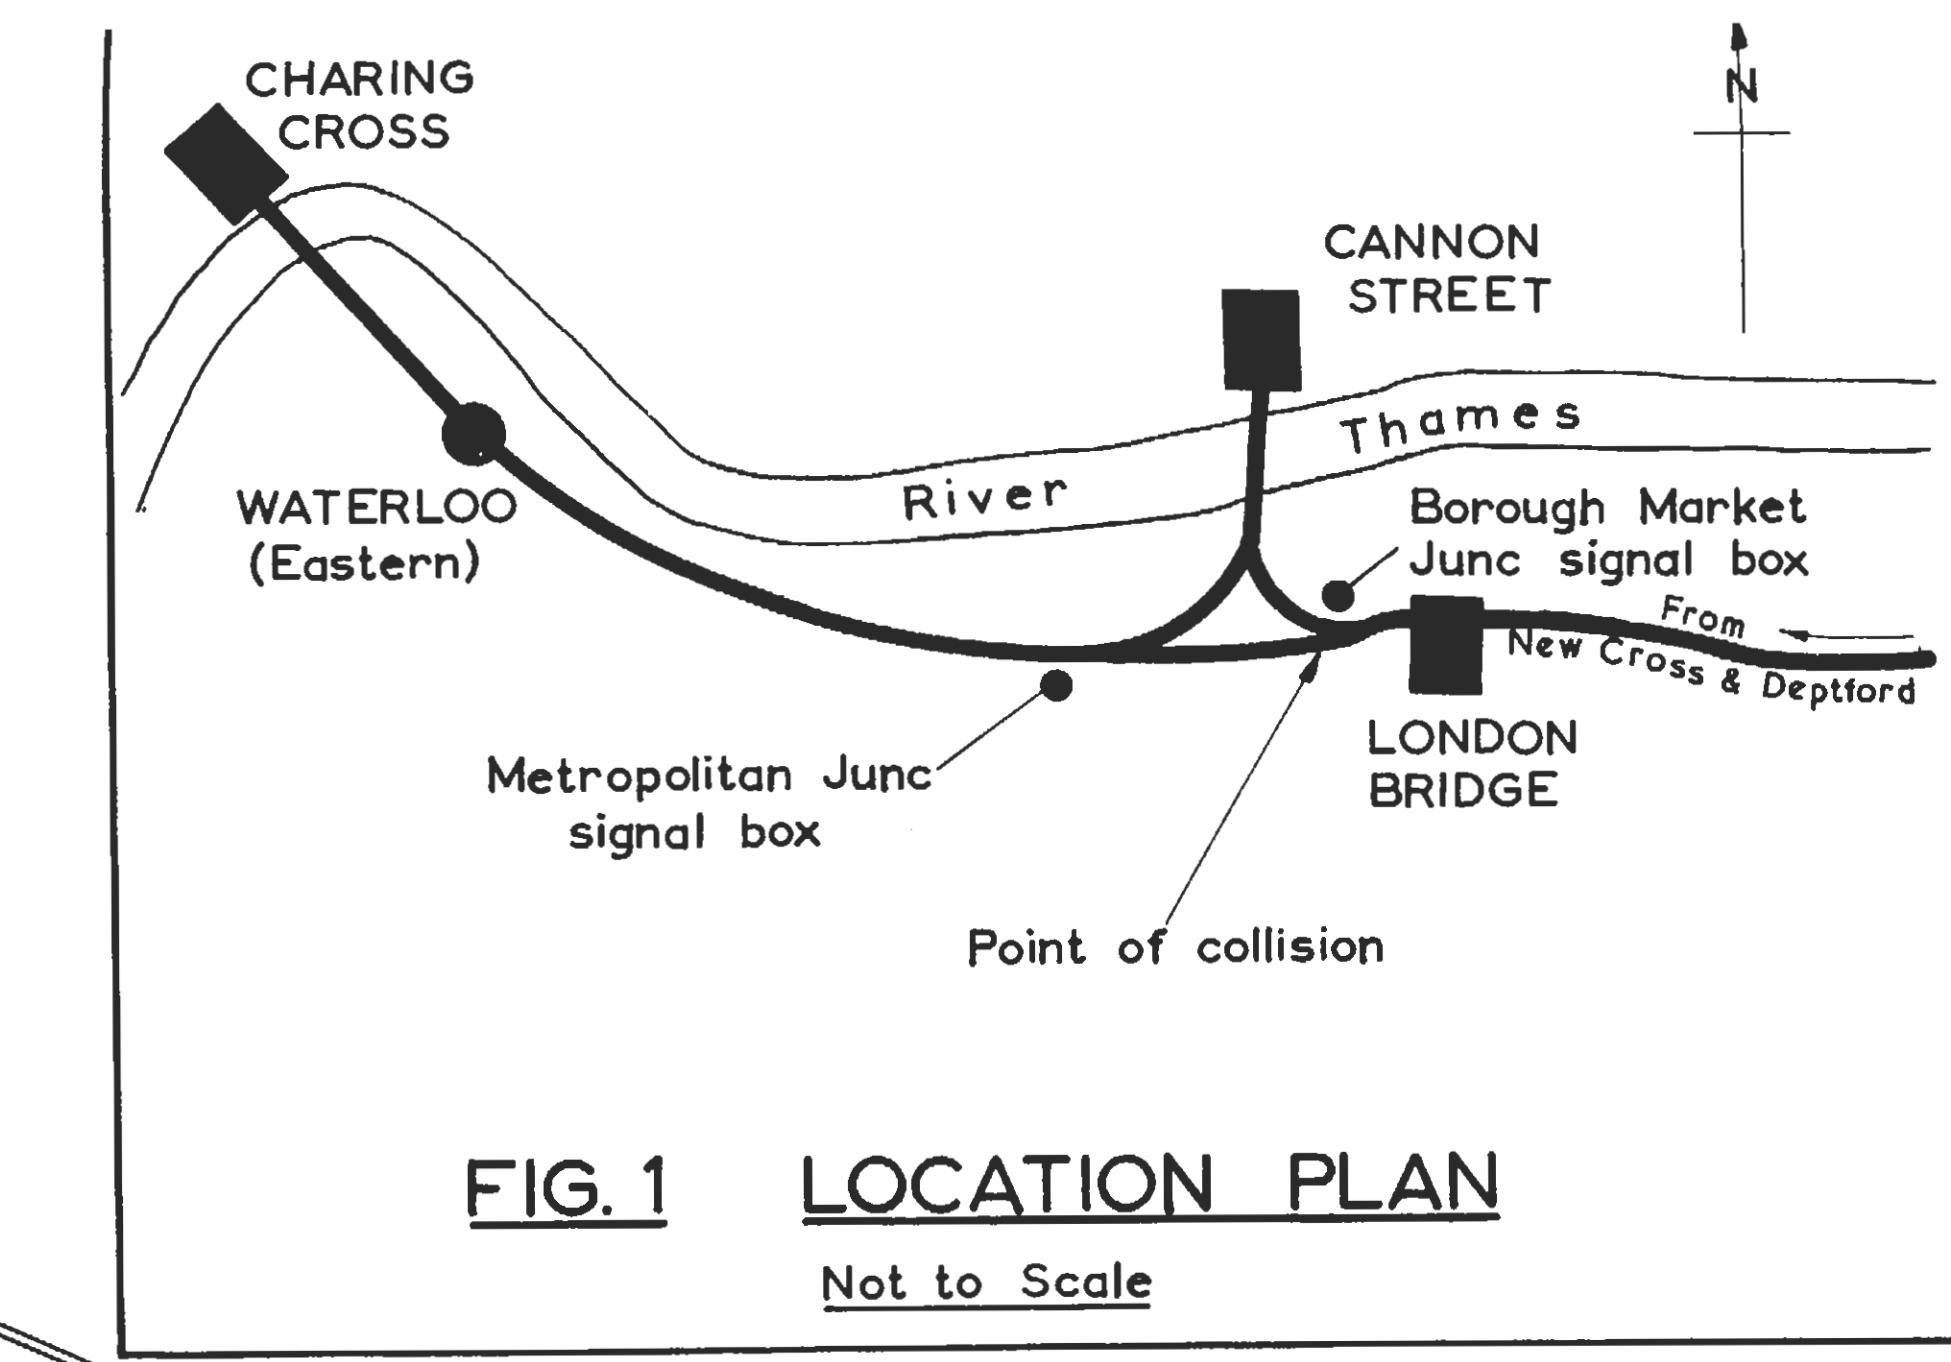
DOUBLE COLLISION AT BOROUGH MARKET JUNCTION ON 28th JANUARY 1960

The diesel train was running through London Bridge and Borough Market Junction on the Up Local line under clear signals, and it was to precede the Hayes train to Charing Cross. The latter train was on the Up Through line and, after it had stopped at London Bridge, the platform starter was cleared for it to draw up to the next signal ahead. That signal protected the converging junction between the Up Through and Up Local lines and it was at danger, but the Hayes train ran past it and came into sidelong collision with the diesel train at a point 72 yards beyond the signal. The collision forced the rear end of the leading coach of the Hayes train towards the Down line from Charing Cross, and it was struck almost immediately by the Tattenham train.

The area is continuously track circuited and the track circuits exercise the usual controls over the signals and points. When a signal has been cleared it is "approach locked" by the occupation by a train of the berth track circuit, but the lever can be placed in the "back-lock" position which replaces the aspect of the signal to red. The locking is released when a track circuit ahead of the signal is occupied and the signal lever has been replaced to normal. In the case of signal No. 19, the berth track circuit is No. 12 and it begins 146 yards on the approach side of the signal. The track circuit next ahead of the signal is No. 13 and when it is occupied the aspect of the signal is replaced to red. However, in the case of signal No. 28, the aspect is replaced to red by the occupation of the second track circuit ahead of the signal, viz. No. 17.
