MINISTRY OF TRANSPORT & CIVIL AVIATION

RAILWAY ACCIDENTS

REPORT ON THE COLLISION
which occurred on
15th August 1953 at
IRK VALLEY JUNCTION,
near **MANCHESTER (VICTORIA),**
in the
LONDON MIDLAND REGION
BRITISH RAILWAYS

1953

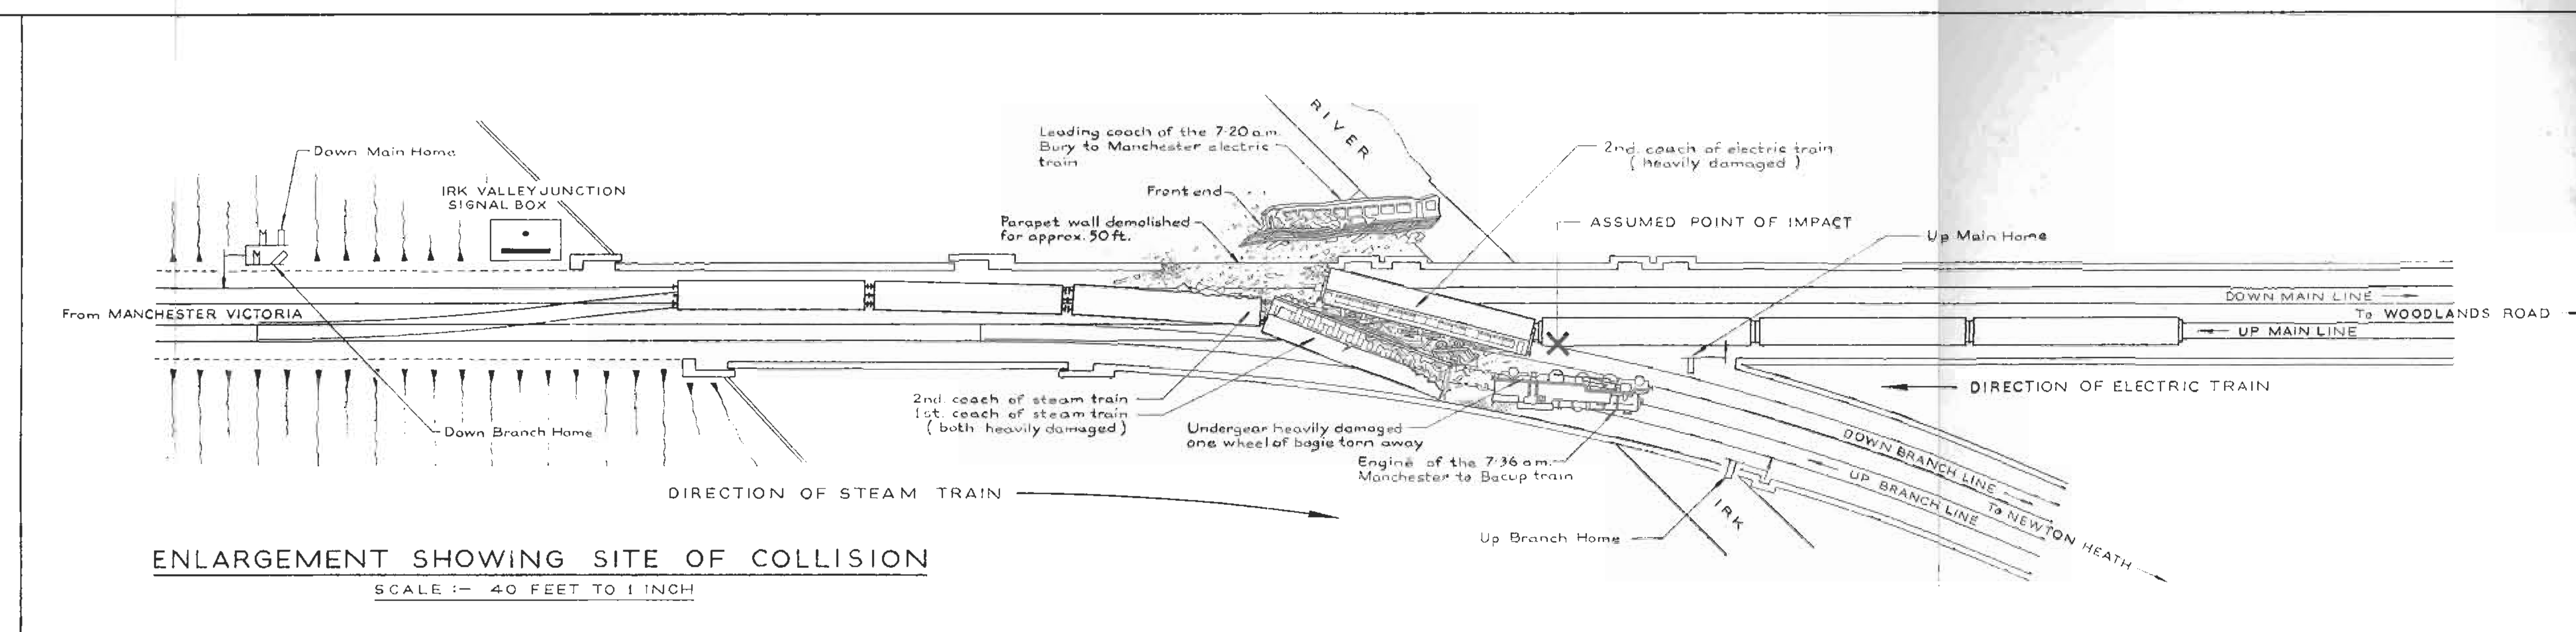
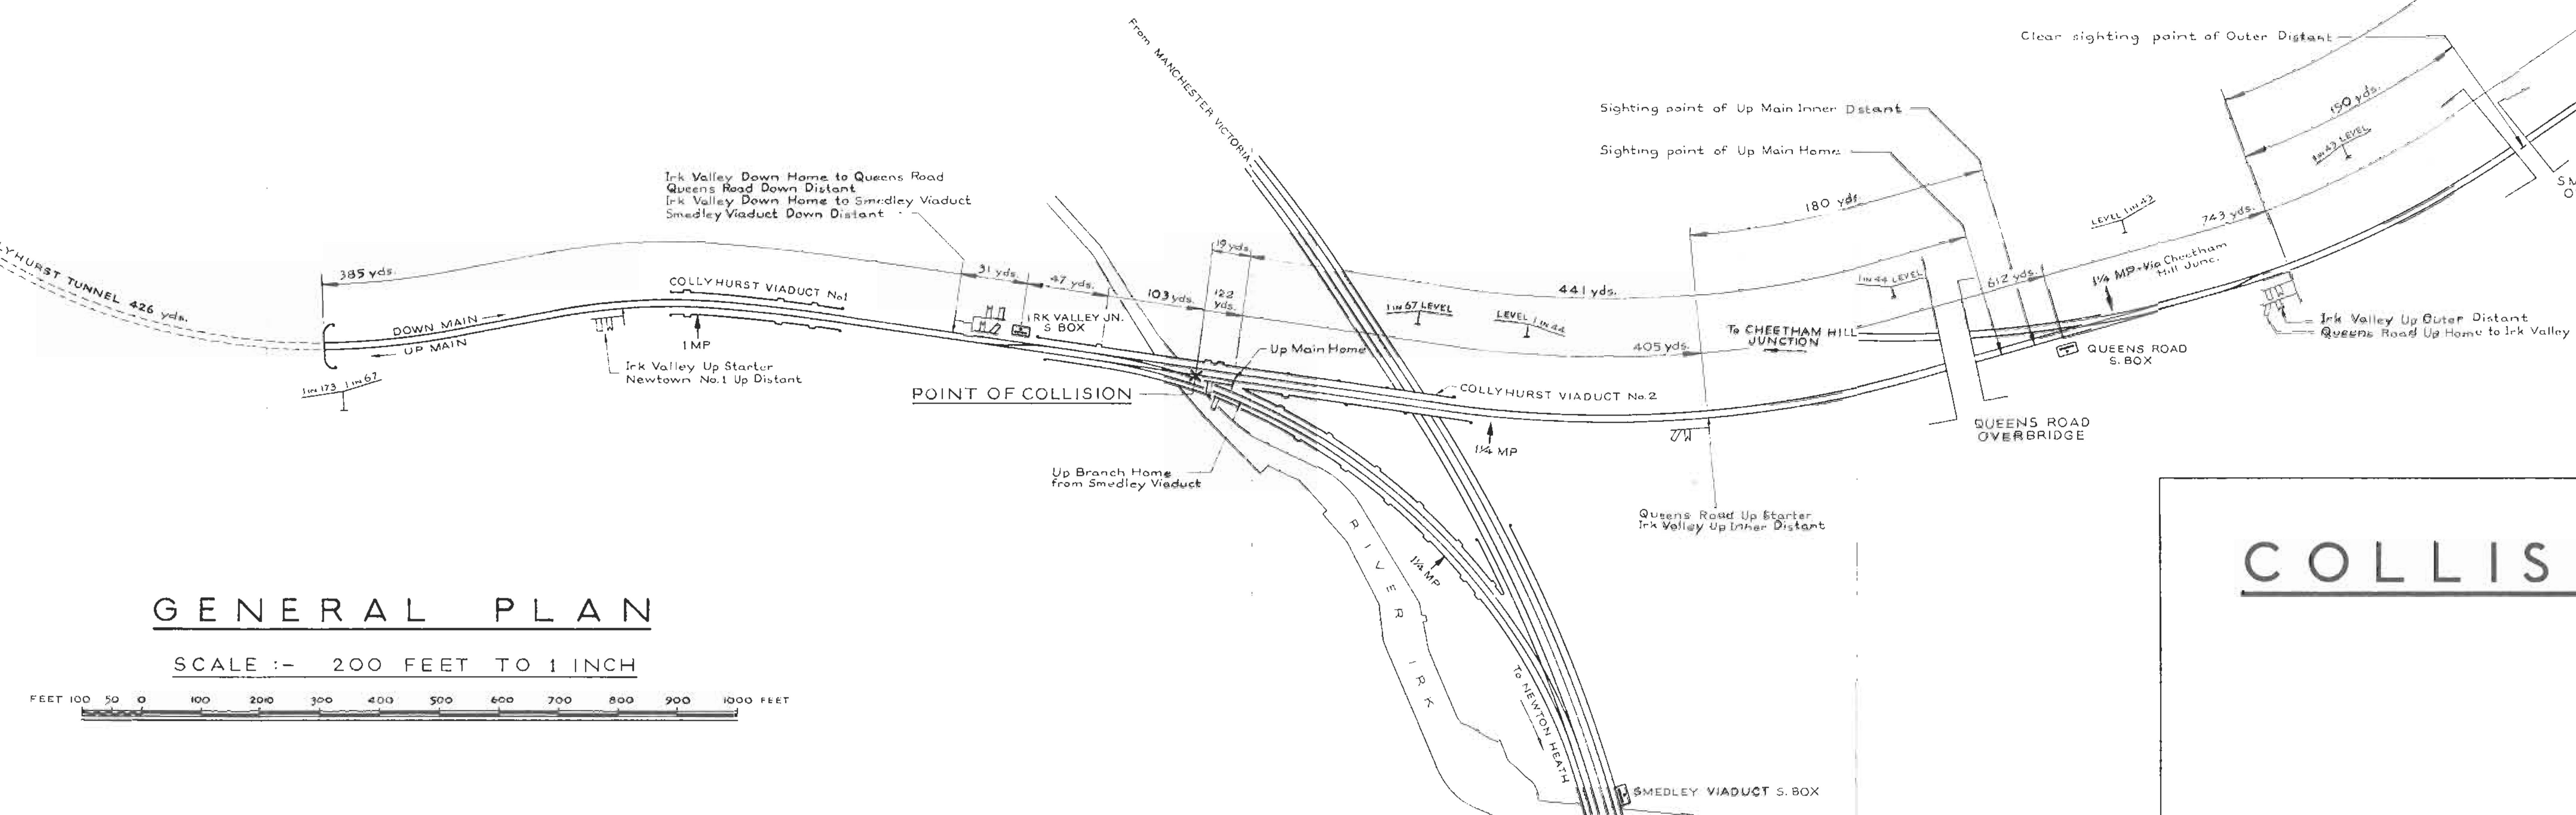
COLLISION AT IRK VALLEY JUNCTION
MANCHESTER

An Up electric passenger train collided with a Down steam passenger train on the diamond crossing of the junction. The former was the 7.20 a.m. stopping train from Bury to Manchester (Victoria) and it ran past the Junction home signal at Danger at about 35 m.p.h. The other was the 7.36 a.m. stopping train from Manchester (Victoria) to Bacup, and it was passing under clear signals over the junction to the branch line at about 10 m.p.h. The leading electric coach struck and overturned the steam engine, smashed through the parapet wall of the viaduct, and fell leading end first 40 feet on to the bank of the River Irk below; the rear end came to rest in the shallow river, 30 feet below the front end. A serious irregularity by the signalman in the junction signal box contributed to the accident.

8. The majority of the casualties occurred in the leading electric coach which was wrecked beyond repair. The second coach was also heavily damaged with severe distortion of the whole underframe.

The main frame of the steam engine was badly buckled and the centre pin of the trailing bogie was fractured. One wheel was torn off its axle. The front ends of the first two coaches on the steam train were heavily damaged.
