# RAILWAY ACCIDENT

**Report on the Collision  
that occurred on  
12th October 1972  
at Wimbledon Station**

IN THE  
SOUTHERN REGION  
BRITISH RAILWAYS

# COLLISION AT WIMBLEDON

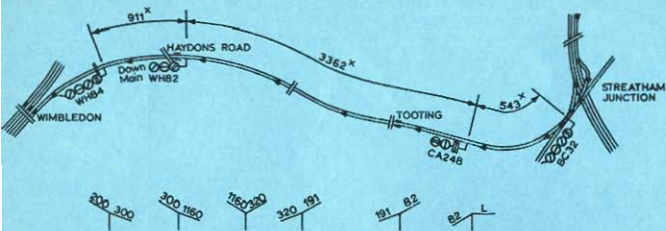
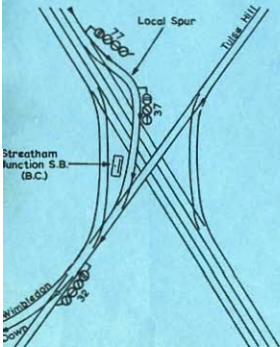
Location Diagram

1. The goods train's route approaches Streatham Junction, which lies 3 miles east of Wimbledon, from Balham on the Down Local Line as shown in the diagram opposite. Its route diverges left-handed climbing steeply onto the Down Local Spur and then curves right-handed over the main lines to connect with the Tulse Hill lines, which also pass over the main lines, beyond the two bridges and opposite Streatham Junction signal box (BC). The route then immediately diverges right-handed onto the Down Wimbledon line (called the Down Streatham Junction line in Wimbledon signal box). The Down local line from Balham has 4-aspect colour light signals. That protecting the turnout onto the Down Local Spur is equipped with a standard British Railways junction indicator (a line of five lunar white lights) controlled by lever BC 77 in Streatham Junction signal box and is 'approach-controlled' when reading to 3-aspect colour light signal BC 37 on the Down Local Spur which protects the trailing connection with the Tulse Hill line. A 4-aspect colour light signal with a right-handed junction indicator controlled by lever BC 32, signals trains to a fully automatic 2-aspect colour light signal CA 248 on the Down Wimbledon line situated 543 yards ahead of signal BC 32. There is an emergency trailing crossover, which is kept normally clipped and padlocked out of use, 354 yards on the approach side of signal CA 248.
