Rail Accident Investigation Branch

Rail Accident Report

**Train overspeeding at Spital Junction,
Peterborough
17 April 2022**

Report 06/2023
v2 August 2024

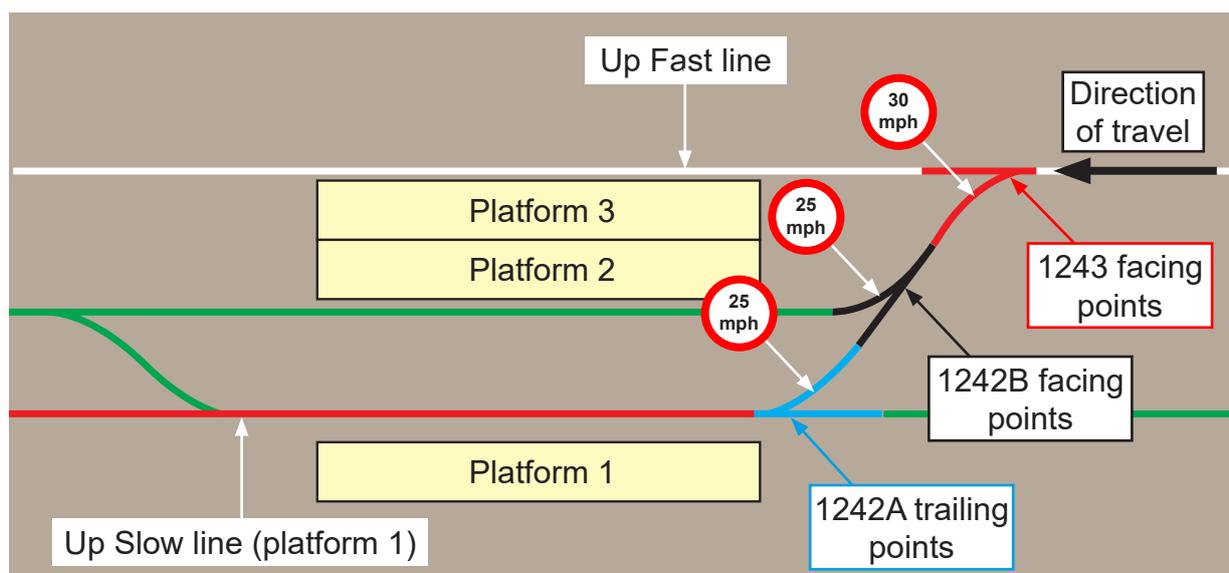
Figure 4: Details of the track layout at the diverging junction to the Up Slow lines.

- 14 The diverging route at the junction, over which the train passed, comprises three turnouts² (figure 4). The first turnout reached, which includes 1243 points, has a maximum permitted speed of 30 mph (48 km/h). The remaining two turnouts have maximum permitted speeds of 25 mph (40 km/h). When viewed in the direction of the train's travel, the first and second sets of points are facing points while the third are trailing points. The maximum line speed on the Up Slow line through platform 1 is 50 mph (80 km/h).

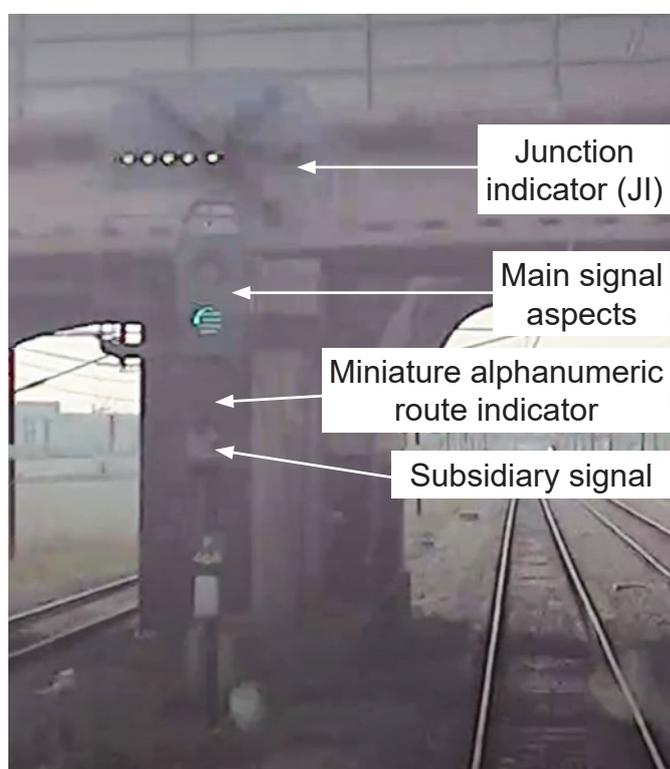
Figure 5: Annotated image of P468 signal.

- 15 Trains approaching on the Up Fast line are signalled from P468 signal across the junction. The signal is located around 700 metres on the approach to the point of divergence towards the Up Slow No 1 and Up Slow No 2 lines which lead to platforms 1 and 2 respectively. P468 signal is a four-aspect colour light signal with a junction indicator (JI), sometimes known as a position light junction indicator (figure 5). P468 signal can display red, yellow and green aspects in the lower aperture and an additional yellow in the top aperture when required to display double yellow aspects.

- 74 At 10:19:09 hrs, the JI for the Up Slow line to platform 1 illuminated, followed within a second by the main aspect of P468 signal changing from red to green (figure 5). The train was travelling at around 25 mph (40 km/h) and was approximately 790 metres from the signal when the aspect changed. Three seconds later and with the train approximately 760 metres from P468 signal, the driver applied full traction power to accelerate the train (figure 16). The train passed P468 signal travelling at around 64 mph (103 km/h) and was still accelerating.

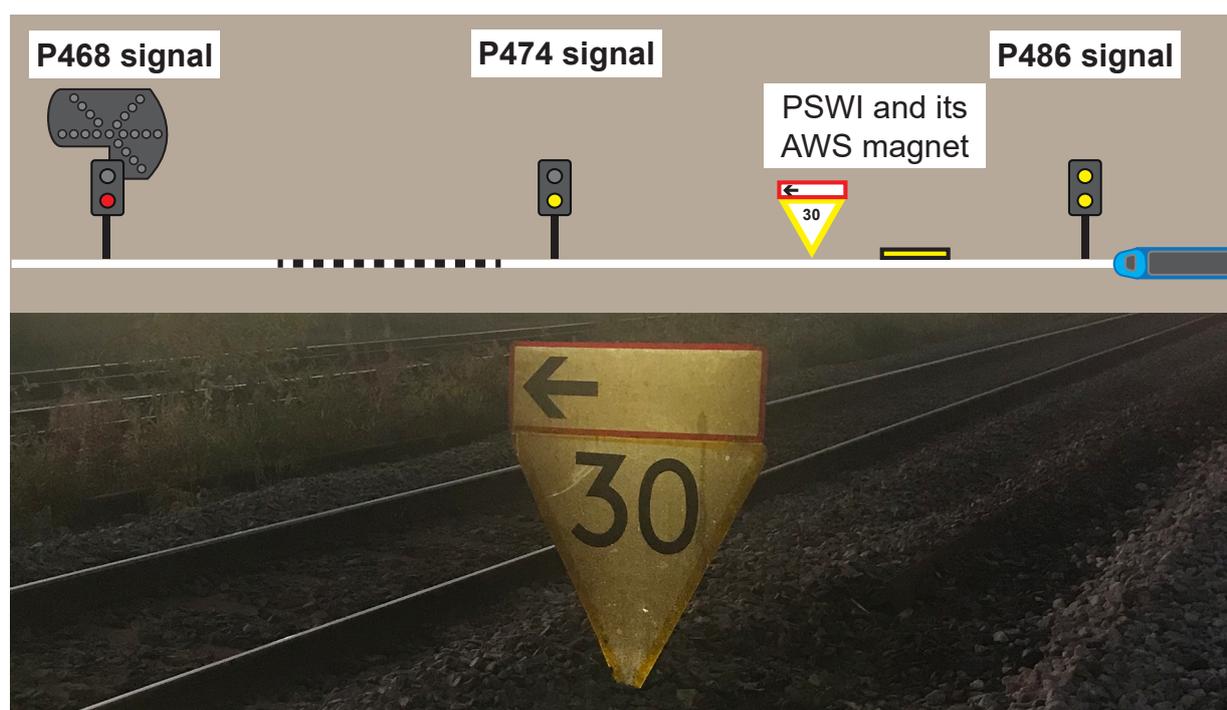
Figure 10: The location of the PSWI in relation to the other signalling equipment and an image of it (courtesy of Network Rail).

- 41 Train drivers on Network Rail infrastructure are provided with lineside signs to provide a point of reference where a permissible speed changes. Drivers are warned of a large speed reduction by a permissible speed warning indicator (PSWI). Trains approaching Spital Junction on the Up Fast line pass a PSWI which warns drivers about the reduction in speed for the 30 mph (48 km/h) divergence for the routes towards platforms 1 and 2. Figure 10 shows the PSWI and its location in relation to the other signalling equipment. The sign shows the 30 mph (48 km/h) permissible speed for the divergence and a directional arrow to indicate that it applies to the tracks to the left of the Up Fast line, that is, to the lines which lead to platforms 1 and 2.

- 42 The PSWI is placed at the required deceleration distance of 2058 metres from the point of divergence, which is the distance needed for a train travelling at the permissible speed of 125 mph (201 km/h) to slow to 30 mph (48 km/h) for the divergence. This distance placed the PSWI between P486 and P474 signals. This PSWI, which is located between signals, is provided with its own automatic warning system (AWS) magnet situated about 180 metres on the approach to the PSWI sign. When a train passes over the magnet, it causes an audible warning in the cab which the driver must acknowledge within a specified time, or an emergency brake application will occur. The aim of this AWS warning is to alert the driver to the PSWI, which in turn aims to remind the driver about the slower speed divergence that is ahead.

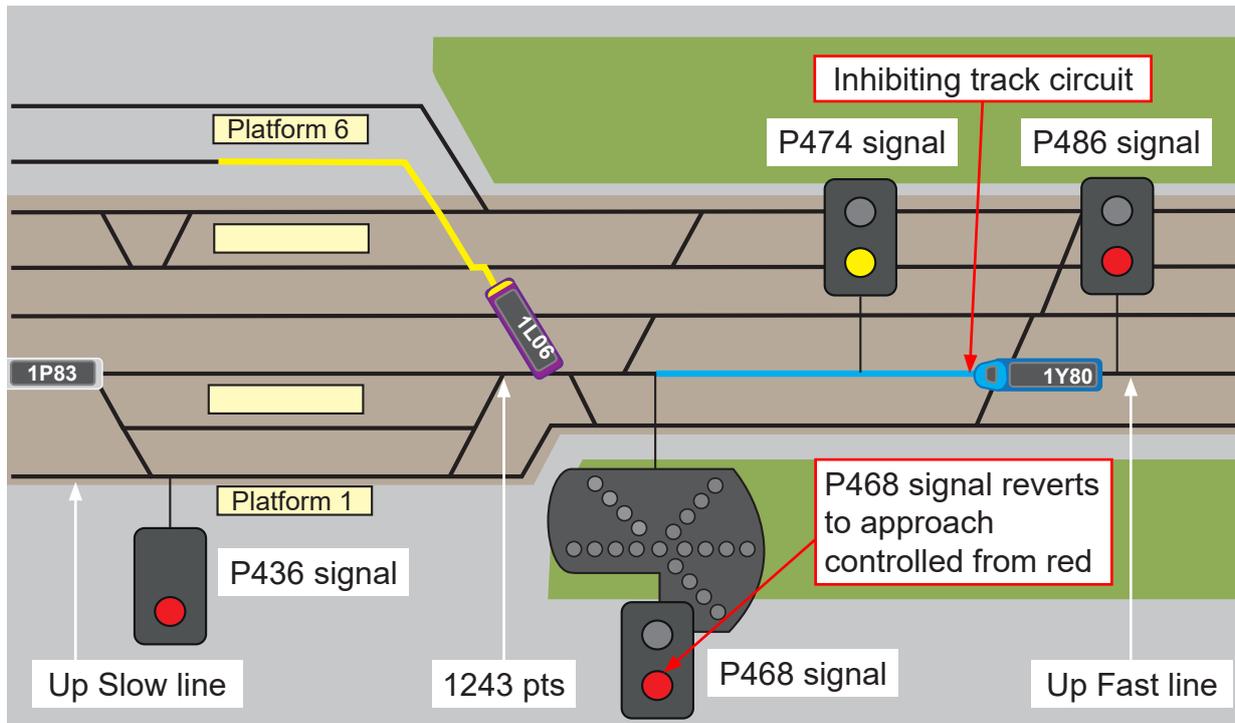
Figure 13: The position of trains 1P83, 1L06, and 1Y80 at 10:17:02 hrs.

69 At 10:17:02 hrs, with train 1L06 still occupying the Up Fast line, train 1Y80 was travelling at around 32 mph (51 km/h) and slowing down as it approached and passed P486 signal displaying a single yellow aspect. Train 1Y80 then occupied track circuit T7726 which inhibited P474 signal from showing a single flashing yellow aspect (paragraph 40). At this time, P474 signal was not visible to the driver of train 1Y80. Because of the proximity of train 1Y80 to P468 signal, it was prevented from using flashing yellow control, and was approach released from a red aspect (figure 13).

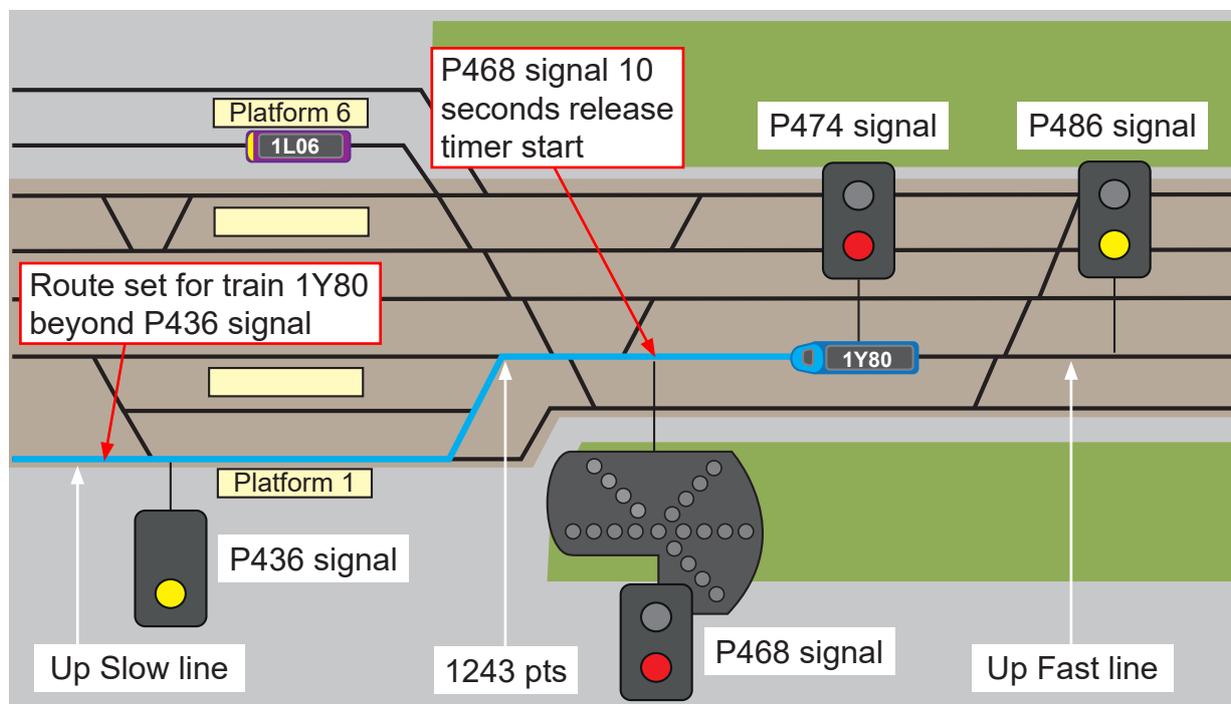
Figure 15: The position of trains 1L06 and 1Y80 at 10:18:58 hrs with 1Y80 having just passed P474 signal.

73 At 10:18:58 hrs, train 1Y80 reached track circuit T7724, having just passed P474 signal previously displaying a single yellow aspect. This started the 10-second timer which, once expired, would allow the release of P468 signal (figure 15). By this time P468 signal, which was showing a red aspect, was visible to the driver of train 1Y80.

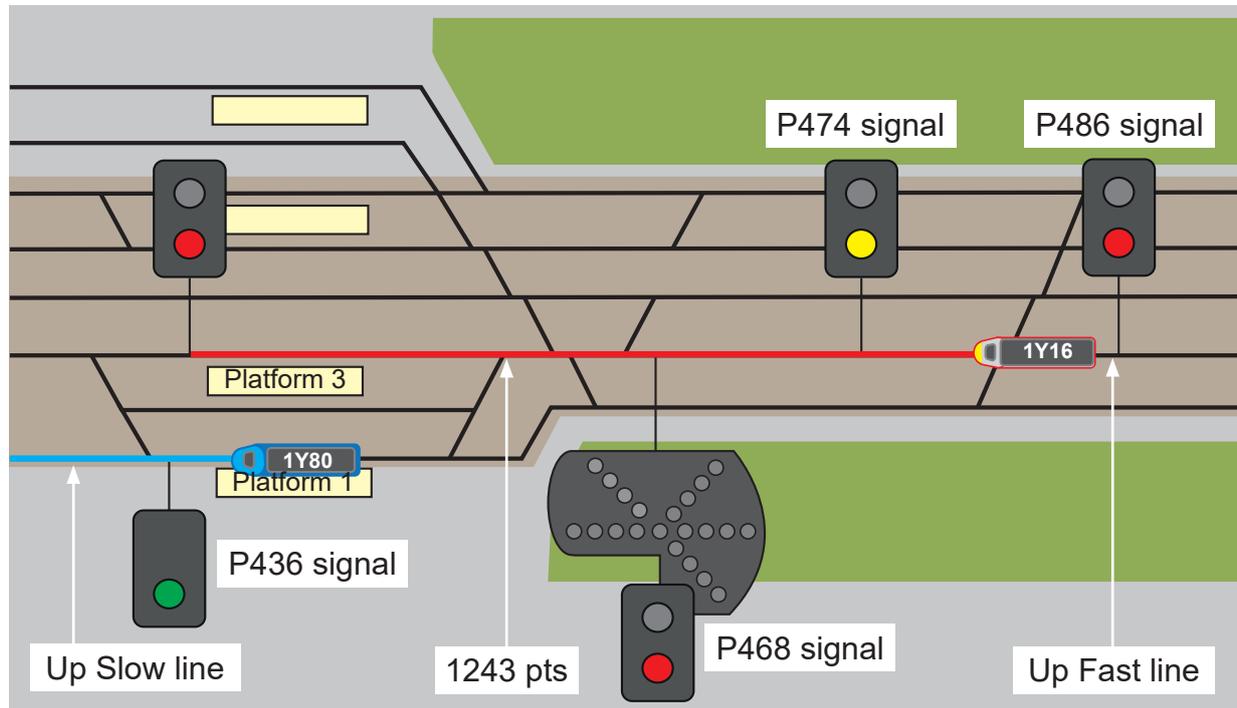
Figure 19: The position of trains 1Y80 and 1Y16 at 10:20:40 hrs.

- 77 At 10:20:40 hrs, the train stopped just before reaching P436 signal at the south end of platform 1 (figure 19). The late running train 1Y16 arrived at platform 3 around 2 minutes later.

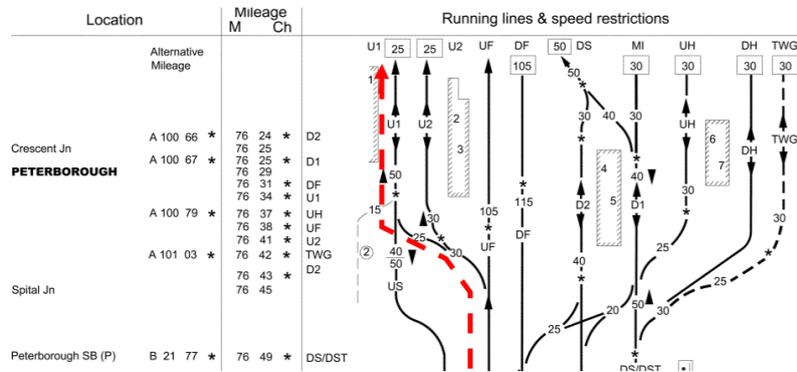
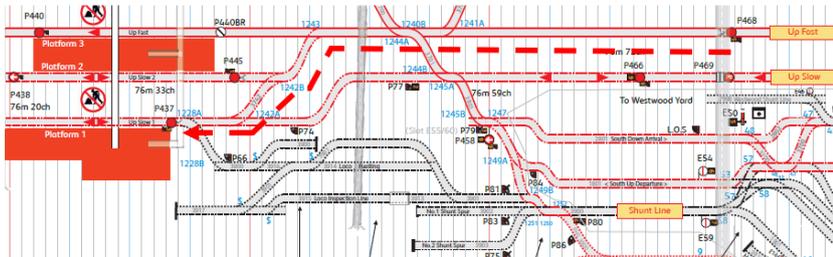
P468 to Peterborough Platform 1

On 4th May 2023 an incident occurred in which a train travelled over the route from the Up Fast East Coast Main Line P468 signal to Peterborough platform 1 at approximately 60mph. The permitted speed for this route is 25mph.

A similar incident occurred on 17/04/22 in which a train passed over the route at approximately 75 mph. This incident is currently being investigated by the Rail Accident Investigation Board.

Please ensure the Permanent Speed Restriction at these points is included in your Route Risk Assessments and is covered in driver training material and assessments.

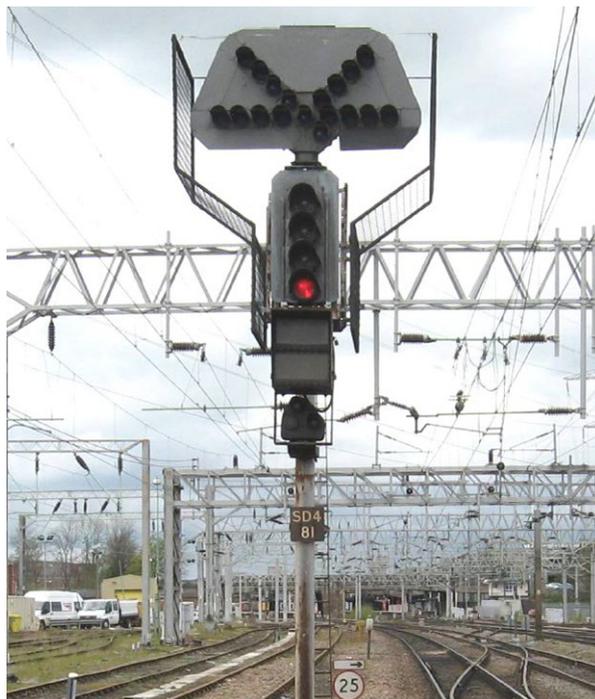
Figure E1: Example of a junction indicator

- E10. As part of its investigation into the 2023 incident, RAIB undertook a survey of the signal beam alignment and light output performance of the JI fitted to P468 signal. It was not possible to accurately determine the light output of the JI on location, or to remove the JI from service for testing, due to the long-lead time required to obtain a replacement. However, Network Rail was able to supply an LED JI of the same type and RAIB commissioned an independent optical consultant to undertake light output testing. The performance of this LED JI was tested and compared with an ‘as new’ BRS SE 156/1 filament bulb JI module.

- E11. Filament bulb JIs use four individual light modules meeting BRS SE 156/1 for each route to be indicated. These are arranged around a similar light module, known as the pivot light, which illuminates with all indication positions to give five white lights (figure E1). The Unipart Dorman Mk1 LED JI is similar in design with a pivot light and four LED modules forming each indication. Both types of JI use a cast metal frame to house the light modules and a large backboard to improve contrast to the white light output.

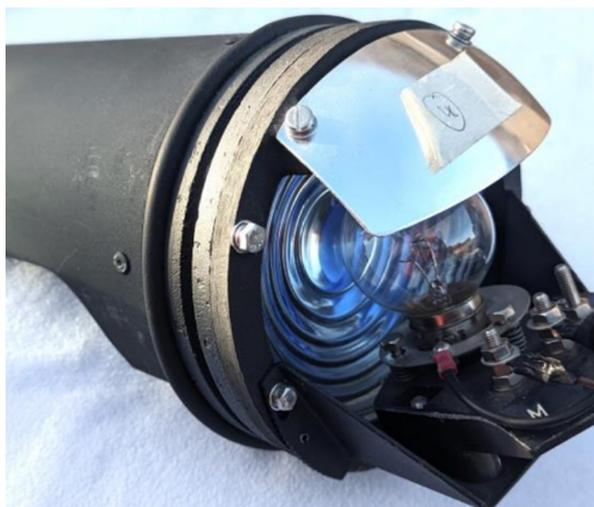
Figure E2: Bulb and lens module used in filament junction indicators.

E12. The BRS SE 156/1 light module utilises a traditional filament bulb and glass lens arrangement to focus the light output towards the driver (figure E2). This produces a focused beam, but because of the long thin horizontally aligned filament used in the SL18 bulb, the intensity of the light output is greater in the horizontal axis than it is in the vertical axis when viewed from the front (figure E4a). In contrast, the Unipart Dorman Mk 1 LED light module uses an array of LEDs mounted at the end of a short tube. This provides improved visibility and reduces problems originating from sunlight reflecting directly on the LED (figure E3). The absence of a filament allows the LED light module to emit light equally in both the horizontal and vertical axis (figure E4b).

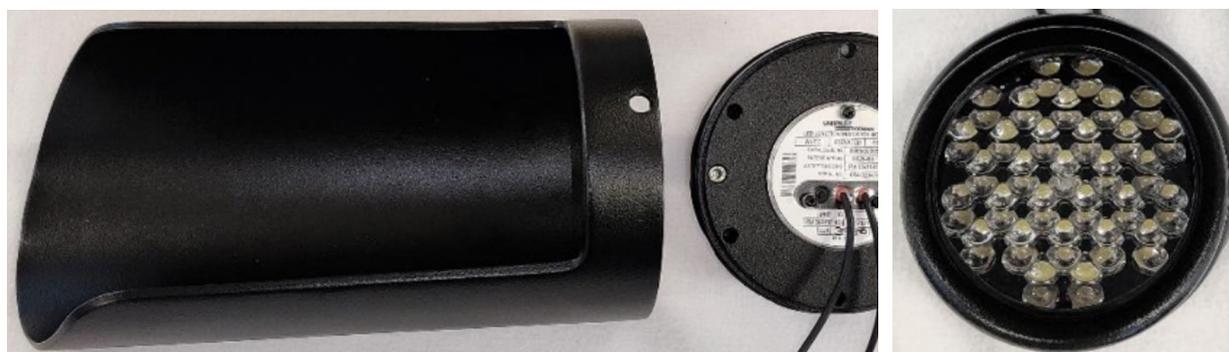
Figure E3: Unipart Dorman Mk1 LED junction indicator module.

E13. The LED JI light modules were found to be at different alignments within the JI housing, ranging between -0.4 and -2.7 degrees error relative to the designed position within the housing. The pivot light was also found to be installed upside down. These issues are likely to be a consequence of the sample JI having been supplied from one of Network Rail's training centres and is unlikely to be representative of the LED JIs in use. To account for the misalignment, the luminous intensity of all modules was tested 'on-axis' and relative to the light module itself, and not to its position within its housing.

E14. During testing, the LED JI modules were found to emit a greater luminous intensity when initially illuminated. The luminous intensity reduced as the modules became warmer. Although it is unlikely that the LED JI modules fitted to P468 signal would create sufficient heat to affect the light output in the time they were illuminated for an approaching train, it was necessary to allow the modules to stabilise to enable the testing to take place. When tested, the LED JI pivot light module produced the highest output of 591 cd initially, which reduced to 403 cd once it had stabilised after 40 minutes (figure E6). The other LED JI light modules produced a light output of between 255 cd and 314 cd when stabilised.

E15. The measured on-axis luminous intensity of the LED JI modules was significantly lower than the output measured for the BRS SE 156/1 filament bulb module, which was approximately 1,450 cd (figure E5). Although the product acceptance testing verified that an LED JI was readable at the required distance of 800 metres, the testing shows that the output of the LED JI module is significantly lower than the output of the example filament JI module it was intended to replace.

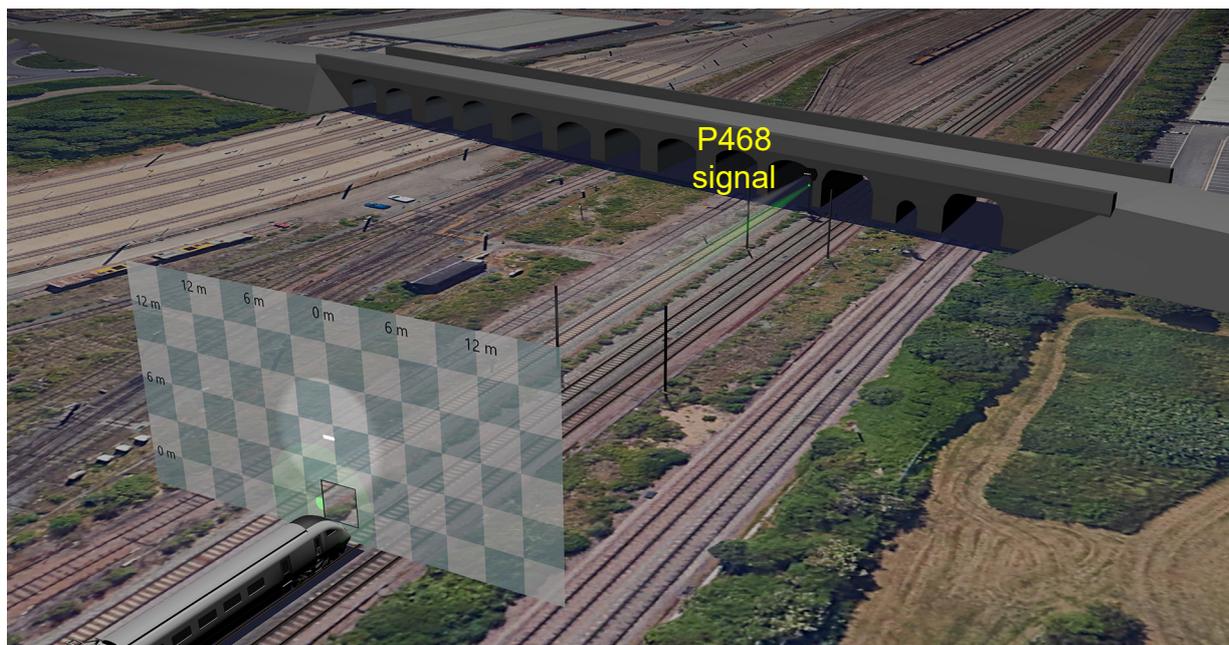
Figure E8: Illustration of beam projected onto virtual 3x3m square grid 100 metres from P468 signal.

- E19. When a beam drawn from the green aspect and JI of P468 signal is overlaid on the topographical survey of the Up Fast line, the centre line of the green main aspect was found to be pointing down towards the track, and the JI pointing upwards (figure E7). This downwards alignment of the main aspect is in line with the signal sighting guidance to aim the main signal towards driver's eye level at the AWS magnet associated with the signal. Figure E8 places an approaching train at 100 metres (110 yards) from P468 signal. At this distance, the centre of the green aspect beam is to the left and at a height approximating that of a driver's eye line. In contrast, the top of the windscreen of an approaching train is approximately 5 degrees below the centre of the beam projected by the JI.

- E20. When these beams are projected to 800 metres (875 yards) from P468 signal, the centre of the green aspect beam remains closer to the driver's eye line, although below the windscreen level of an approaching train. However, the centre of the JI is much further from the driver's eye line (figure E9).
