Rail Accident Report

**Signal passed at danger on approach to
Wootton Bassett Junction, Wiltshire
7 March 2015**

Signal passed at danger on approach to Wootton Bassett Junction, Wiltshire, 7 March 2015

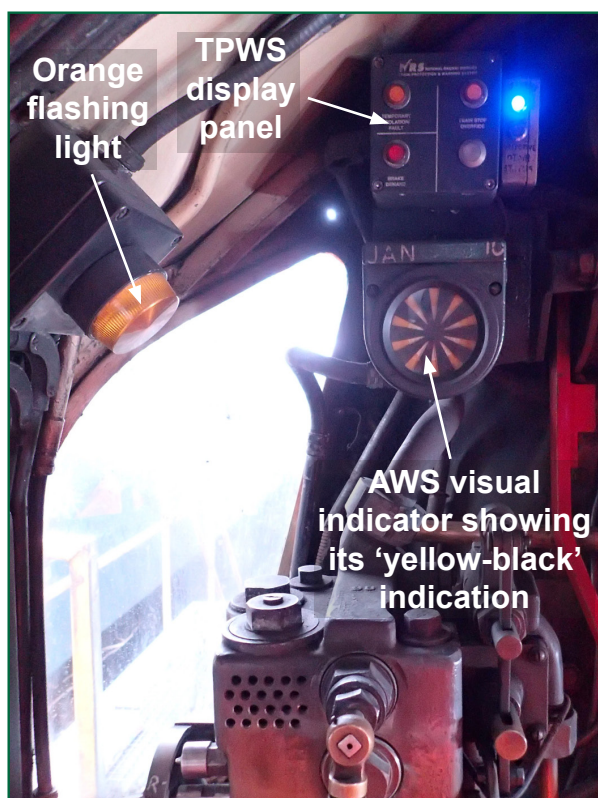
- 15 At the time of the incident, the AWS audible warning indicator on Tangmere was positioned on the inside of the cab roof, just above the *driving position* (which is on the left-hand side of this locomotive) and towards the rear of the driver's side window. The orange flashing light was also positioned on the inside of the cab roof, slightly higher than the audible warning indicator and to the front of the driver's side window (figures 8 and 9). The AWS visual indicator (commonly called the 'sunflower') is mounted in front of the driving position just above the main driving controls, with the TPWS display panel positioned directly above it (figure 9).

Figure 9: The position of the AWS flashing light, AWS visual indicator and TPWS display panel on 7 March 2015. Note :the blue light next to the TPWS display panel relates to the locomotive's OTDR.

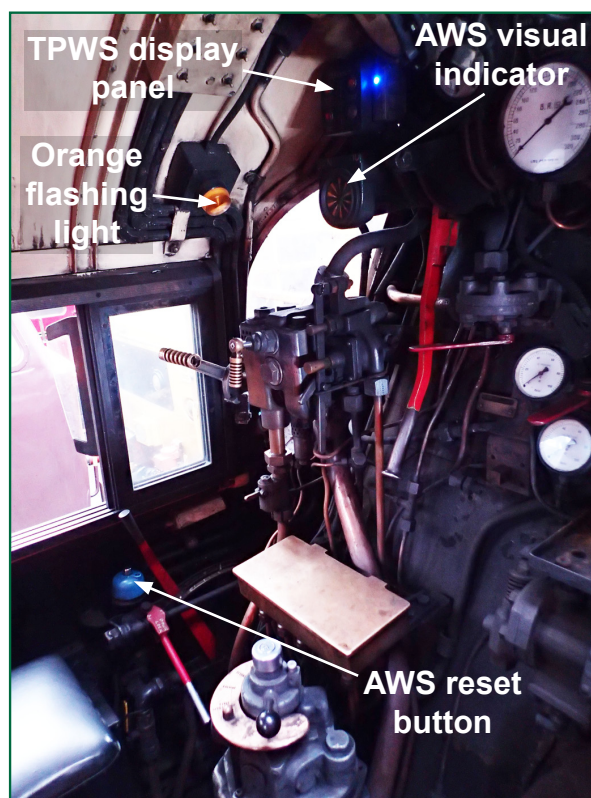
- 16 Drivers acknowledge AWS warnings on Tangmere by pressing and releasing the AWS reset pushbutton, which is located to the left of the driver's seat (figure 10). The *railway group standards* applicable at the time that Tangmere's AWS system was installed required that the driver be given a period of up to 2.7 seconds to acknowledge warnings. Should a driver not acknowledge an AWS warning within this time period, then the combined AWS/TPWS control unit will generate an AWS brake demand. The relevant standards required that AWS brake demands remain active until the driver acknowledged the warning and that any brake demand continue for at least 59 seconds after this had been done. In the event that an AWS brake demand occurs, the *Rule Book*⁴ requires drivers to immediately bring their trains to a stand and then to contact the signaller.

Figure 10: The position of the AWS flashing light, AWS visual indicator, AWS reset pushbutton and TPWS display panel on 7 March 2015

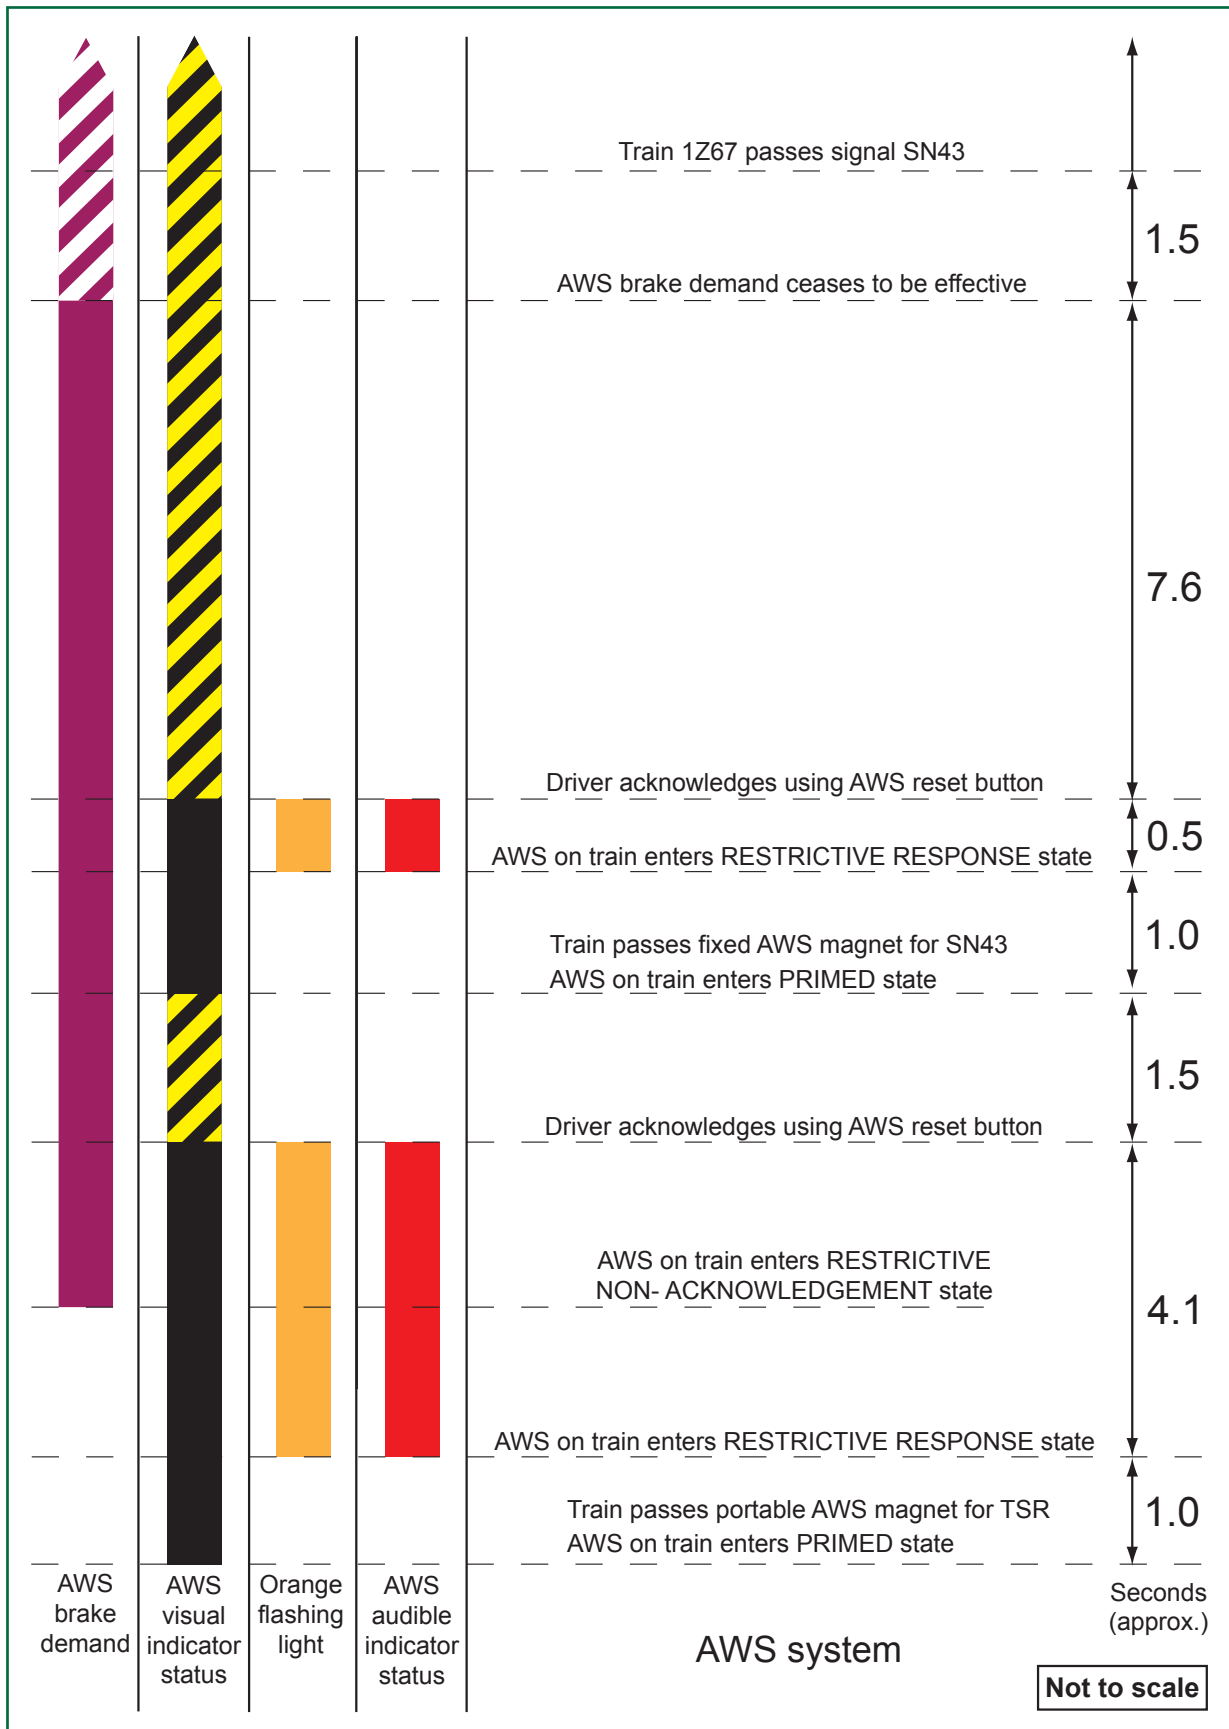
Figure 14: Timeline of events at signal SN43

- 47 At around 17:24 hrs, 1Z67 was approaching signal SN43 at 59 mph (95 km/h), when it passed over the portable AWS magnet associated with the TSR (paragraph 10). Around a second after this, an AWS warning occurred. OTDR data showed that it took the driver 4.1 seconds to acknowledge this warning, by which time the combined AWS/TPWS control unit had already generated an AWS brake demand (figure 14).
- 48 The driver indicated to the fireman that an AWS brake demand had occurred. His expectation was that the fireman would open the AWS isolating cock in order to by-pass the AWS brake demand and release the brakes. The fireman has stated that he believed that he was following the driver's instructions when he subsequently crossed the cab and opened the AWS isolating cock. The fireman stated that the AWS isolating cock was not sealed before he opened it.

- 80 **The AWS warning relating to signal SN43 did not alert the driver that he had passed signal SN43 and that it was displaying a caution aspect.**
- 81 Once it had passed over the AWS magnet for the TSR (paragraph 47), train 1Z67 passed over the fixed AWS magnet which was associated with signal SN43 (paragraph 51). This signal was displaying a single yellow caution aspect and, as a result of this, the driver received another AWS warning. This warning started around a second after the train passed over the fixed magnet and was acknowledged by the driver within 0.5 seconds (figure 14).
