Rail Accident Investigation Branch

Rail Accident Report

Collision between a train and a collapsed signal post at Newbury 17 November 2014

Report 15/2015
September 2015

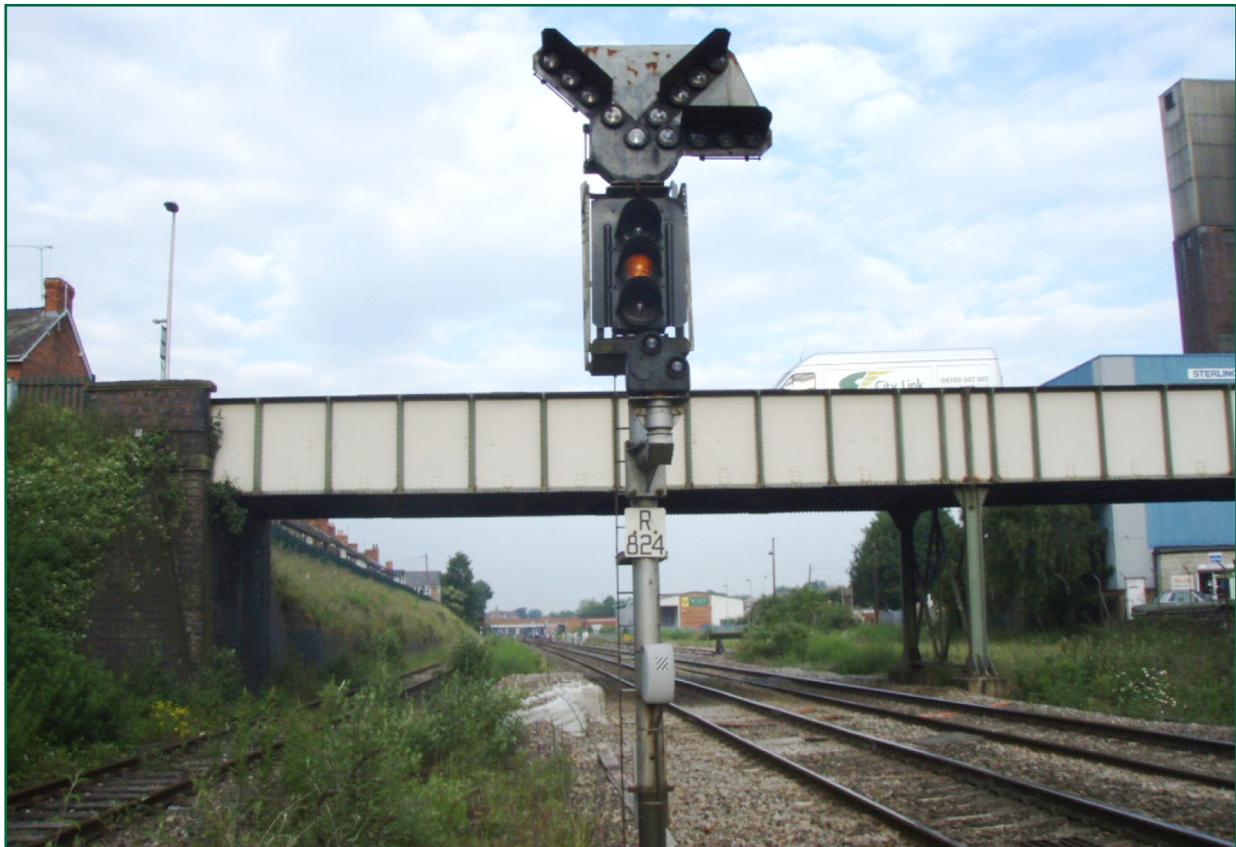
Figure 5: Photograph of the signal from 2009 (prior to the LED signal head being fitted) (courtesy of Amey)

- 14 Signal T265 is a simple straight post LED type three-*aspect* signal for the Down Westbury line (see Figure 5). It has three junction indicators and a *position light* signal which is used for *call-on* moves into the platforms at Newbury station as well as wrong-direction shunt moves onto the Up Westbury line.
- 15 The signal is located in the *ten-foot* between the Down Westbury and Down Newbury Loop lines.
- 16 The post is of hollow round tubular construction made of carbon steel, with an outside diameter of approximately 168 mm, while the manufactured wall thickness was approximately 6 mm. As a structure, the post is welded into a baseplate assembly which, in turn, is bolted to a concrete foundation (see Figure 6). The signal structure also includes an access ladder which is similarly fixed into the ground.

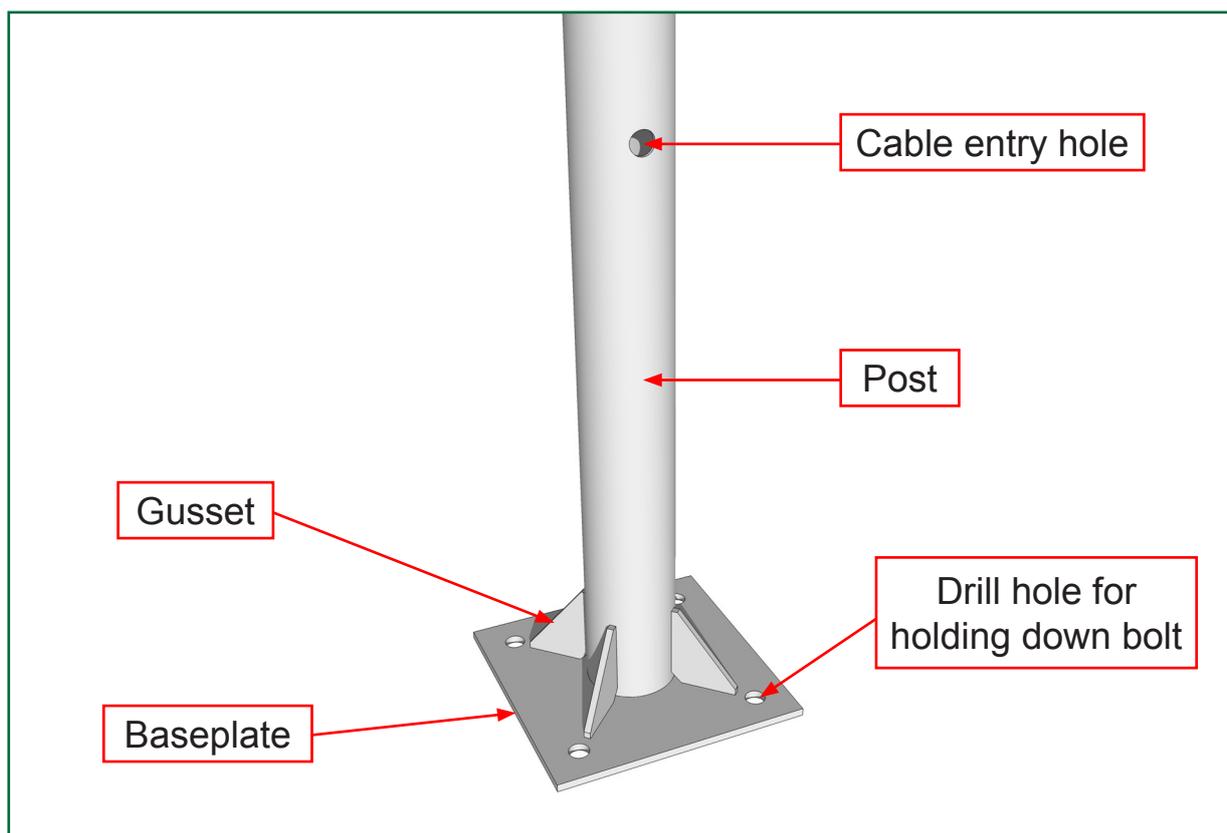
Figure 6: Schematic of post and baseplate assembly (holding-down bolts and concrete foundation not shown)

- 17 The structure is approximately 40 years old. Standard design drawings were first issued in 1974, while Network Rail believes this particular post was installed in 1978. The design drawings do not specify any protective coating, although a version update in 1993 refers to hot dip galvanisation.
- 18 Two weeks before the accident, on 3 November 2014, *axle counters* replaced *track circuits* as the means of train detection as part of a resignalling project in the area, which also replaced the older style incandescent signal lamps with LED technology. The signal was originally numbered R824. It became TR824 in 2010, and was redesignated T2865 after the resignalling was commissioned. Since this report discusses different times throughout the life of the signal, the designation correct for the period of discussion will be used in each case.

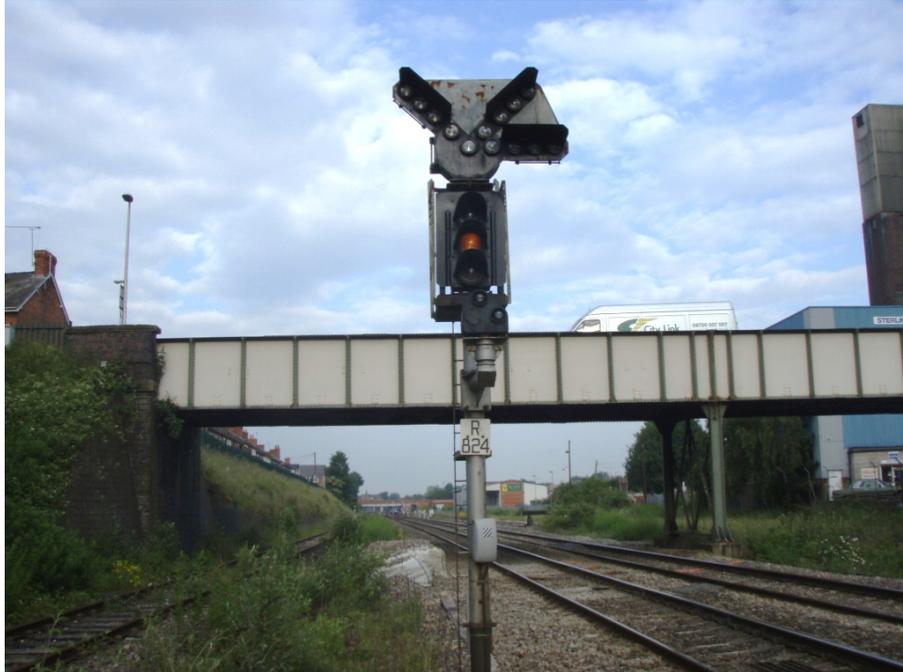
photo 1

Examiner General Comments
Engineers recommendations.
No action
New defects
This signal post R824 is located in the ten foot general deterioration throughout surface protection. see photo 1.
Has all of the structure been examined? Yes
(If no, state reasons below)
SIGNED
EXAMINERS NAME
DATE 11 Jun 2009

Abridged⁸ example of Line of Route (Generic) examination report form – 2009 examination including signal TR824 (highlighted)
