Rail Accident Investigation Branch

Rail Accident Report

Derailment at Knaresborough 7 November 2015

Report 16/2016
August 2016

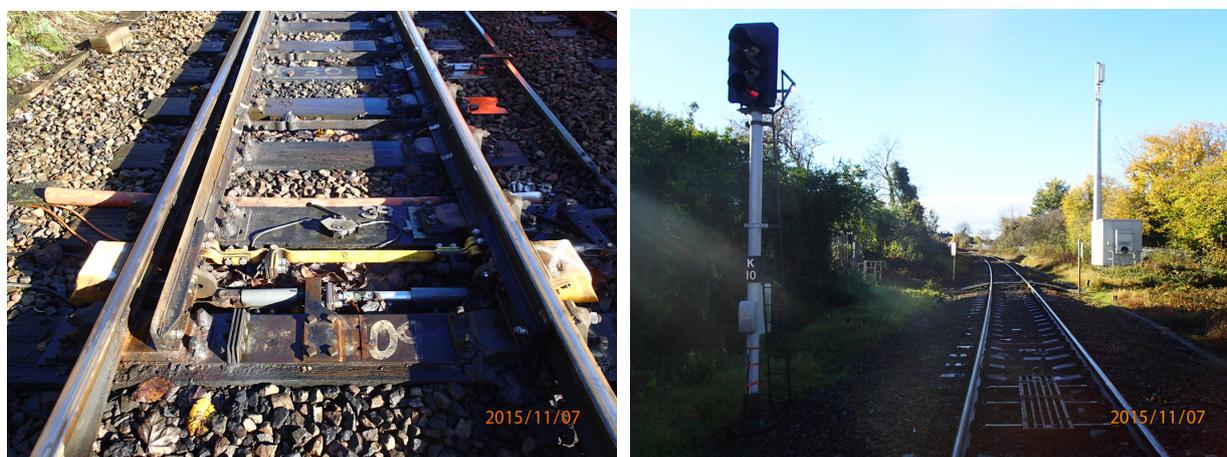
Figure 4: Points 3 in the 'normal' position and signal K10

- 14 Points 3A are of the *E-type*, using *flat bottom rails* laid vertically. The points are fitted with an electrical '*clamp lock*' machine and a mechanical *back drive* used to move the *switch rails* from one position to the other. When in the '*normal*' position, the points are set for a train approaching from the single line to remain on the DownYork line. When in the '*reverse*' position, the points are set for a train approaching from the Up York line moving onto the single line.

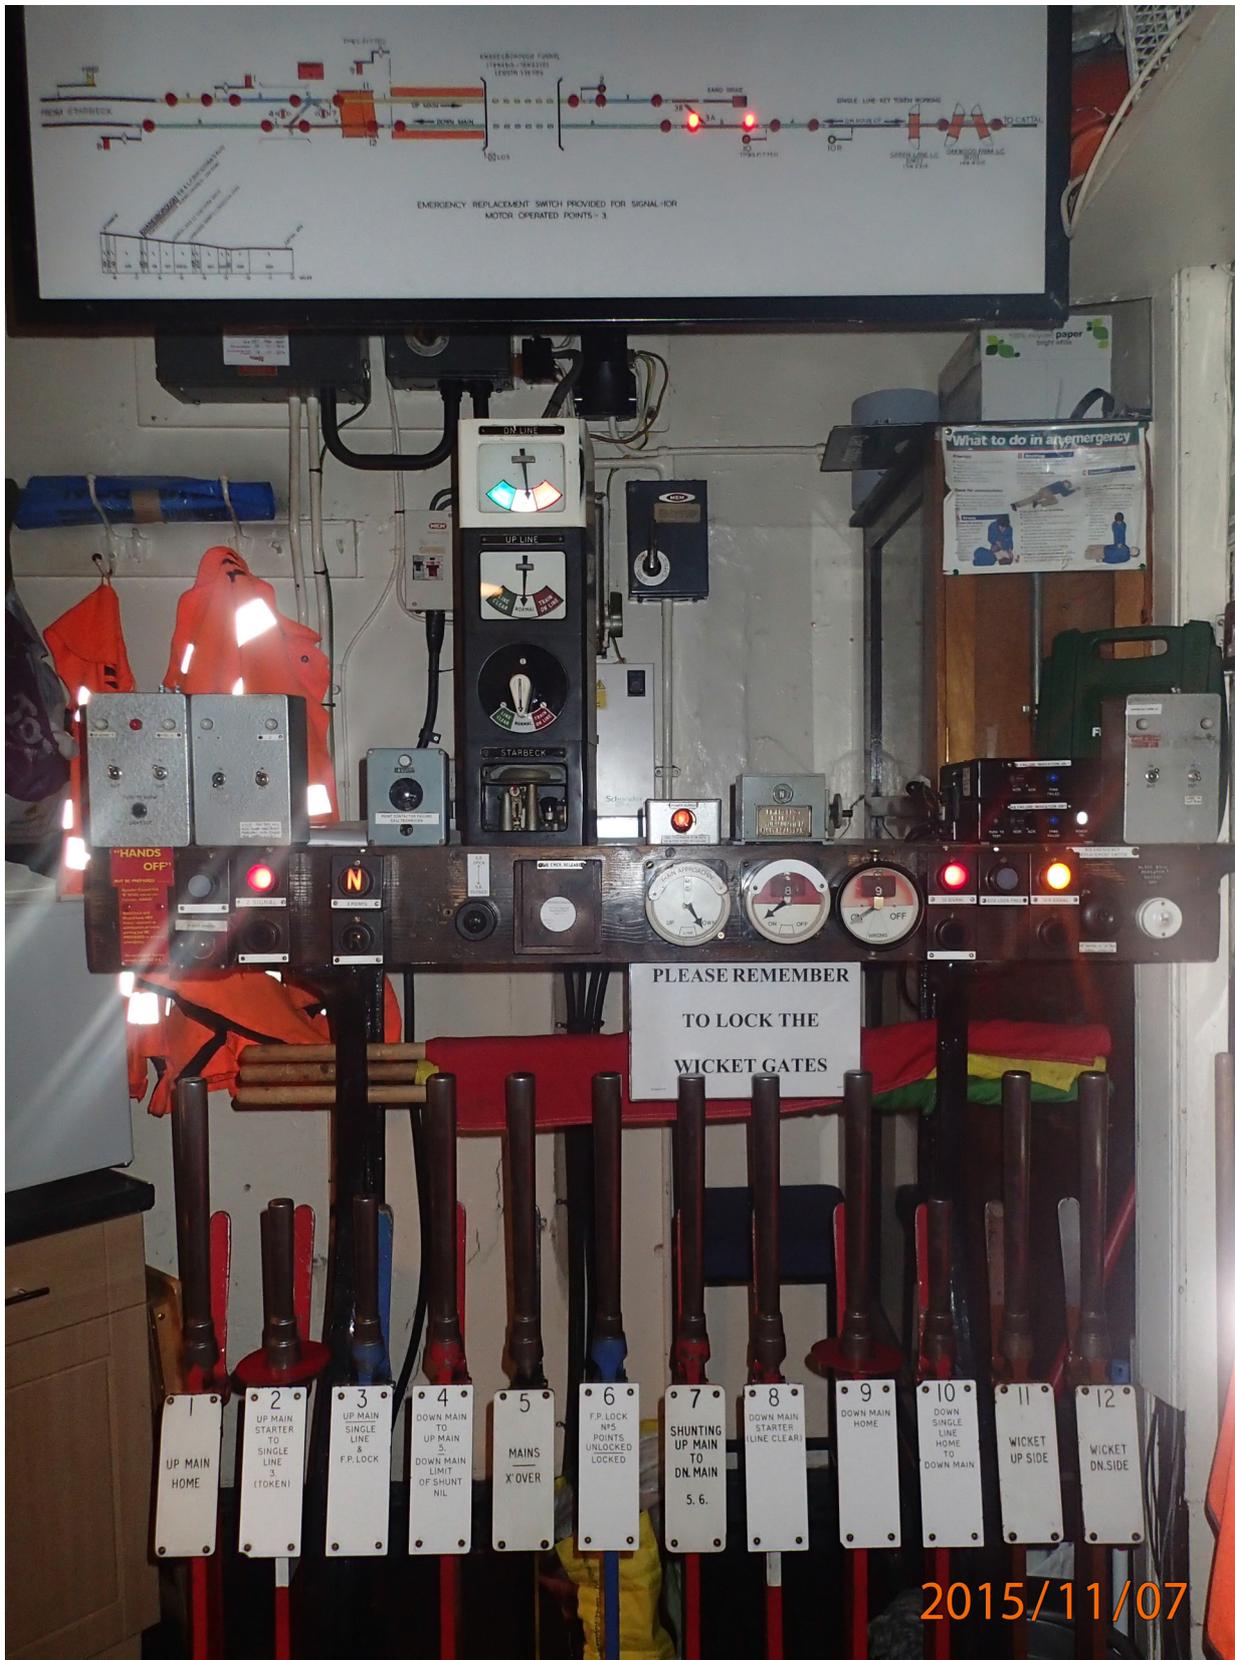
Figure 5: Knaresborough signal box lever frame

- 16 Knaresborough signal box is fitted with a frame containing 12 mechanical levers. The levers are used to operate the points and signals controlled by the signal box. The area controlled by the box spans from Oakwood Farm crossing to the east to signal K8 on the DownYork line to the west.

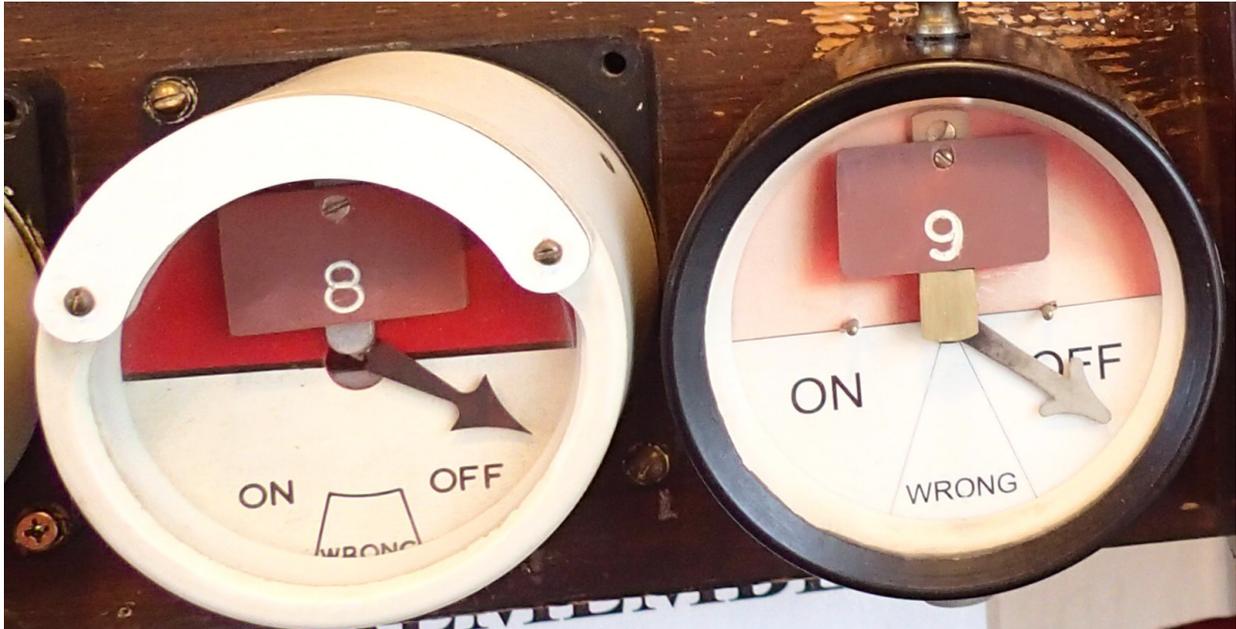
Figure 6: Signal aspect indication at Knaresborough signal box for signals K8 and K9 (semaphore)

- 24 Mechanically operated semaphore signals are moved by a wire which pulls the arm to the 'clear' (or 'off') position when the signaller reverses the corresponding lever. An indicator, located on the shelf above the signal lever provides the signaller with confirmation of the position of the semaphore arm (figure 6).
