RAILROAD ACCIDENT INVESTIGATION

REPORT NO. 4163

ILLINOIS CENTRAL RAILROAD

SEPTEMBER 26, 1969

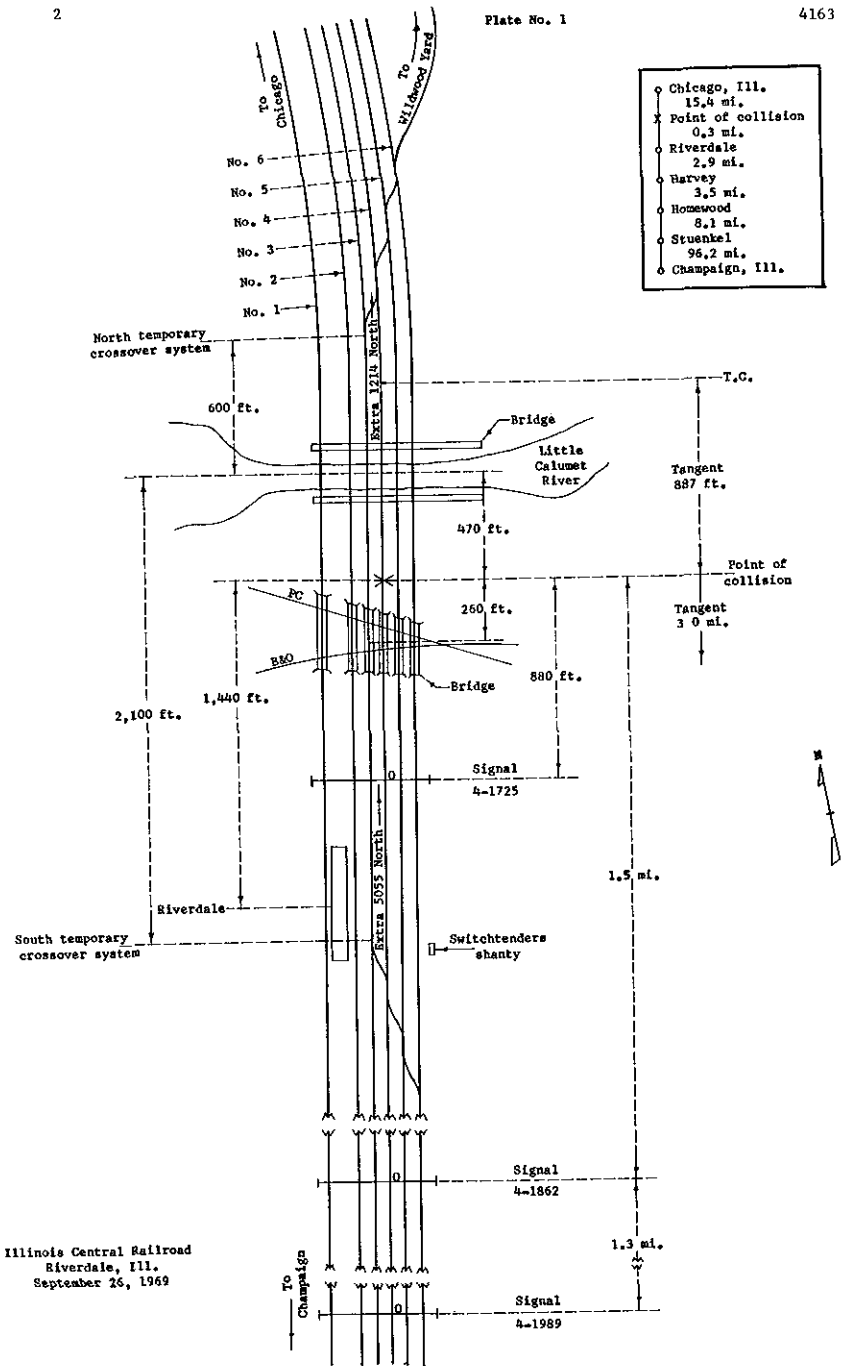
Illinois Central Railroad
 Riverdale, Ill.
 September 26, 1969

The collision occurred on track No 4, 110 7 miles north of Champaign and 1440 feet north of the station at Riverdale, a suburb of Chicago
