**RAILROAD ACCIDENT INVESTIGATION**

**Report No 4009**

THE BALTIMORE AND OHIO RAILROAD COMPANY

WEBSTER, IND

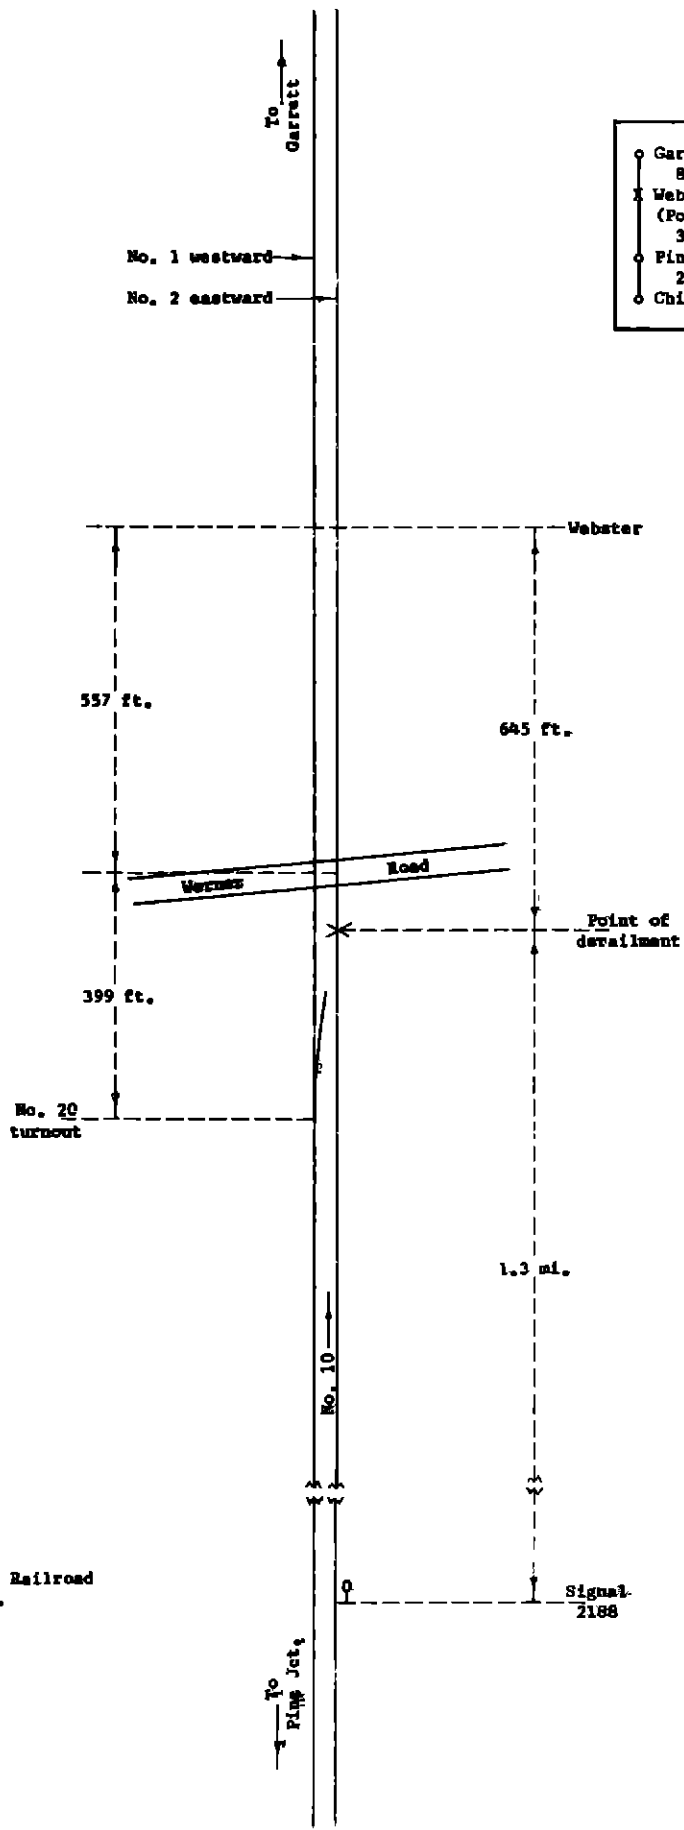
The Baltimore and Ohio Railroad  
 Webster, Ind.  
 May 2, 1964

- Garrett, Ind. 89.3 mi.
- × Webster (Point of derailment) 31.7 mi.
- Pins Jct., Ind. 29.8 mi.
- Chicago, Ill.

Examination of track No 2 disclosed the derailment occurred about 88 feet west of the Werner Road crossing. The track structure was destroyed or heavily damaged throughout a distance of about 500 feet.

Between points  $1\frac{3}{4}$  miles and 1 mile west of the derailment point, an average of only three rail anchors per rail were found on track No 2. There were no rail anchors on this track between points 1 mile and 105 feet west of the derailment point. Track spikes at rail joints were bent eastward. Marks on rail bases indicated the rails had moved approximately 9 inches eastward. From 105 feet west to 30 feet east of the derailment point, there was no ballast in the tie cribs.

It is recommended that the Baltimore and Ohio Railroad Company take necessary measures to provide additional protection by issuance of slow orders and placement of speed restriction signs when track conditions require their use for safe operation of trains.
