# National Transportation Safety Board

## Railroad Accident Brief

**Accident No.:** DCA-05-MR-013  
**Location:** Chicago, Illinois  
**Date:** September 17, 2005  
**Time:** 8:35 a.m. central daylight time<sup>1</sup>  
**Railroad:** Northeast Illinois Regional Commuter Railroad Corporation (Metra)  
**Property Damage:** \$6.35 million  
**Fatalities:** 2  
**Injuries:** 117  
**Type of Accident:** Derailment

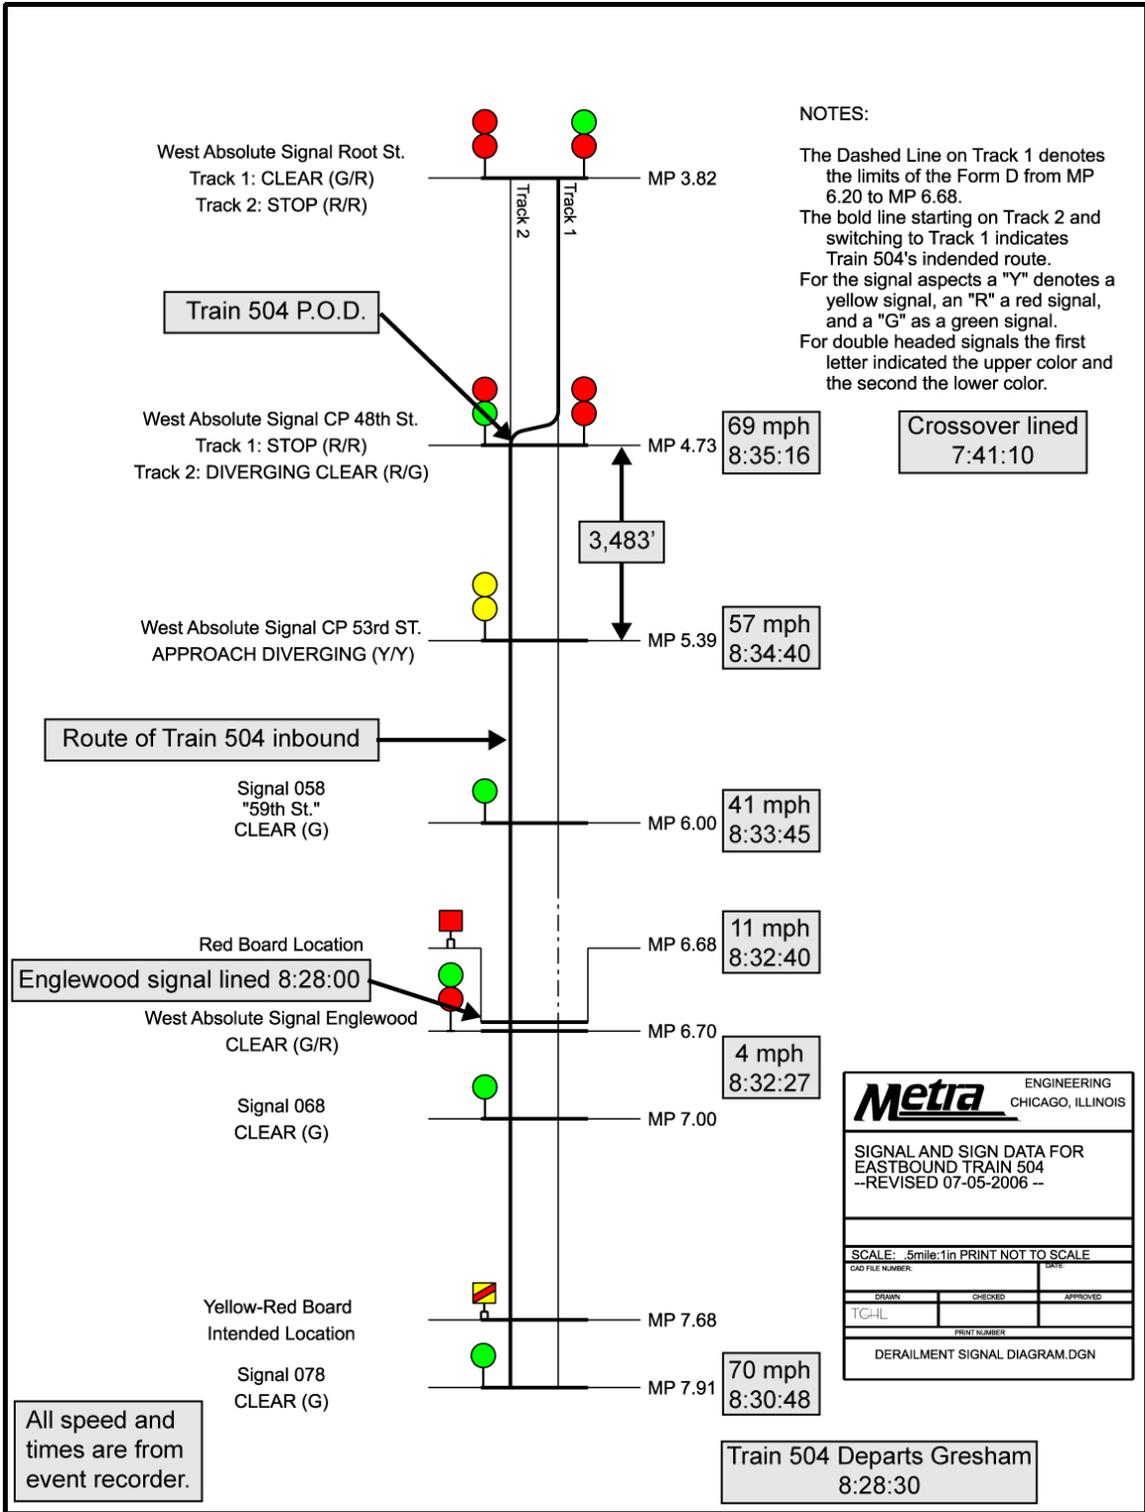
Figure 2: Map.

The yellow/red flag had not been installed 1 mile in advance of the work zone (MP 7.68) when train 504 passed that point at 70 mph about 8:30:58. a.m.<sup>7</sup> At 8:31:42 a.m., signal 068, MP 7.0, displayed a *clear* signal indication (green aspect)<sup>8</sup> as the train slowed to 42 mph in preparation for the 40-mph speed restriction between MP 6.9 and MP 6.6 for the Norfolk Southern Railroad grade crossing at Englewood (MP 6.7). (See figure 2.)
