# NATIONAL TRANSPORTATION SAFETY BOARD

## RAILROAD ACCIDENT REPORT

COLLISION INVOLVING THREE  
CONSOLIDATED RAIL CORPORATION FREIGHT TRAINS  
OPERATING IN FOG ON A DOUBLE MAIN TRACK  
NEAR BRYAN, OHIO  
JANUARY 17, 1999

RAILROAD ACCIDENT REPORT  
NTSB/RAR-01/01 (PB2001-916301)

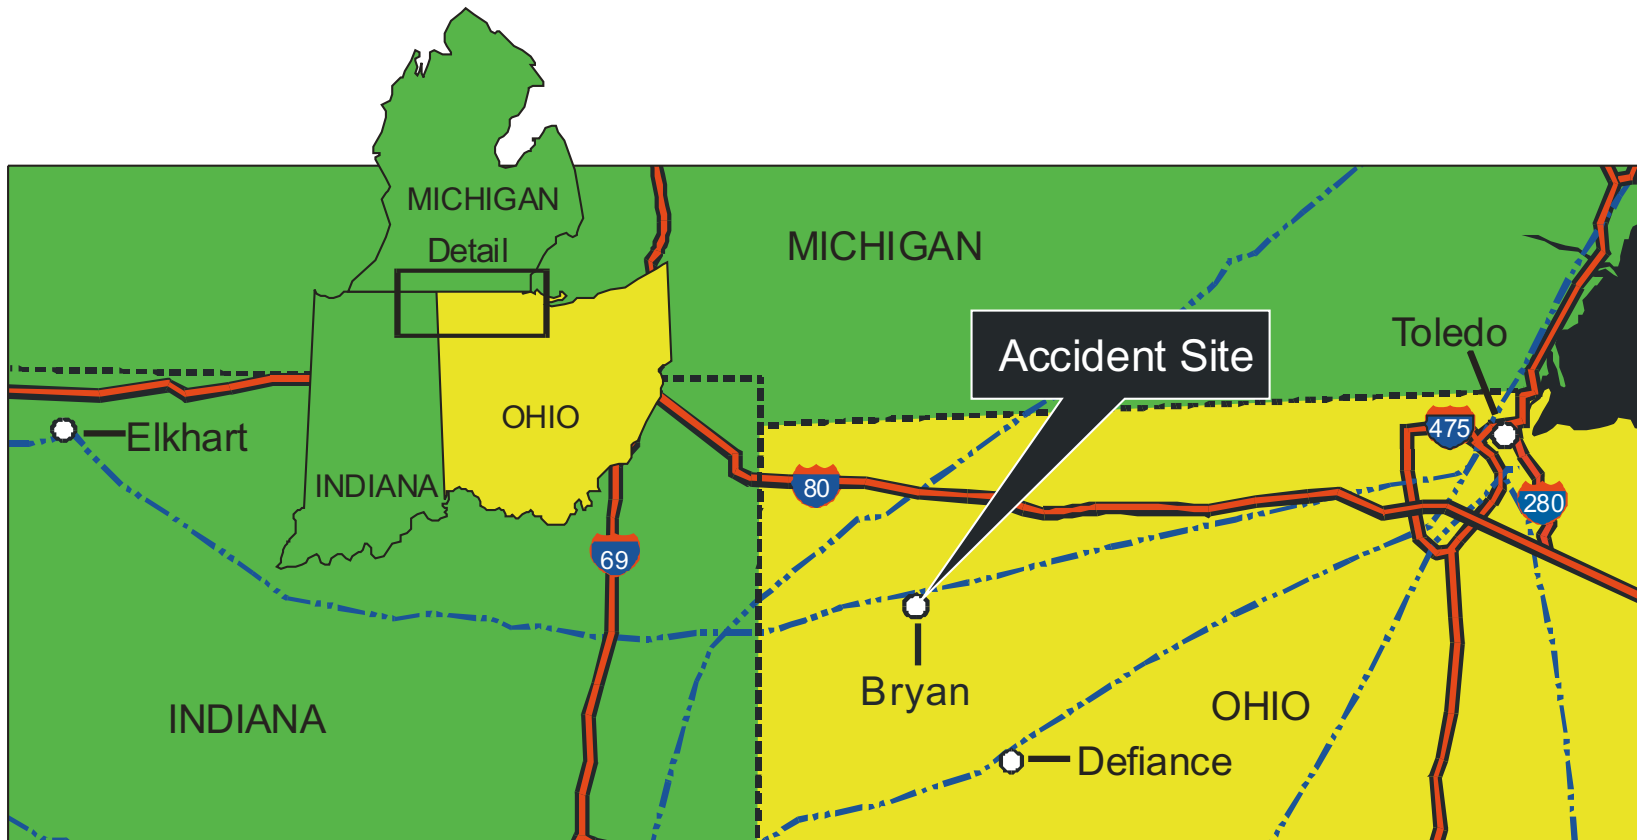
**Figure 1.** The collisions occurred about 65 miles west of Toledo, near Bryan, Ohio. On the night of the accident, a weather warning advised of “patchy dense fog” for southern Michigan, northern Indiana, and northwest Ohio. Visibility estimates ranged from zero to less than 1/4 mile.

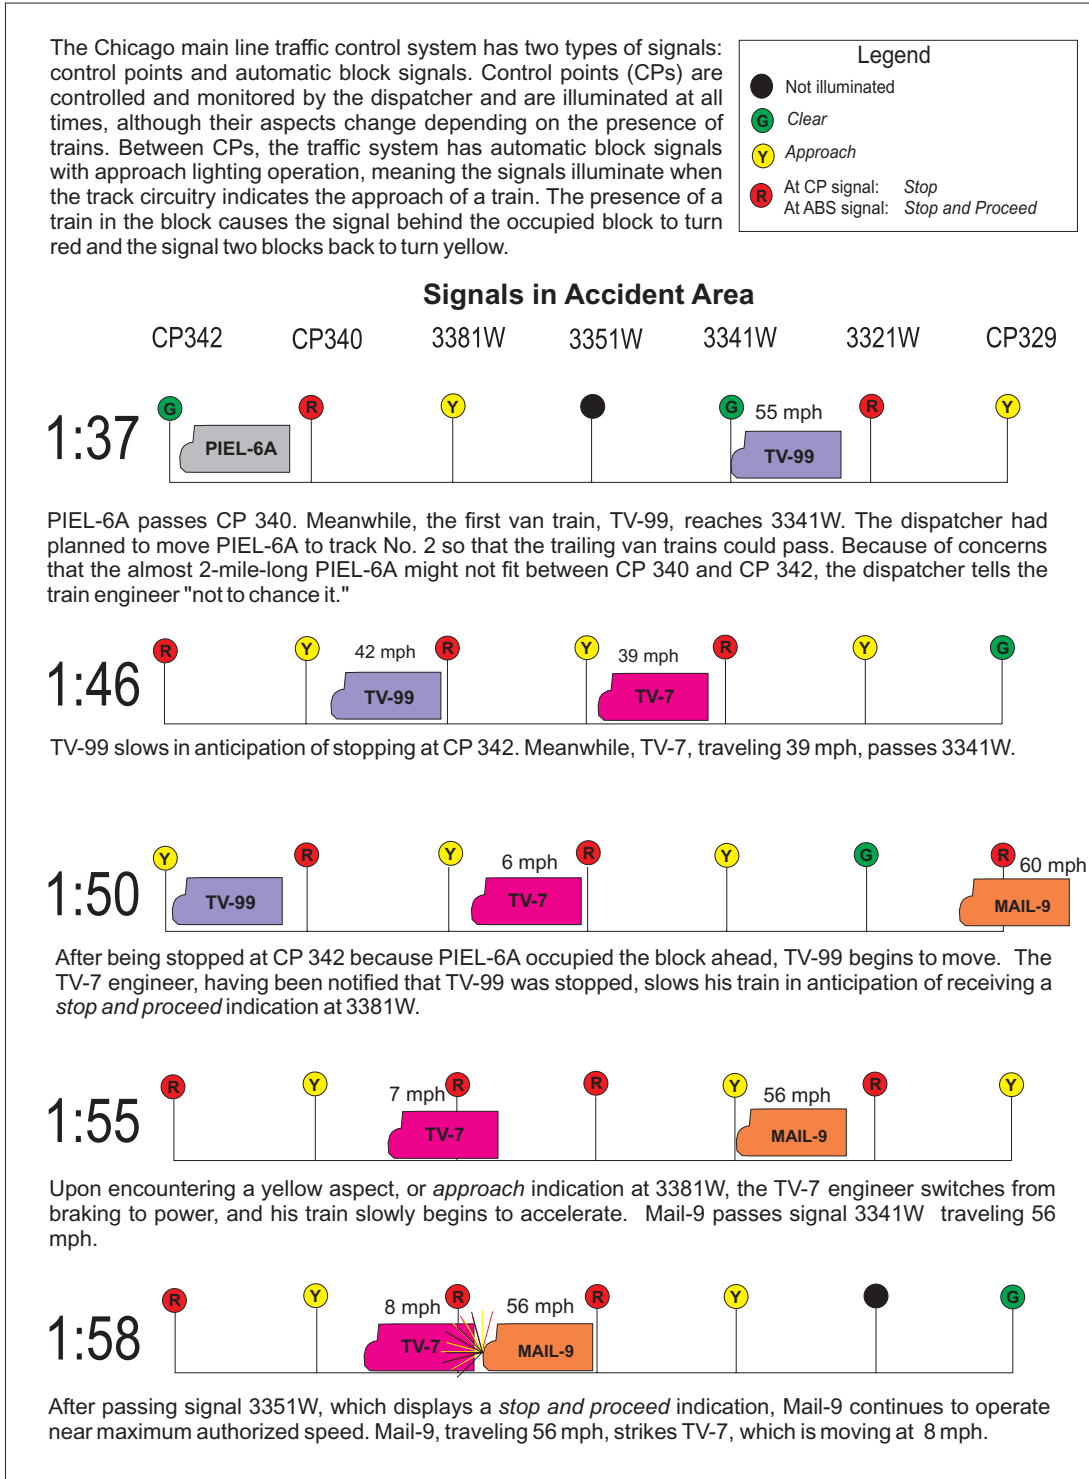
The operators of the first two van trains, TV-99 and TV-7, each said that when they approached signal 3341W, it was displaying a *clear* indication (green aspect). Northeast Operating Rules Advisory Committee (NORAC) operating rule No. 281 states that upon encountering a *clear* indication, the train operator should “proceed not exceeding Normal [authorized] Speed.” (See figure 3.)

**Figure 3.** Progress of the trains during the 21 minutes before the accident. Clock times are at the left of the track layout.
