Collision of Burlington Northern Santa Fe Freight Train With Metrolink Passenger Train Placentia, California April 23, 2002

Railroad Accident Report **NTSB/RAR-03/04**

**NTSB/RAR-03/04
PB2003-916304
Notation 7590
Adopted October 7, 2003**

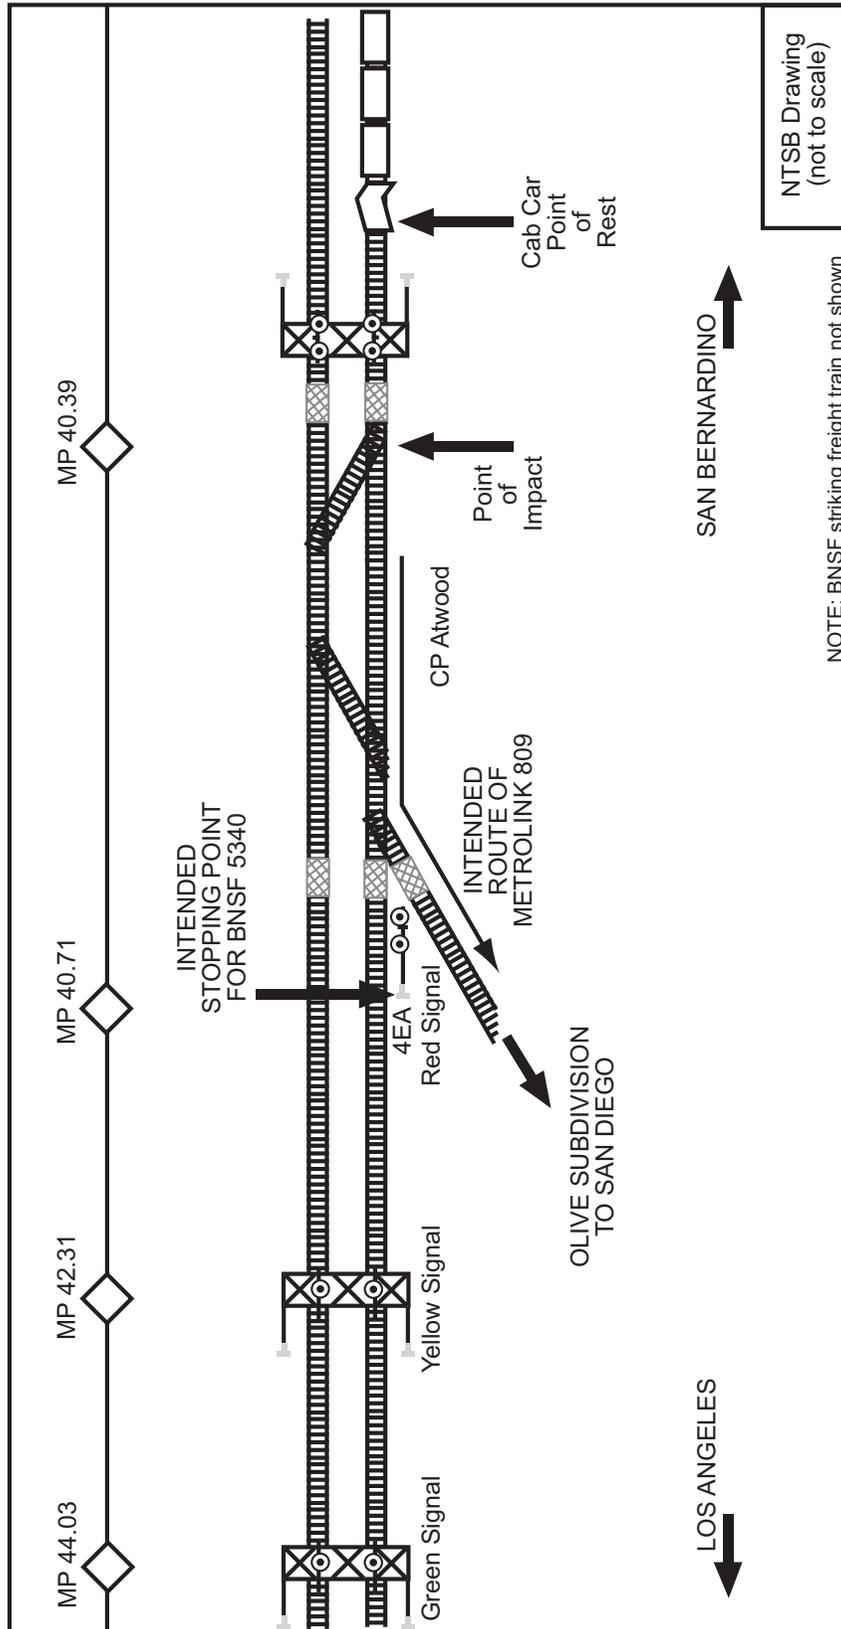
Figure 2. Signal System Layout

Both BNSF 5309 crewmembers said that just before the train reached CP Atwood, they realized that signal 4EA (MP 40.71) was showing *stop*.⁸ The train was traveling about 49 mph at the time. (See figure 2.) They said they noticed Metrolink train 809 on the same track heading toward them, and the engineer placed the train brakes in emergency. The Metrolink 809 engineer said he was slowing the train preparing to go through a switch at 25 mph when he saw the freight train coming toward his train on the same track. He also placed his train in emergency, left the control compartment, and ran back through the lower level of the car warning passengers to brace themselves.

⁸ The *approach* signal at MP 42.31 was intended to prepare the freight train crew to stop short of the *stop* signal at CP Atwood.

As the freight train slowed, the conductor jumped clear of the locomotive at approximately 25 to 30 mph. Soon after, the engineer also jumped clear. The train was traveling about 23 mph when it collided head on with the standing Metrolink train about 1,630 feet past signal 4EA.
