Derailment of Chicago Transit Authority
Train Number 220 Between Clark/Lake
and Grand/Milwaukee Stations
Chicago, Illinois
July 11, 2006

ACCIDENT REPORT

NTSB/RAR-07/02
PB2007-916302

Railroad Accident Report

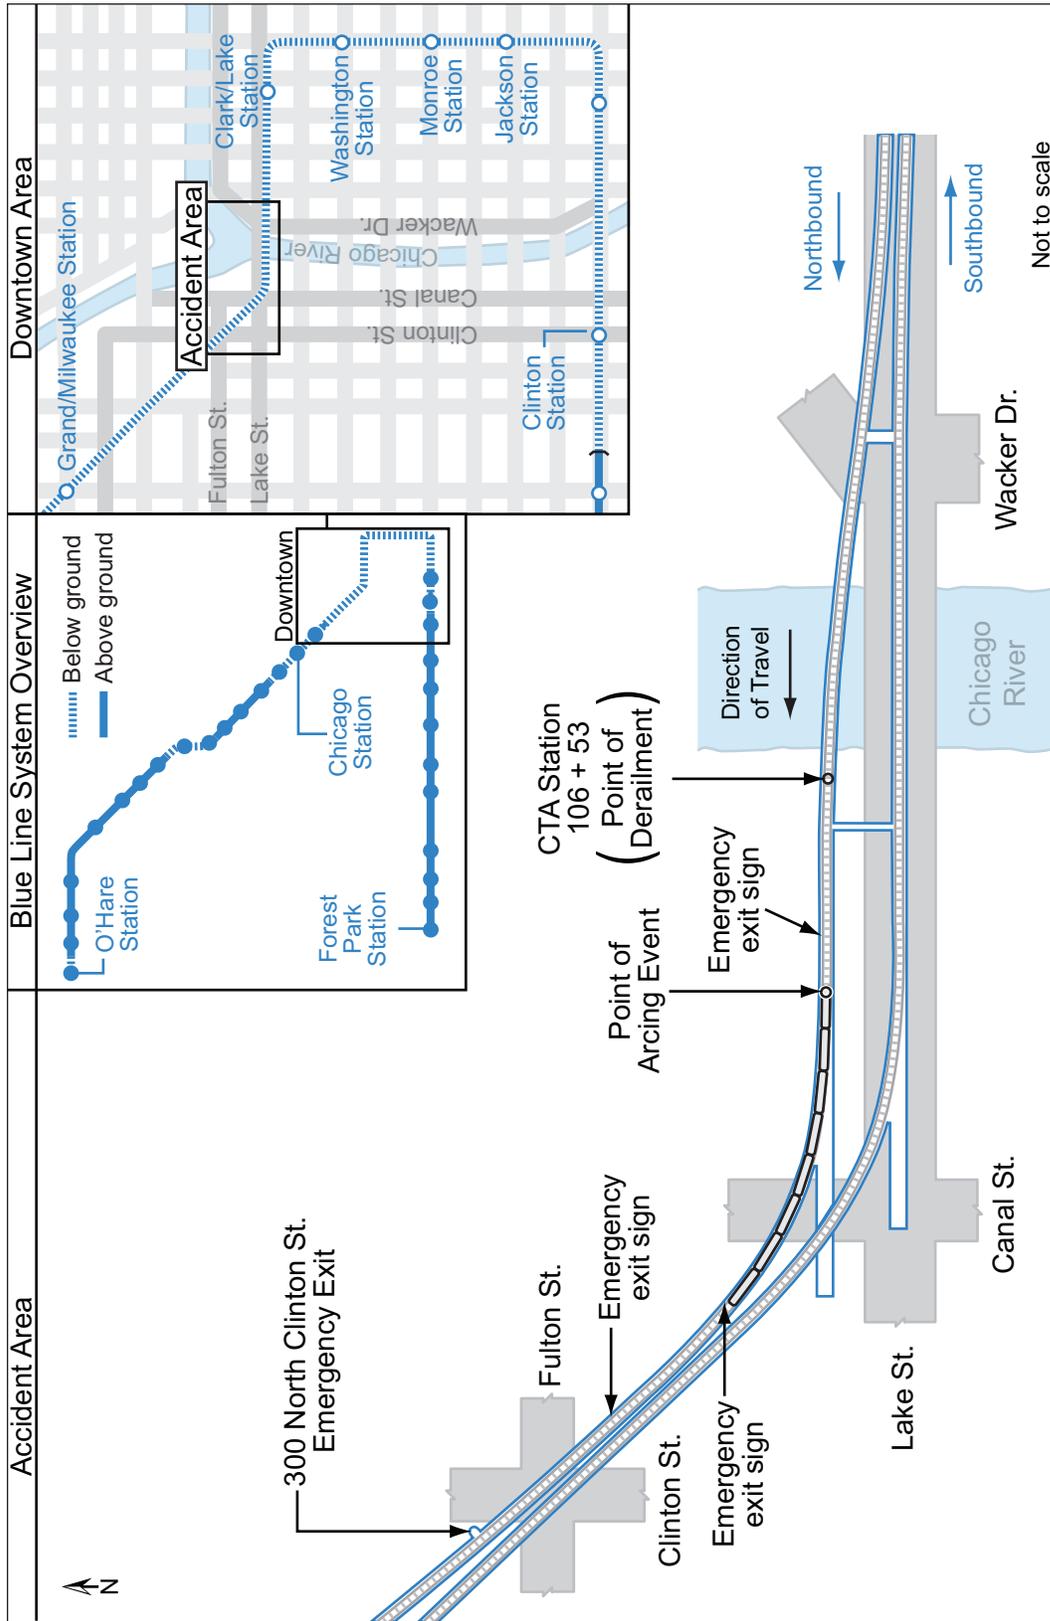
Figure 1. Accident location.

The derailment occurred in the Dearborn Subway section of the CTA system on the northbound track between the Clark/Lake and Grand/Milwaukee stations in downtown Chicago, Illinois. Postaccident investigation revealed that only the last car of the eight-car train had derailed. The point of derailment⁵ was located at station 106+53 in a slight curve⁶ to the left, which was the approximate location of the rear of the train when the blue light alarm occurred. The train came to a stop in a right-hand curve about 356 feet beyond the point of derailment. (See figure 1.)

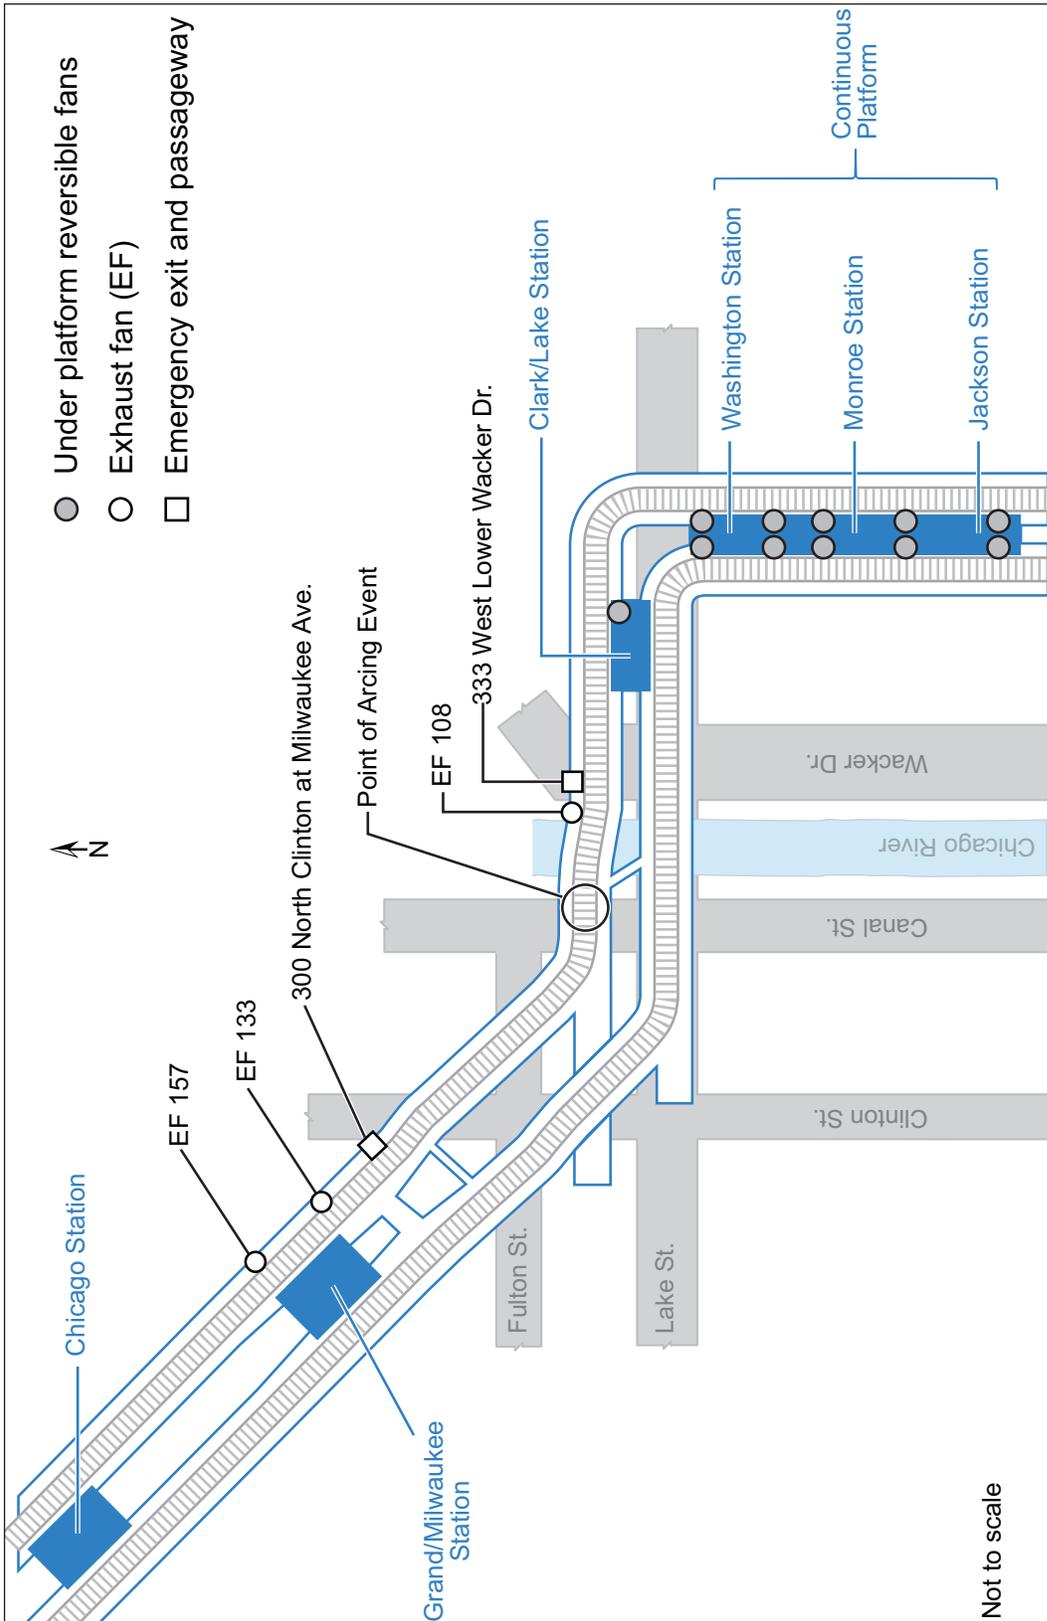
Figure 6. Map of Chicago Transit Authority ventilation system in derailment area.

At least one vent shaft is located midway between stations along each tunnel. (See figure 6 for the location of the accident in relation to the various fans and stations cited.) The station platform at the Clark/Lake station is equipped

The power controller stopped the exhaust operation of the Clark/Lake under-platform fan and then immediately turned this fan on the high setting in the supply mode. At 5:52 p.m., the power controller stopped the exhaust operation of the under-platform fans for the Washington, Monroe, and Jackson stations' continuous platform. At 5:56 p.m., the power controller turned these fans back on the high setting in the supply mode. The Clark/Lake platform was cleared of smoke by 6:00 p.m.
