Collision of BNSF Coal Train With the Rear End of Standing
BNSF Maintenance-of-Way Equipment Train
Red Oak, Iowa
April 17, 2011

Accident Report

NTSB/RAR-12/02
PB2012-916302

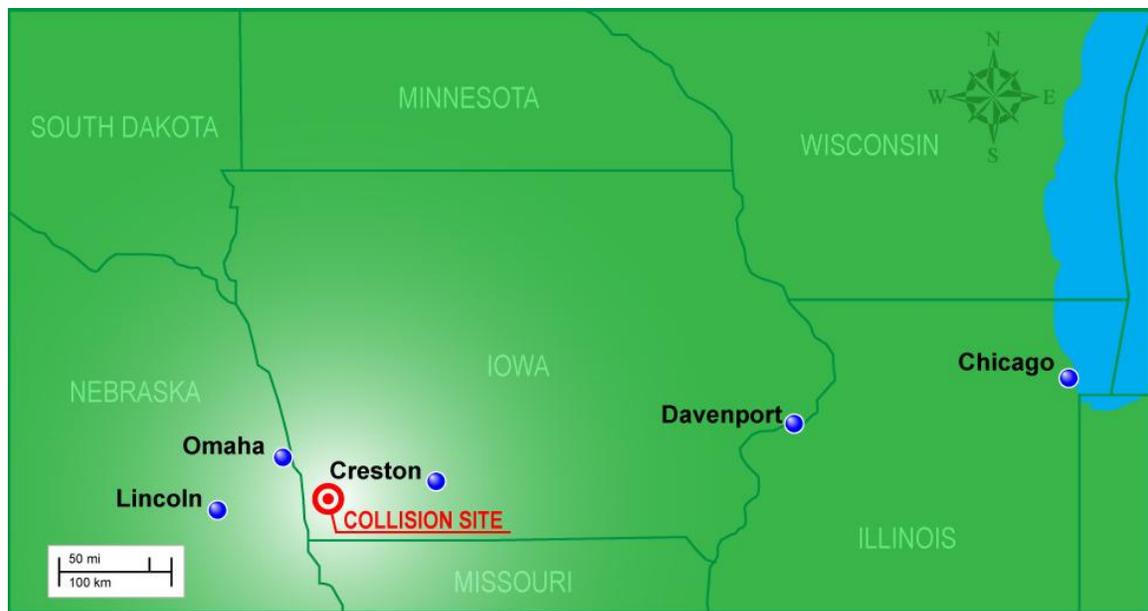
Figure 1. Accident location.

On April 17, 2011, about 6:55¹ a.m. central daylight time, eastbound BNSF Railway² (BNSF) coal train C-BTMCNM0-26, BNSF 9159 East, collided with the rear end of standing BNSF maintenance-of-way (MOW) equipment train U-BRGCRI-15, BNSF 9470 East, near Red Oak, Iowa. (See figure 1.) The accident occurred on a curve near milepost (MP) 448.3 on main track number two (track two) on the Creston Subdivision of the BNSF Nebraska Division. The striking coal train was travelling about 23 mph when it struck the standing MOW equipment train.

As a result of the collision, the two lead locomotives of the striking train derailed along with the first two coal cars. The modular crew cab on the lead locomotive of the striking train was detached, partially crushed, and involved in a subsequent diesel fuel fire. Seven additional coal cars were also damaged but did not derail. The 10 rear cars of the struck train derailed. Both the engineer and the conductor on the striking train were fatally injured in the collision. The crew on the locomotive of the struck train reported non-life-threatening injuries. Damages were estimated at more than \$8.7 million. The

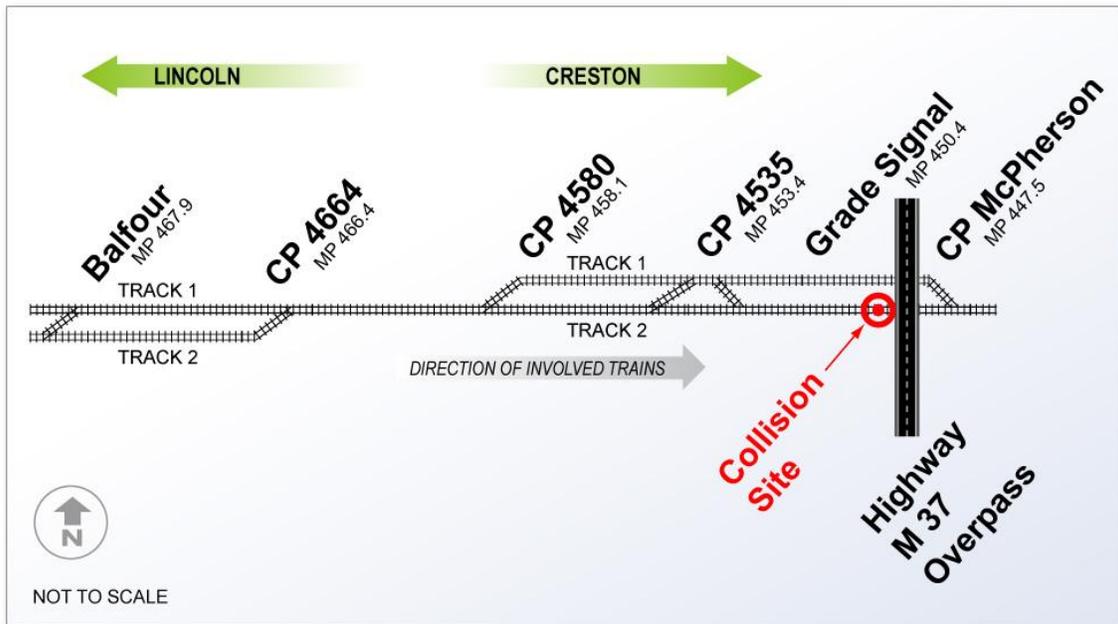
Figure 2. Track map of accident area.

At railroad control point³ (CP) 4580, the MOW equipment train entered track two behind two eastbound coal trains, neither of which was involved in this collision. The MOW equipment train stopped at a red stop signal⁴ at CP 4535 (MP 453.5) because two coal trains were ahead on track two and the first had stopped at the end of the multiple tracks at CP McPherson (MP 447.5). (The milepost numbers were decreasing in an eastward direction). (See figure 2.)

The first uninvolved coal train received a proceed signal and entered the single track east of CP McPherson. The second uninvolved coal train then moved eastward on track two and stopped at CP McPherson. The MOW equipment train followed, having received a yellow approach signal at CP 4535. The MOW equipment train then encountered a red (restricting) “grade signal”⁵ at MP 450.38 and continued at restricted speed⁶ until stopping about 300 feet behind the second uninvolved coal train.

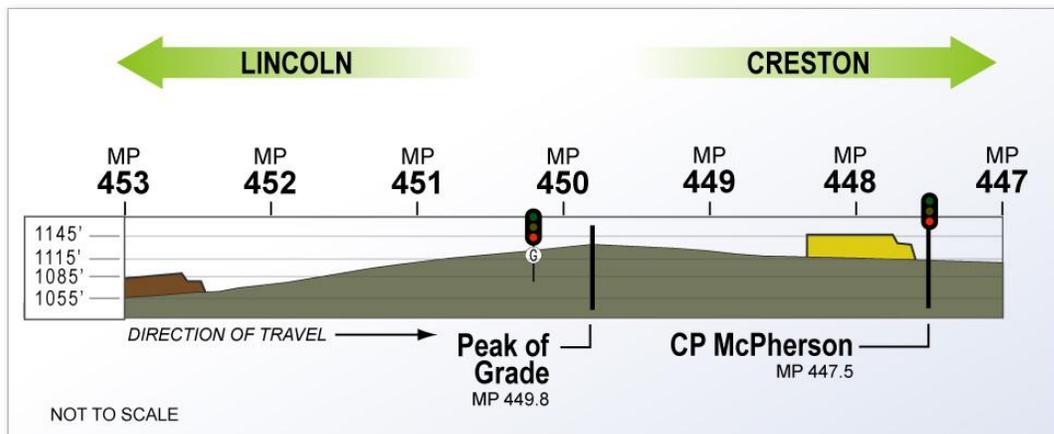
Figure 3. Track profile between MP 453 and MP 447.

Based on event recorder data and dispatcher records, the striking coal train's trip was without incident before it reached the crest of the grade about 2 miles before the collision. Figure 3 shows 6 miles of the track profile in the area of the collision and includes the positions of the signals, the peak of the grade, and the two trains involved in this accident about 15 minutes before the collision.

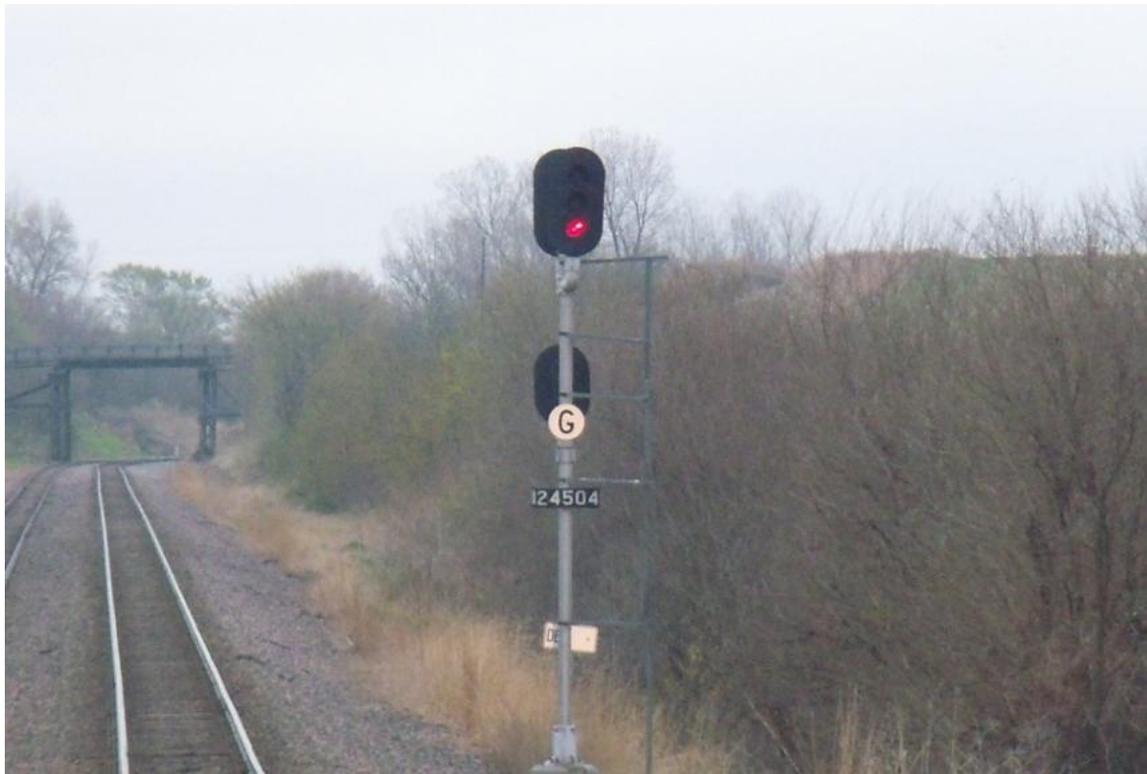
Figure 13. Eastbound intermediate grade signal 24504 with G Plate.

Intermediate signals are located on both main tracks at MP 450.38 about midway between the crossovers at CP 4535 (MP 453.4) and CP McPherson (MP 447.5). The last signal the striking coal train passed before the accident was intermediate signal 24504.¹⁷ This consisted of a three-position color-light display with a G plate¹⁸ and a number plate attached to the signal mast. (See figure 13.) Signal system data indicated that this signal was displaying a red (restricting) aspect. There were no slow orders, track bulletins, or other advisories in effect between the grade signal and the point of collision.

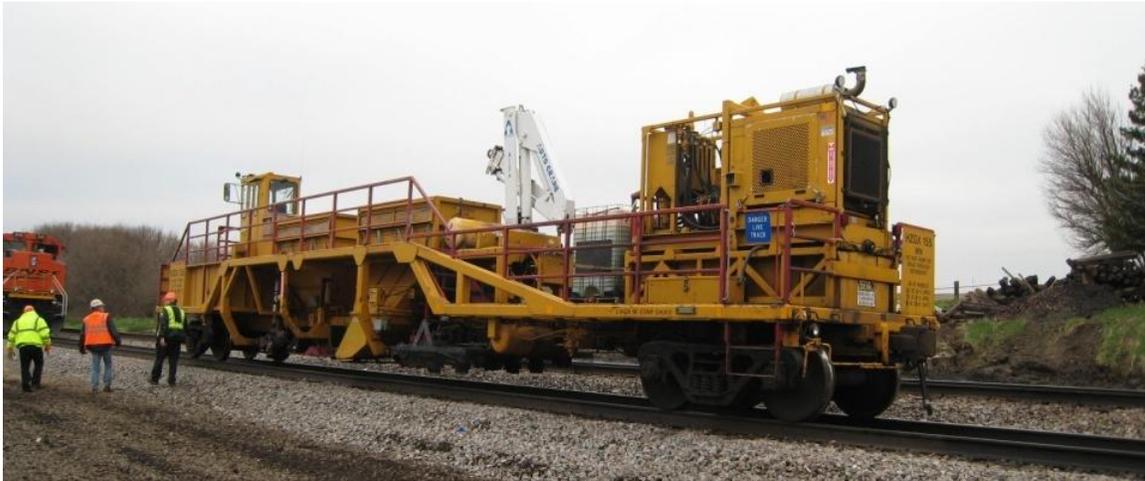
Figure 16. Exemplar HZGX clip car.

The last car of the struck train, the 34th car, was the HZGX-150, a clip car. (See figure 16.) This was the first car struck by locomotive BNSF 9159 in the collision. It is a diesel-engine-powered self-propelled unit that can be coupled into a train for transport. It has a 300-gallon fuel tank. This car was manufactured by Herzog Railroad Services, Inc.; weighed 177,000 pounds; and was 54 feet long.²³

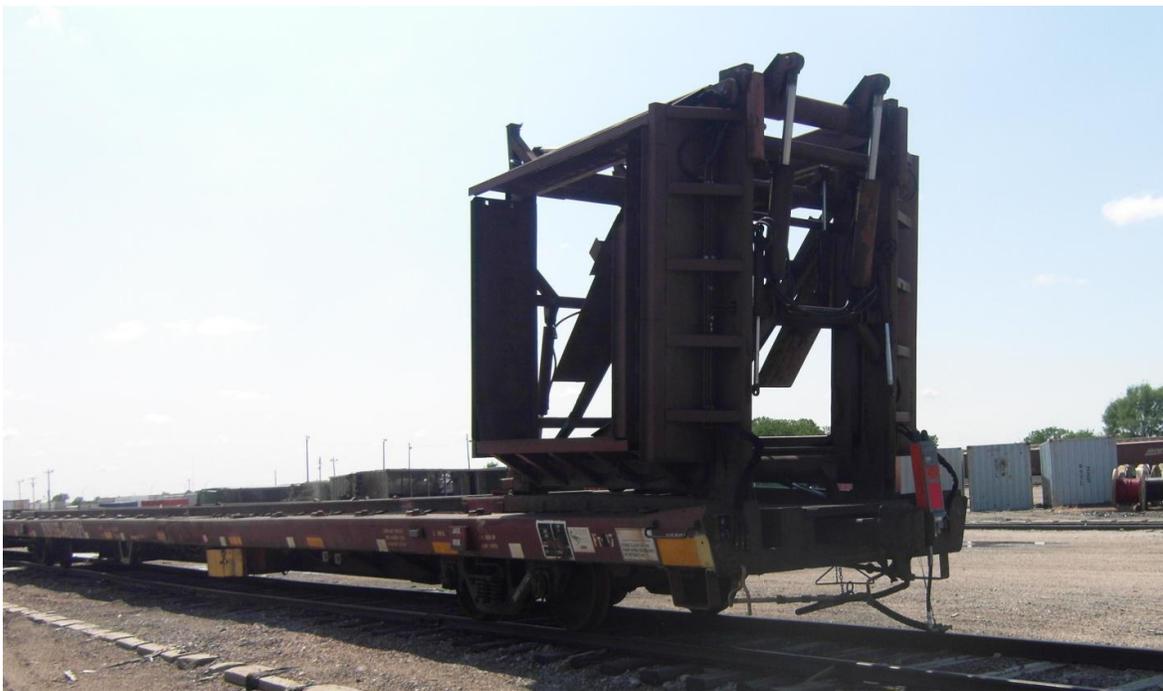
Figure 17. Exemplar scorpion-equipped flatcar.

The second to the last car in the struck train was BNSF 927022. This was a scorpion car: an 89-foot flatcar with a folding loading ramp attached to the end of the car. (See figure 17.) The scorpion ramp was composed of six segments tied together with pin joints and hydraulic rams. The ramp unfolds so that MOW equipment can roll on and off the flatcar. When the ramp is fully open and extended, it is 52 feet 8 inches long. The ramp is powered by a diesel engine and has an 11.5-gallon fuel tank. The hydraulic fluid tank had a 25-gallon capacity. This car weighed 155,400 pounds.

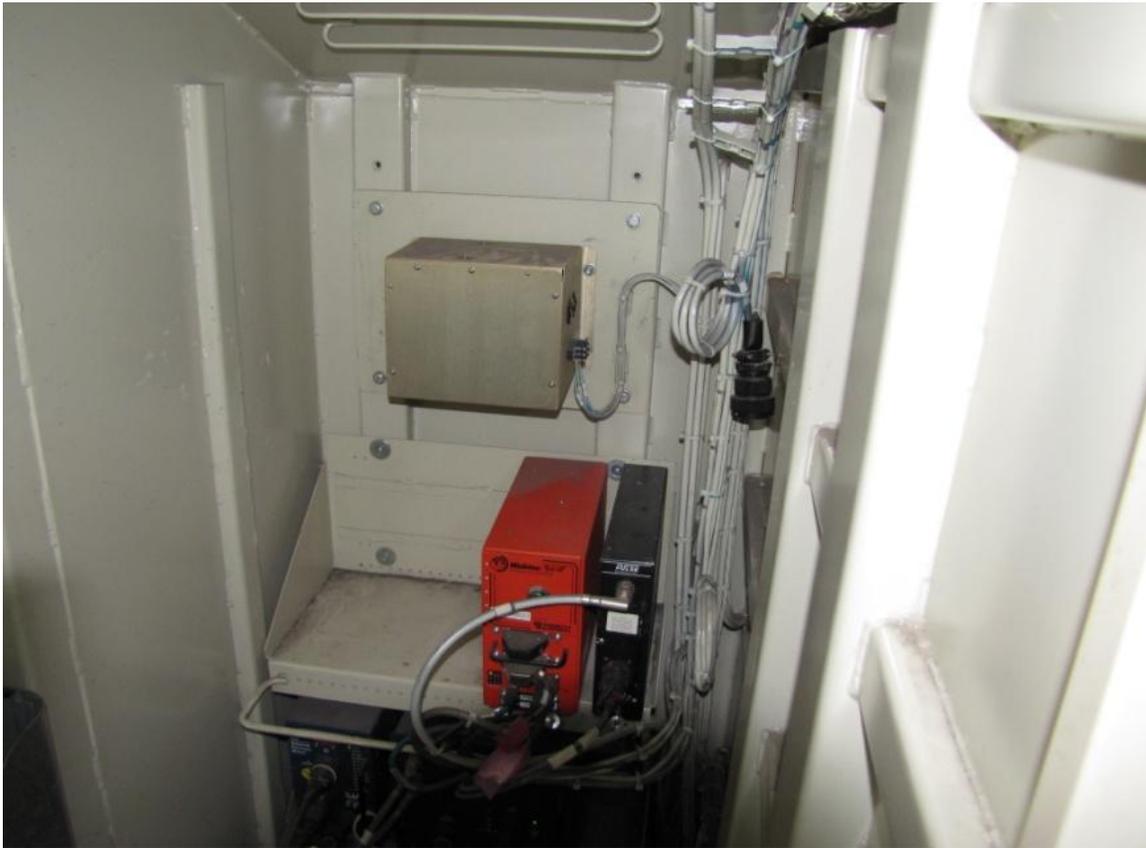
Figure 20. Exemplar video recorder hard drive enclosure (orange case).

Locomotive Cab Video Recorders. The lead locomotive of the striking train, BNSF 9159, had a Wabtec Video Trax model forward-facing video recorder. The recorder hard drive enclosure was located in the wreckage, successfully recovered, and shipped to the NTSB laboratory in Washington, D.C. The enclosure and its contents were in poor condition because of the fire. (See figures 20 and 21.) Video data is stored on a hard drive within the enclosure. The hard drive was removed and transported to a vendor specializing in hard drive data recovery. After an examination and attempts to repair the damaged hard drive, it was determined that the hard drive was damaged beyond repair and its contents were unrecoverable. Forward-facing video recorders are not required by regulation.
