Collision of Two Canadian National Railway Freight Trains near Two Harbors, Minnesota September 30, 2010

Accident Summary Report

NTSB/RAR-13/01/SUM
PB2013-104865

Railroad Accident Report

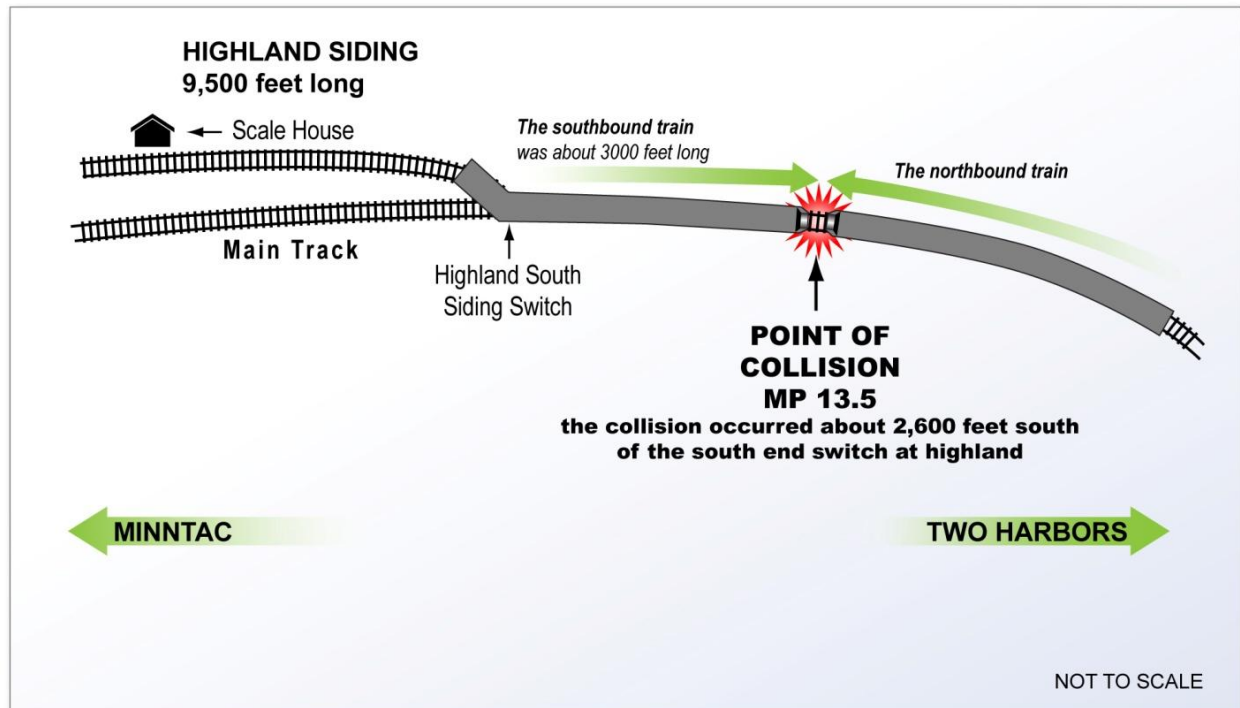
Figure 3. This map depicts the point of collision.

The student engineer told National Transportation Safety Board (NTSB) investigators that when he had completed weighing the southbound train, the locomotive engineer instructed him to depart the Highland siding while making no mention of the after-arrival requirement contained in the track authority. The southbound train departed the Highland siding and entered the single main track at the Highland south siding switch without waiting for the arrival of the northbound train. Meanwhile, the northbound train crew had already received a track authority authorizing them to proceed at the maximum track speed of 40 mph past the Highland south siding switch on the main track. The southbound engineer said that he first saw the oncoming northbound train as it rounded a curve and that he told the student to apply the emergency brakes. Figure 3 shows the Highland siding and the point of collision.

observations conducted after the accident indicated that the crews of the two trains would have first been able to see the other train when they were about 1,295 feet apart.
