Chicago Transit Authority Train Collides with Bumping Post
and Escalator at O'Hare Station
Chicago, Illinois
March 24, 2014

NTSB/RAR-15-01
PB2015-103738

Railroad Accident Report

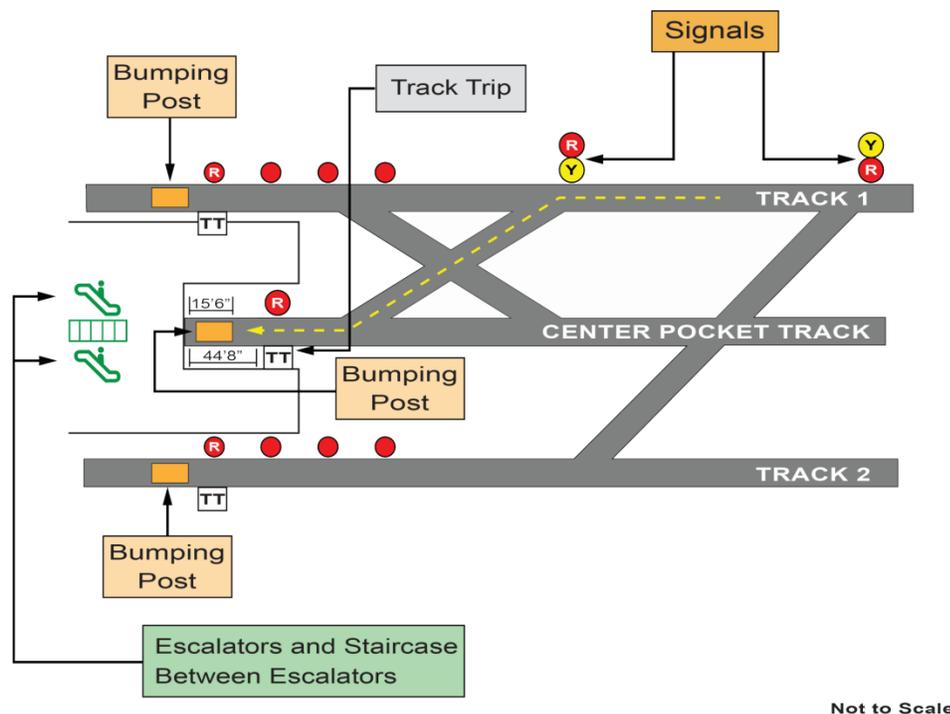
Train No. 141 continued to travel into the station. Two other trains were already occupying track 1 and track 2, the two outside tracks. Train No. 141 was diverted from track 1 to the center pocket track through the interlocking switches. The aspects of the block signals indicated the tracks had been lined for train No. 141 to travel and berth into the center pocket track. The train traveled through the station with no braking or manipulations of the master controller.⁴ (See figure 2.)

Figure 2. O'Hare Station.

A permanently positioned track trip was installed 29 feet 2 inches from the bumping post and about 44 feet 8 inches south of the end of the center pocket track.⁵ The track trip was bolted
