RAILROAD ACCIDENT REPORT

PENN CENTRAL COMPANY
COLLISION OF TRAINS
N-48 AND N-49 AT
DARIEN, CONNECTICUT
AUGUST 20, 1969

REPORT NUMBER: NTSB-RAR-70-3

ADOPTED: OCTOBER 14, 1970

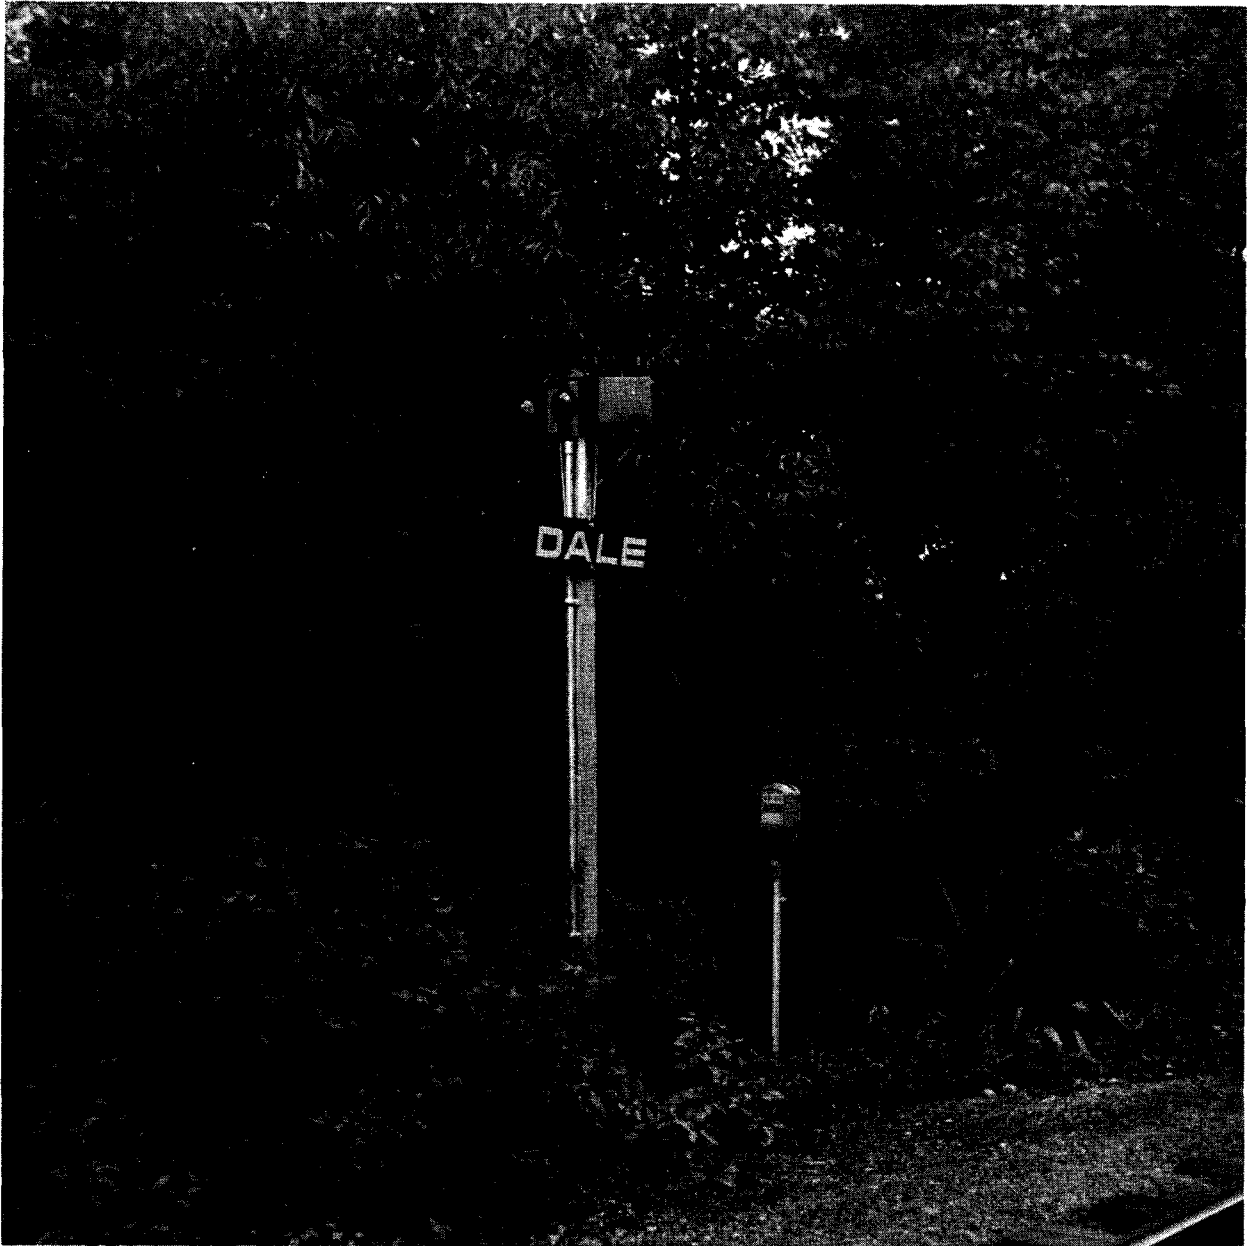
Figure No. 1

At Dale siding, there is a similar block-limit signal with "Dale" mounted below the lights. (See Figure 1, page 5.) This signal is located along the north side of the track, 299 feet east of the west switch of the siding. Dale block-limit station was opened by timetable instructions from 6:55 a.m. to 8:25 a.m. and from 6:10 p.m. to 7:25 p.m., daily except Saturday, Sunday, and holidays for regular meets between opposing trains. Dale block-limit station was opened as needed at other times by train order. Since the accident, rules regarding the time of the open block-limit station have been changed. When Dale block-limit station was opened, the New Canaan Branch was divided into two manual blocks, and a train was not permitted to pass the block-limit station without obtaining permission from the operator to occupy the block.

Dale block - limit station

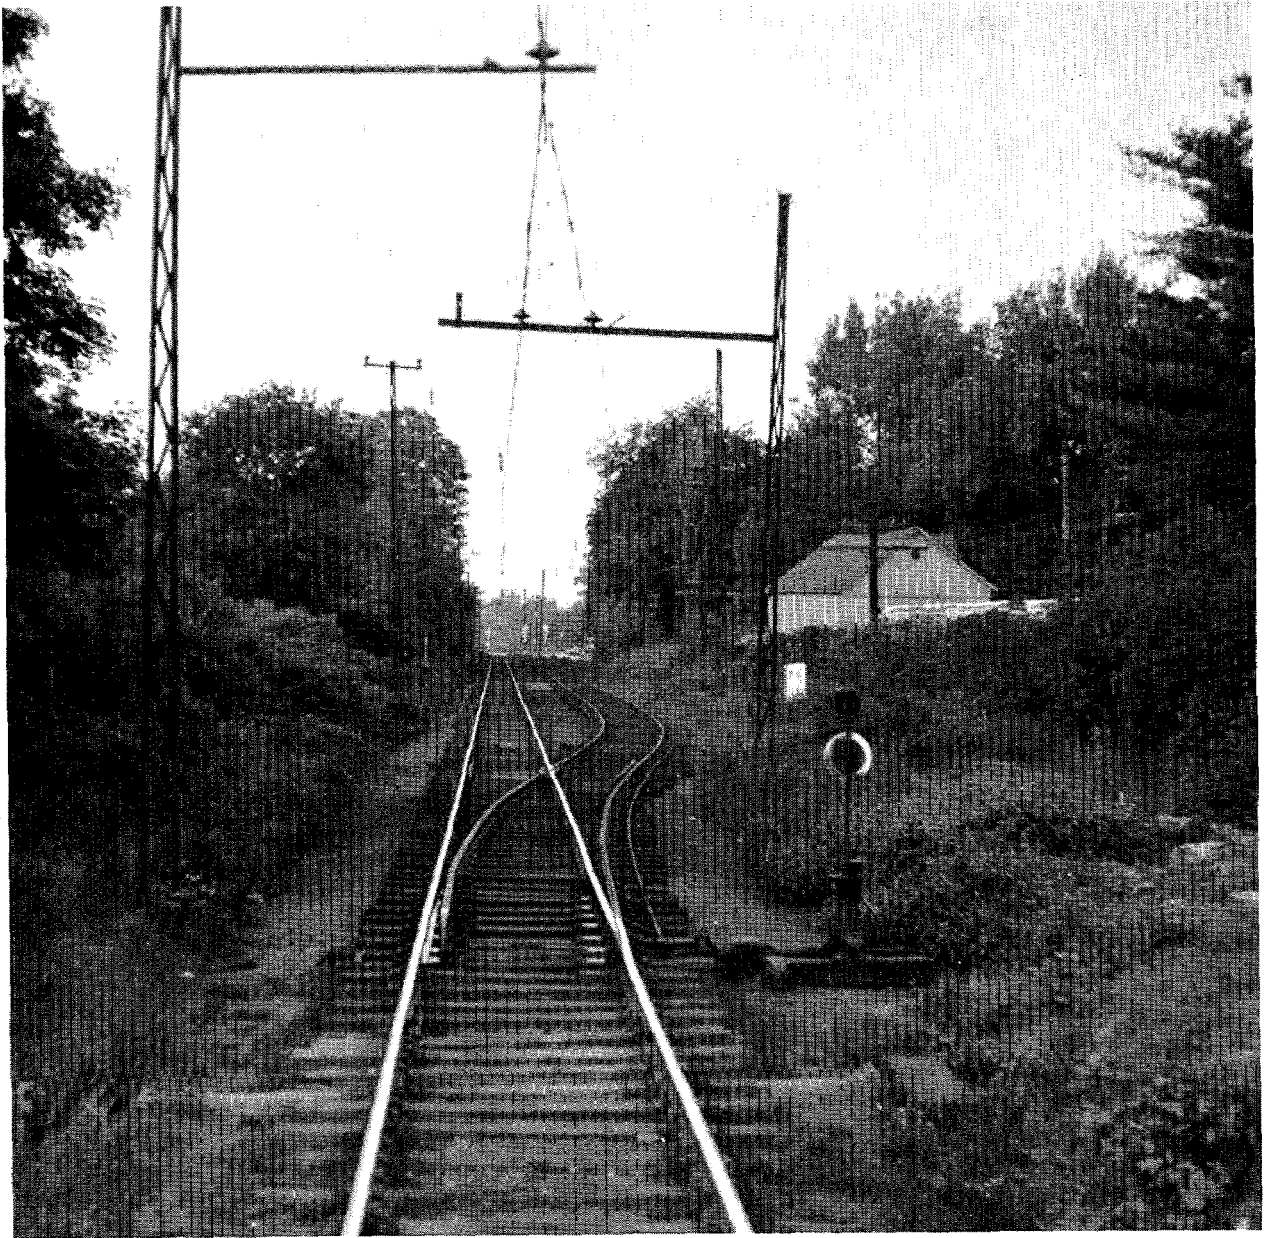
Figure No. 4-2

The only siding on the New Canaan Branch provided for the passing or meeting of trains is located at Dale and is 587 feet in length. The switches at each end are hand operated by high-type switch stands and are not protected by any type of electric locking. The switch stands are provided with targets and reflectors to indicate the position of the switch to trains approaching on the main track. With the switch lined for movement on the main track, a green circle with a white band and a green reflector are displayed to an approaching train. See Figure 4-2. With the switch lined for movement to the siding, a red arrow pointing perpendicular to the track and a red reflector are displayed. See figure 4-3. A derailing device is installed on the siding about 175 feet east of the west switch for the protection of the main track. This device is connected to the switch-operating mechanism so that when the switch is lined for movement on the main track, the device is in derailing position, and when the switch is lined for movement to the siding, the device is clear of the track. The same lever operates both the switch and the derailing device.

West switch of Dale siding
Lined for the Main track

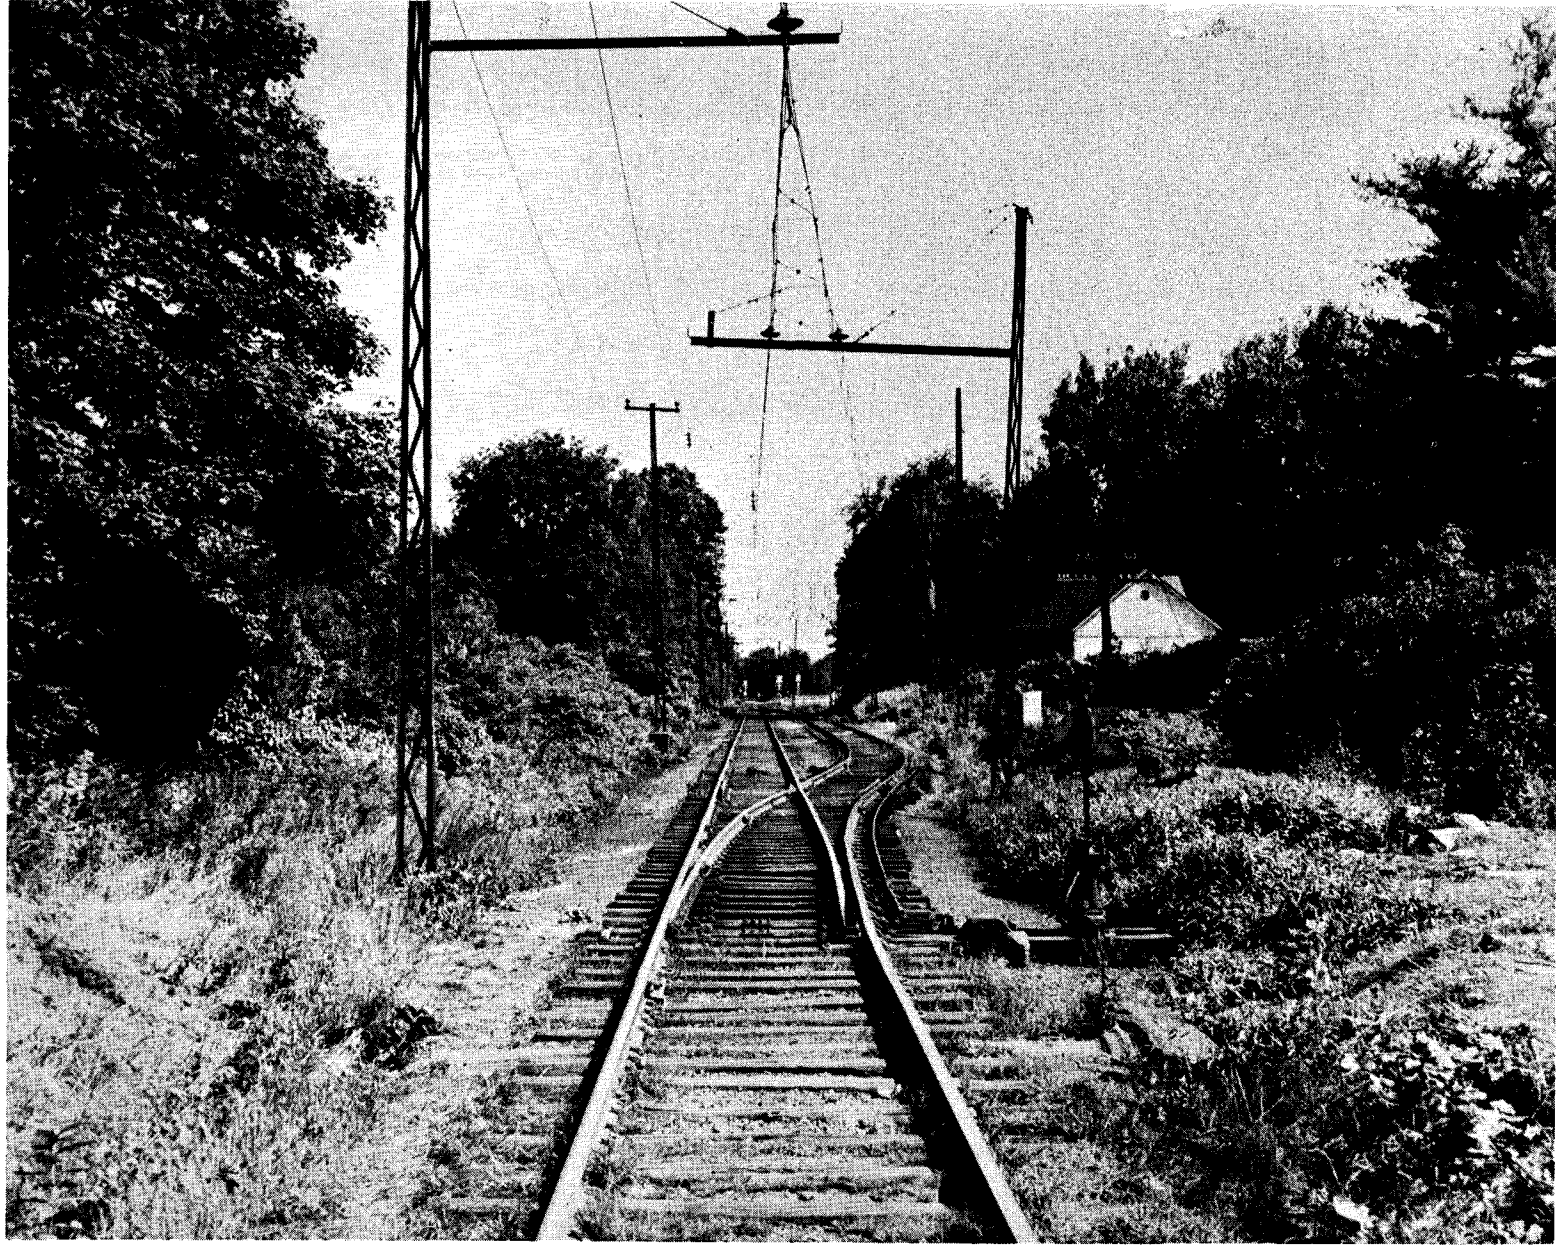
Figure No. 4-3, West switch of Dale siding lined for the siding
