# RAILROAD ACCIDENT REPORT

DERAILMENT OF AMTRAK TRAIN NO. 1  
WHILE OPERATING ON THE  
ILLINOIS CENTRAL RAILROAD NEAR  
SALEM, ILLINOIS

June 10, 1971

REPORT NUMBER. NTSB-RAR-72-5

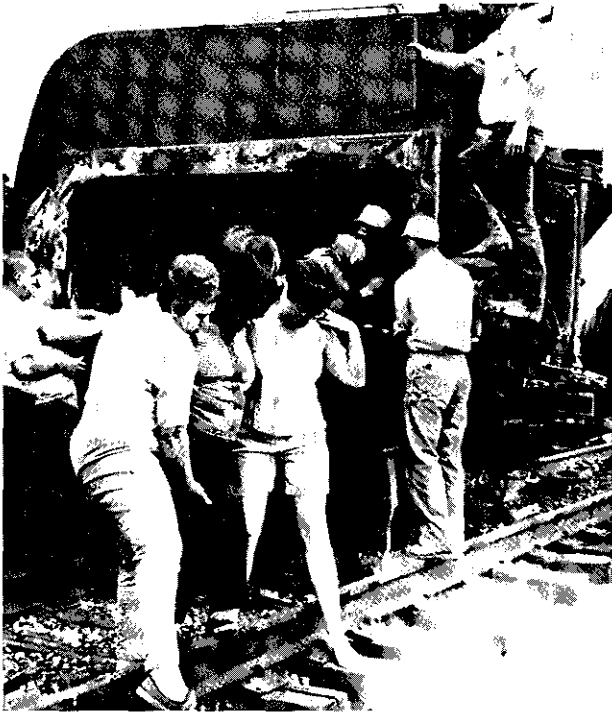
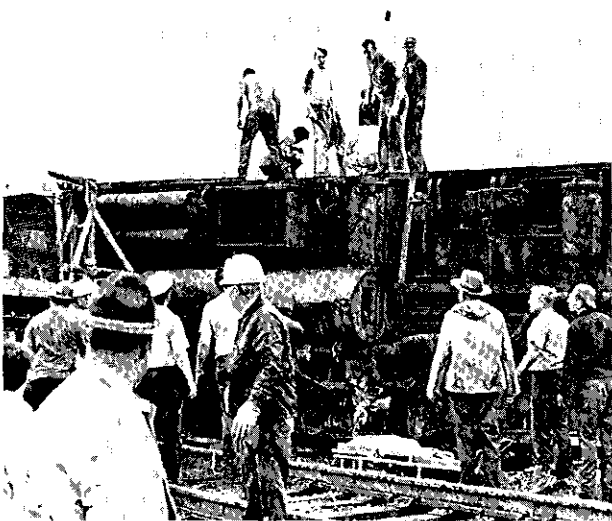
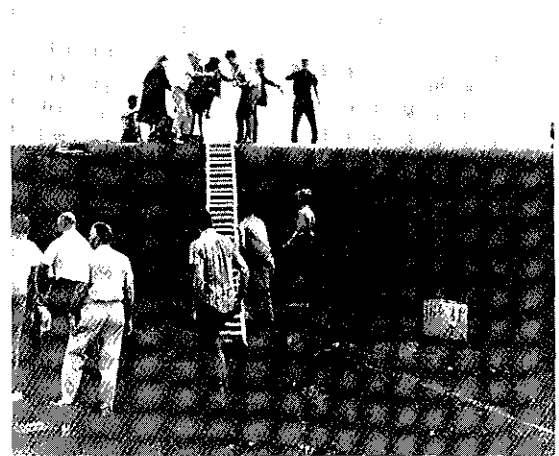
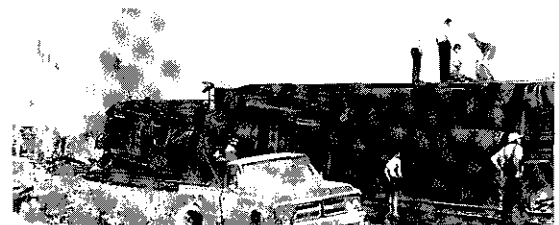
Figure 14

The bending of the roofs downwards caused the metal ceiling to separate, producing sharp edges in three of the overturned cars.<sup>8</sup> (See Figure 13.) The deformation of the superstructure of the cars not only caused injuries but made rescue of the passengers extremely difficult. The passageways at the ends of the cars were either blocked or difficult to use, and with no emergency exits, the passengers had to wait until the rescue personnel could break windows on the top sides and provide ladders for climbing out. (See Figure 14.)

a Injured passengers being helped out the end of the car and down to the ground after having climbed over partitions and through the 2-foot high tunnels over or under the rest rooms

b Some were rescued by being lifted up through windows by means of ropes

d View of rescue workers lowering a ladder through a window they have knocked out to rescue passengers

c Other rescue workers brought ladders to assist passengers to the ground after they climbed up the seats and out the windows
