# RAILROAD ACCIDENT REPORT

COLLISION OF  
ILLINOIS CENTRAL GULF RAILROAD  
COMMUTER TRAINS,  
CHICAGO, ILLINOIS  
OCTOBER 30, 1972

NATIONAL TRANSPORTATION SAFETY BOARD  
Washington, D.C. 20591  
REPORT NUMBER: NTSB-RAR-73-5

ADOPTED: JUNE 28, 1973

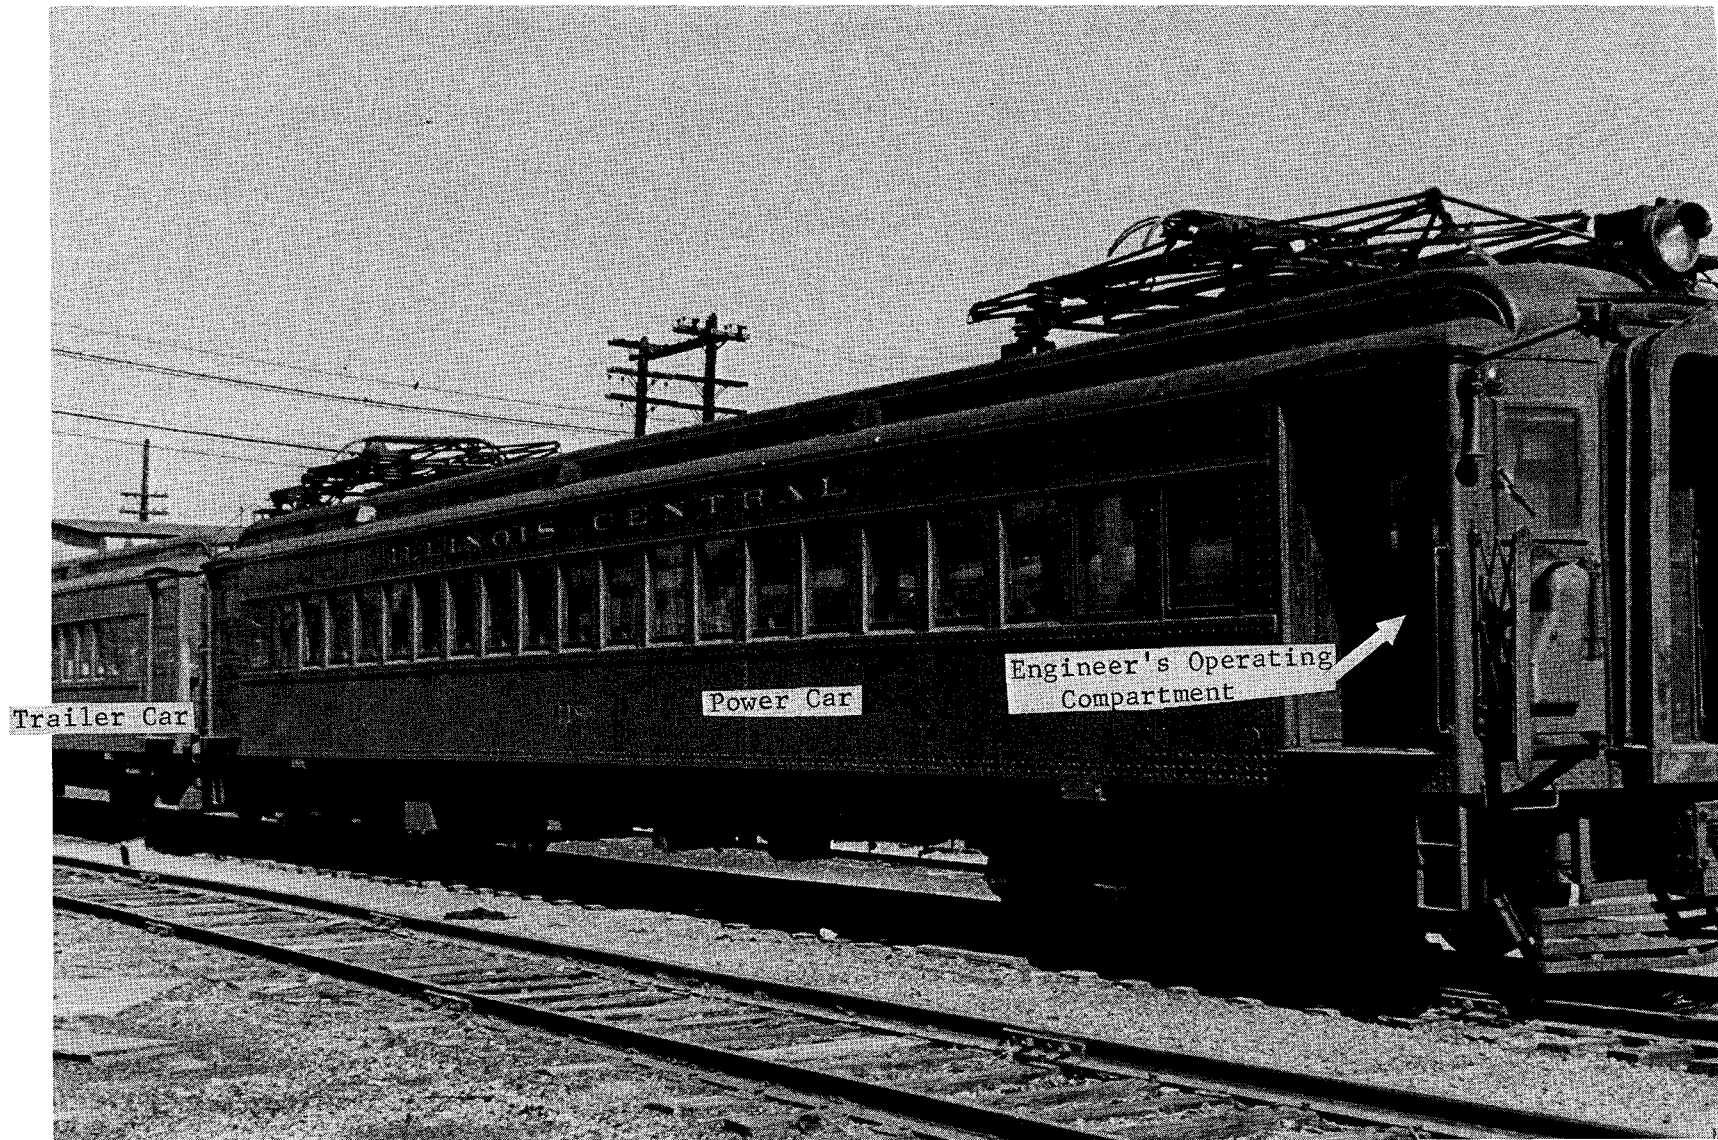
Train 720. The six multiple-unit (MU) cars of train 720 were of steel construction and had been built between 1924 and 1926. The cars operated in pairs, with a motor car and a trailer car forming a semipermanent unit. The first car of 720 was a trailer car. A vestibule with side doors was located at each end of each car. The operating controls, which did not include a speedometer, were in the end vestibules of each pair of cars. (See Figure 3.)

The cars of train 720 were constructed prior to the establishment of Federal regulations for MU equipment and the couplers, the anti-climbing arrangement, and the collision posts did not comply with the requirements in 49 CFR 230.457.

Figure 3. "Old" car, similar to those of train 720.

The first 10 feet of the lead car of train 720 was demolished. The center sills and couplers on several of the other cars of the train were broken, and these cars sustained sufficient damage to prevent prompt return to service.

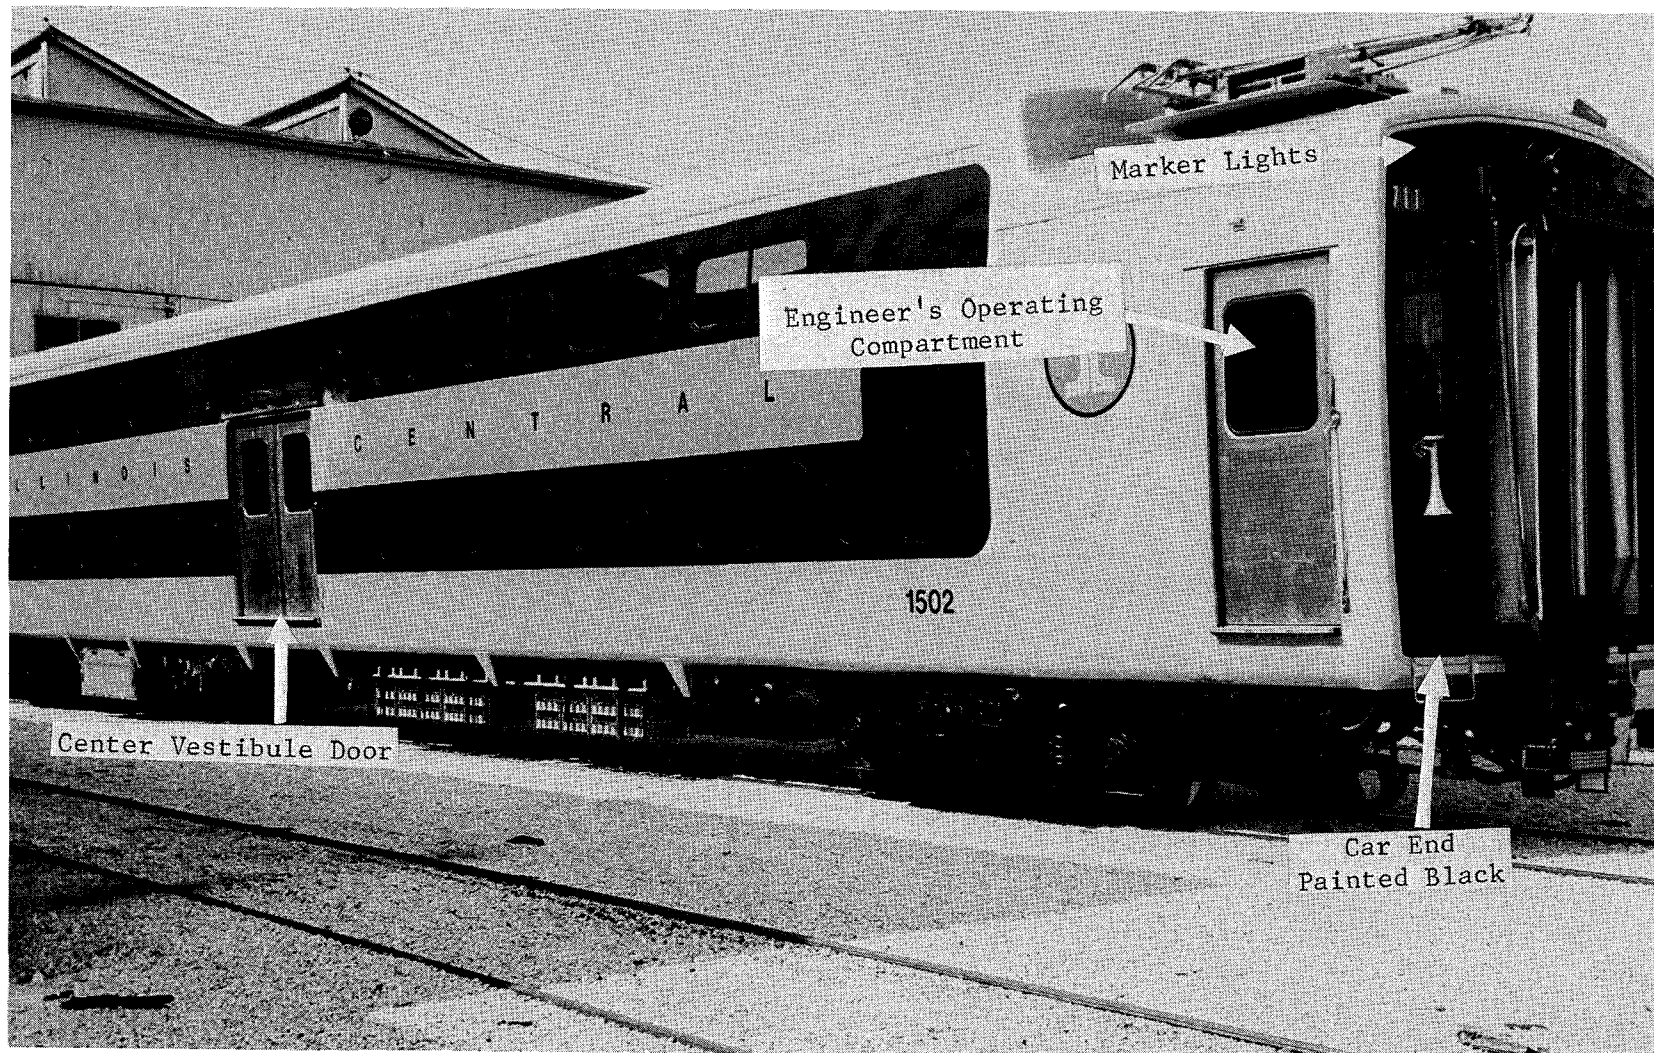
Train 416. The Highliner cars were self-propelled, electric MU cars in which passengers were seated on two levels. Each car was 85 feet long, 15 feet 10 inches high, and 10 feet 6 inches wide, and weighed about 134,000 pounds. (See Figure 4.)

Figure 4. Highliner car, similar to those of train 416.

Train damage. The rear half of the last car of train 416 was demolished. The end of the car and most of the right side were sheared off at floor level. A portion of the left side and several seats on the upper level remained intact. All lower-level seats were destroyed. The underframe of the car was not buckled, and the three other cars of 416 received only minor damage and were returned to service.

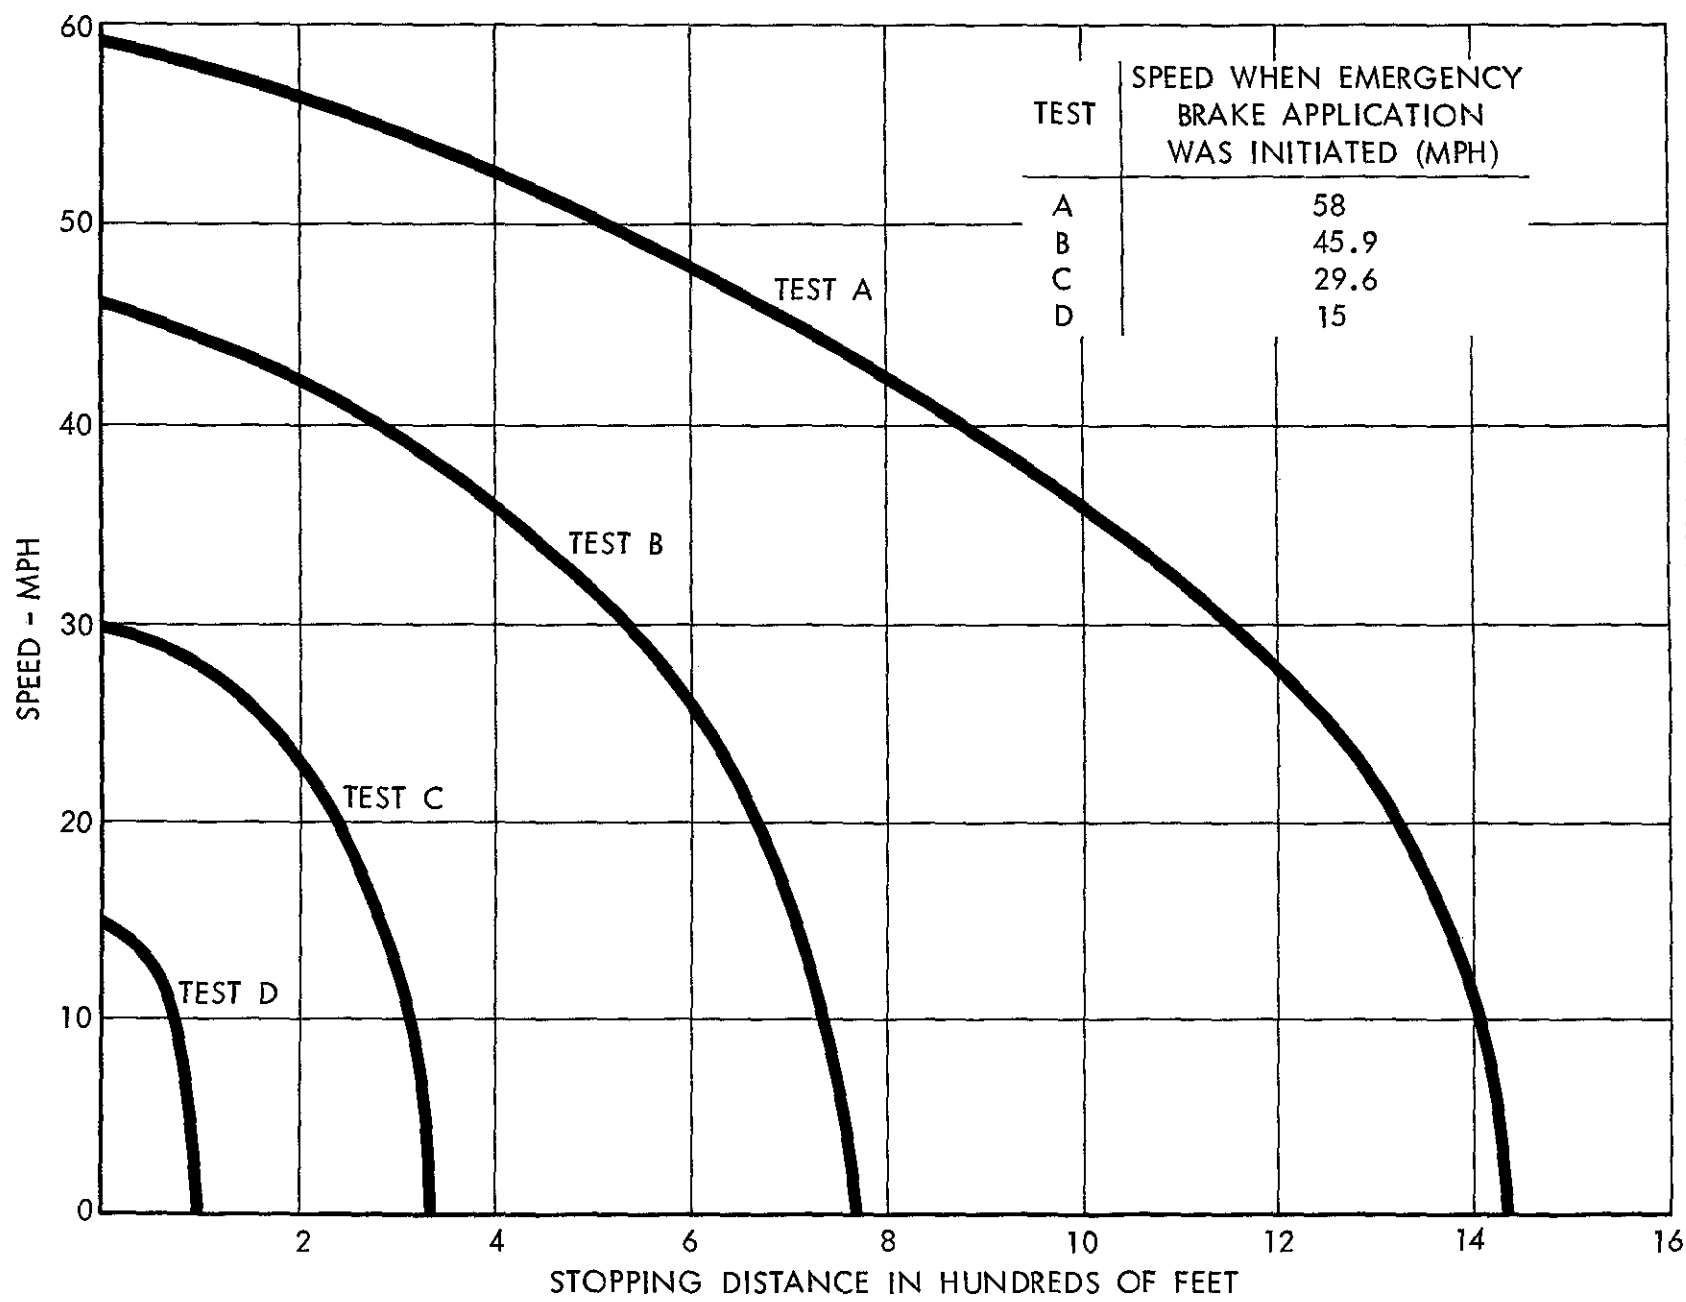
APPENDIX B

STOPPING DISTANCES OF TRAIN 720
