COLLISION OF PENN CENTRAL FREIGHT TRAIN  
OV-8 WITH AN OPEN DRAWBRIDGE  
CLEVELAND, OHIO  
MAY 8, 1974,

REPORT NUMBER: NTSB RAR-75-3.

ADOPTED: MARCH 26, 1975

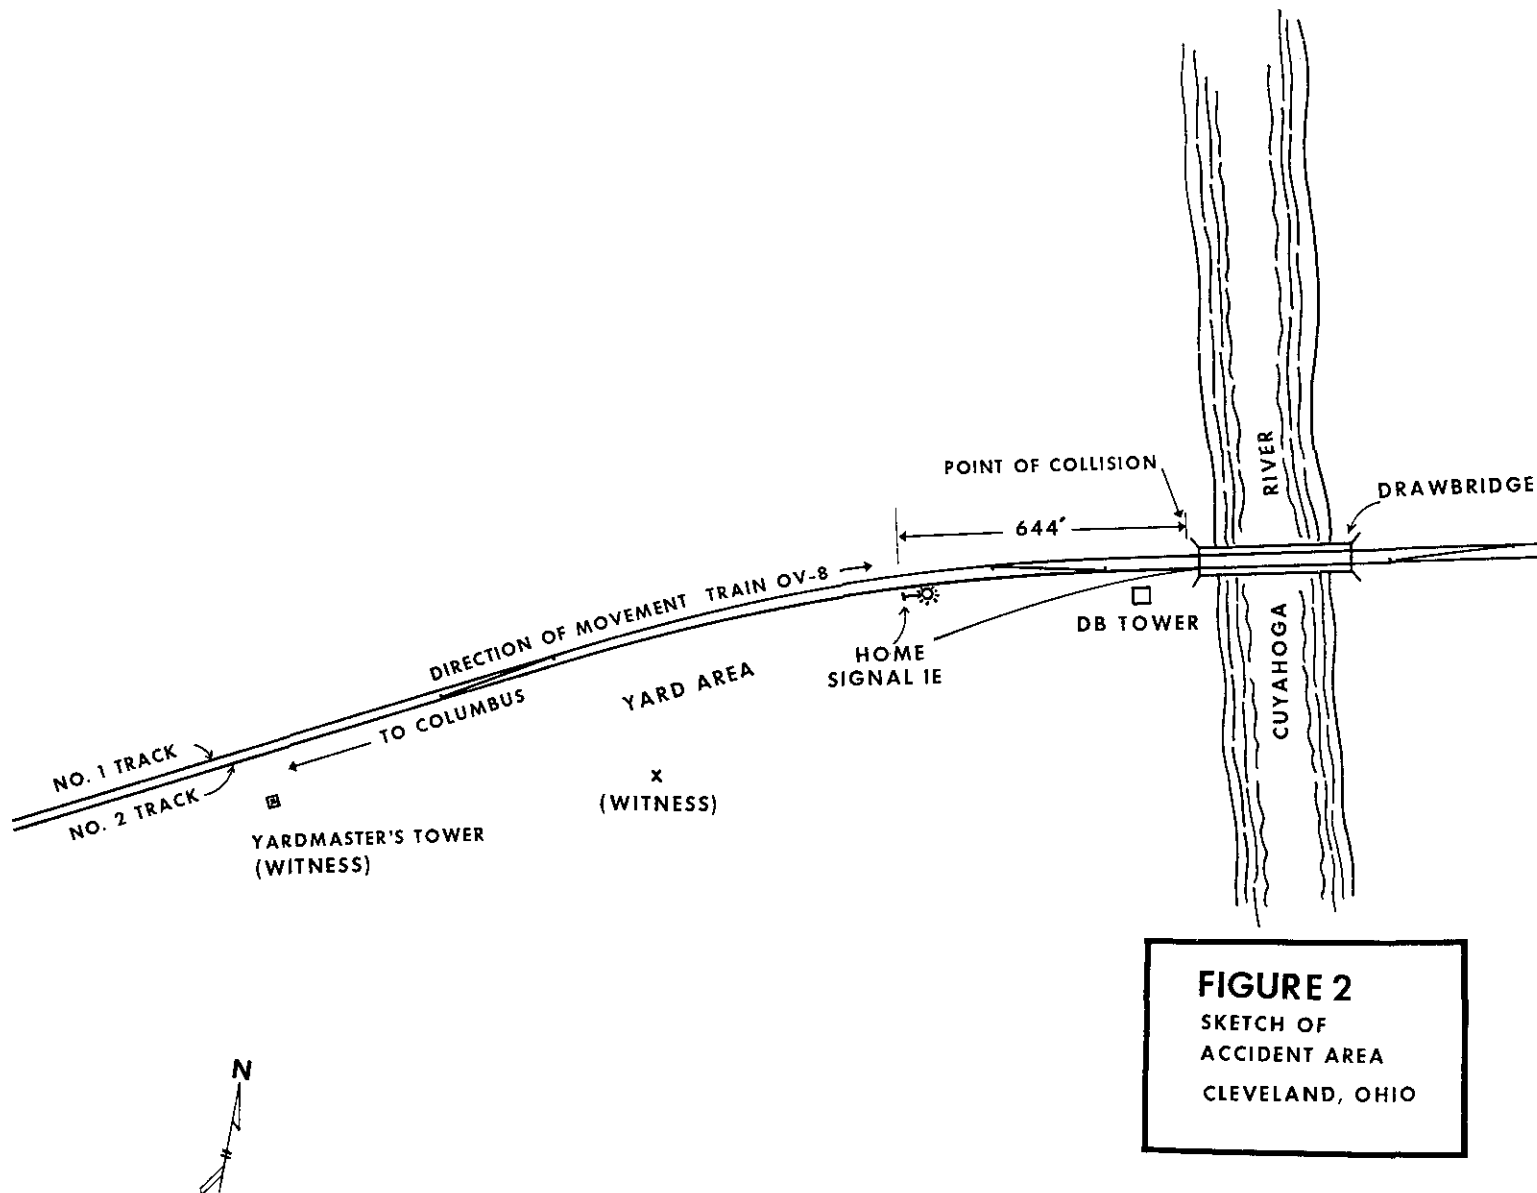
Following that conversation, the DB operator remembered that a U.S. Corps of Engineers' boat had been awaiting passage through the bridge channel since 3:20 a.m., and he immediately opened the bridge. When the bridge was raised, the bridge counterweight was within 5 feet of the track. At 3:56 a.m., train OV-8 collided with the bridge counterweight. (See Figure 1.)

Figure 1. View of wreckage looking east toward Cleveland and the Cuyahoga River.
