NATIONAL TRANSPORTATION SAFETY BOARD

RAILROAD ACCIDENT REPORT

SIDE COLLISION OF
SOUTHERN RAILWAY COMPANY
TRAINS NOS. 1 AND 152
SPENCER, NORTH CAROLINA
OCTOBER 8, 1977

REPORT NUMBER: NTSB-RAR-78-3

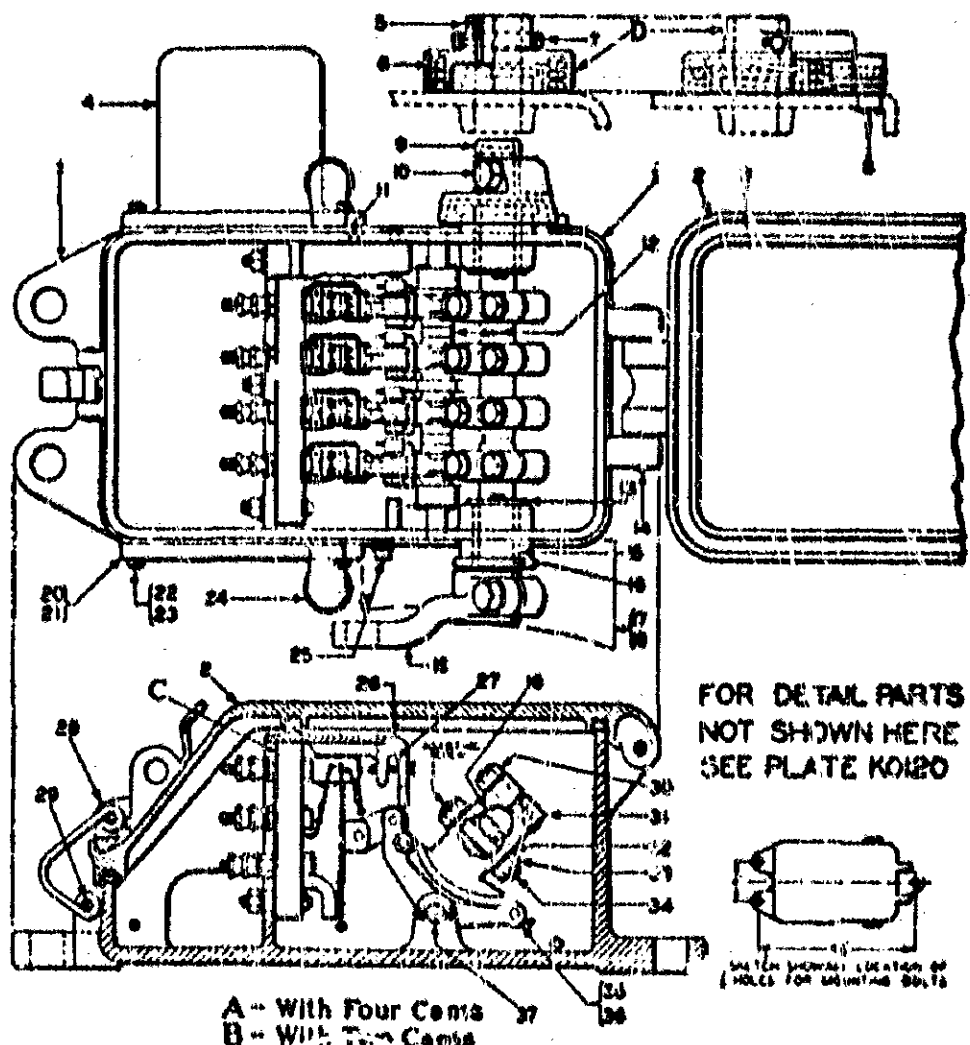
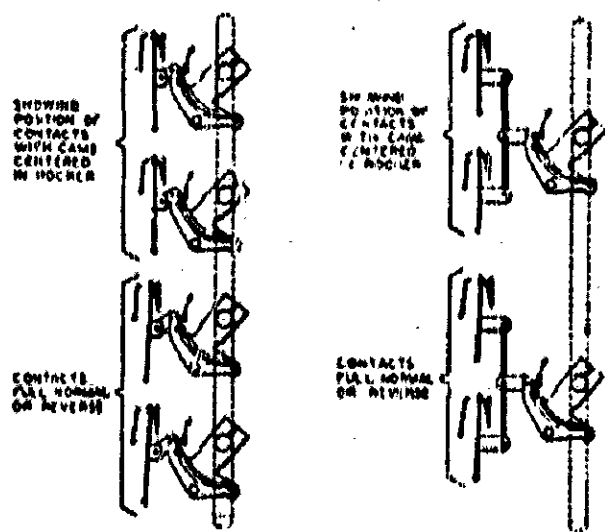
A red signal aspect on signal 330.7 can be caused, among other reasons, by a shunt circuit ^{2/} between the two running rails. A shunt circuit can be imposed by the presence of a train or by a switch that either is not fully closed in a normal position, or is in a full reverse position. The shunt removes the track voltage from the track relay; this causes the signal to display a red aspect. Federal regulations (49 CFR 236.6) require that when a facing-point, hand-operated switch equipped with a circuit controller connected to the switch points is operated 1/4 inch or more from its normal position, track or control circuits will be opened or shunted or both. The shunt at Spencer Yard was imposed by the closing of electrical contacts within a circuit controller. (See Appendix C and figure 2.)

The shunt wires were two 5/16-inch, stranded, insulated track wires which had a tapered plug on one end driven into a hole in the web of the rail. Each rail had two wires that were connected to separate contacts in the circuit controller. Each of these contacts in the circuit controller were then connected parallel to another set of contacts to provide redundancy in shunt circuit paths. The movement of either switch of the crossover from 1/4 inch to a full reverse position should have caused signal 330.7 to display a red aspect.
